Futures Fire Risk Assessment

Futures Homescape, Community Centre Park
Crescent: DE56 2AD, - UPRN: 13 / 173532 / QA
Approved / Andy Cloke

Futures Homescape,
Community Centre Park
Crescent: DE56 2AD, - UPRN:
13, Fire Risk Assessments,
Futures Homescape

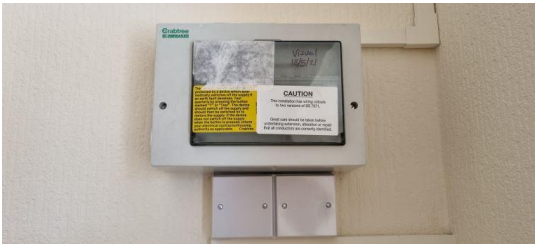
Photo 3

There is no label displayed on the consumer unit to confirm the date of the last fixed wiring test. Refer to Policy Principle.

Management should confirm that the fixed wiring has been tested in line with Policy Principle.

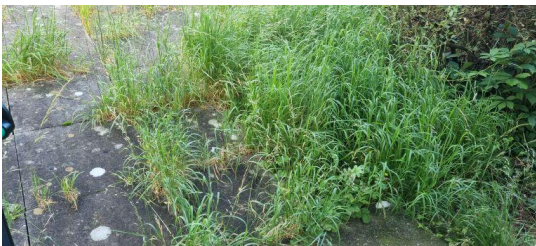
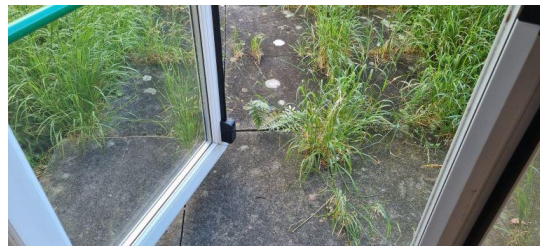
There are weeds growing in front of the rear exit which may hamper safe egress from the sitting room exit as they grow.

Management should monitor and review and ensure that weed growth is cut back if the centre becomes used in future.

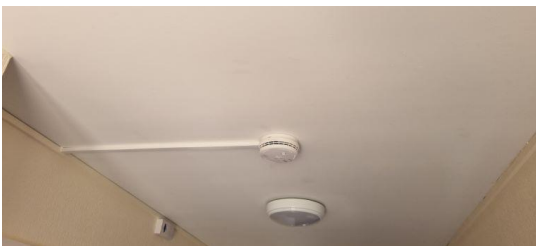
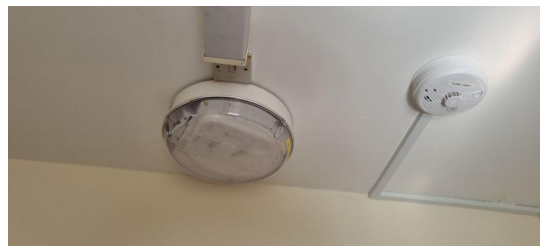
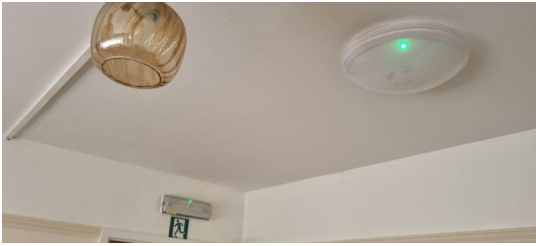
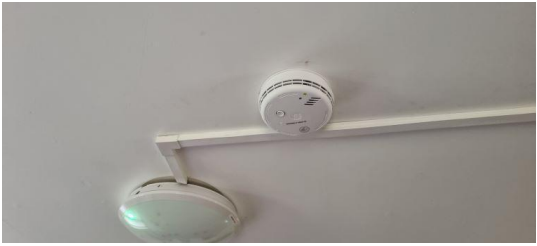
Conduit and cables were noted throughout and it was not possible to confirm that the requirements of Regulation 521.10.202 of the BS 7671 - 18th Edition of The IET Wiring Regulations, which requires all cables to be adequately supported using non-combustible fixings to prevent premature collapse in the event of a fire. The new regulation is not applied retrospectively so any wiring systems fitted before 2019 do not need to be immediately updated. Any new installation or additions and alterations to existing systems, including temporary wiring, have to comply with the regulations.

Management is to consider the requirements of the Regulation 521.10.202 of the BS 7671 - 18th Edition The IET Wiring Regulations which requires all cables to be adequately supported using non-combustible fixings to prevent premature collapse in the event of a fire albeit not retrospective and seek the advice of a suitably qualified competent person or organisation and undertake any remediation identified by the aforementioned competent person or organisation.

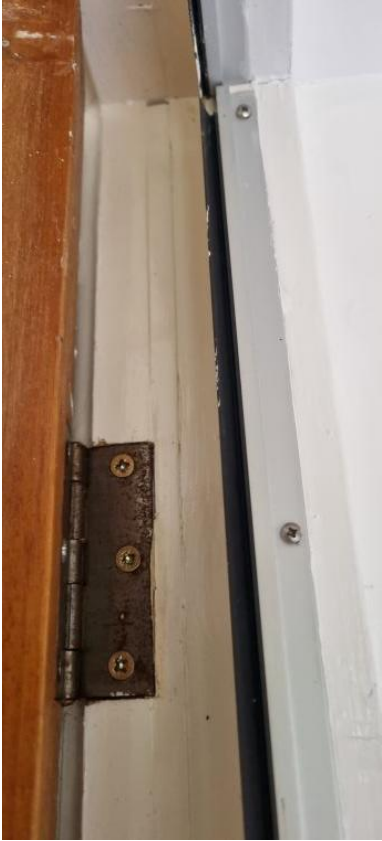
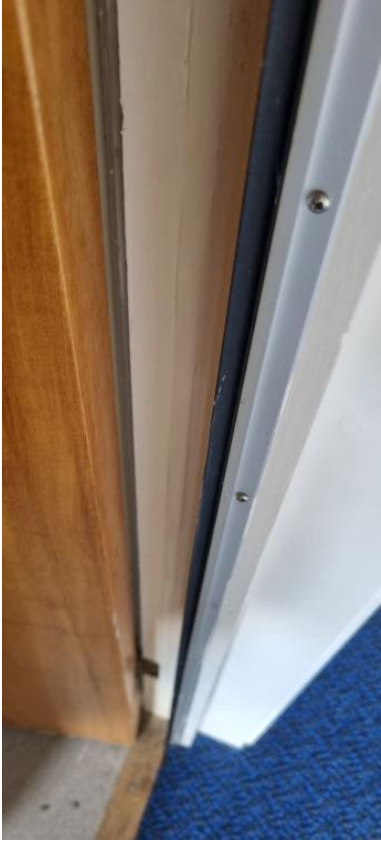
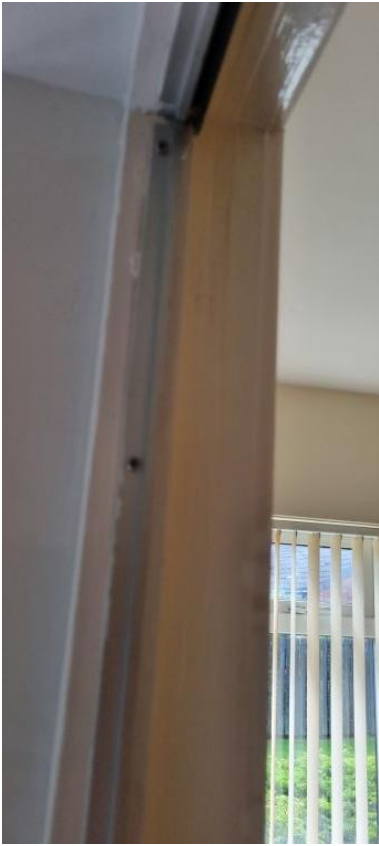
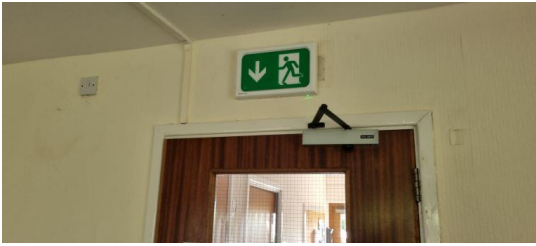
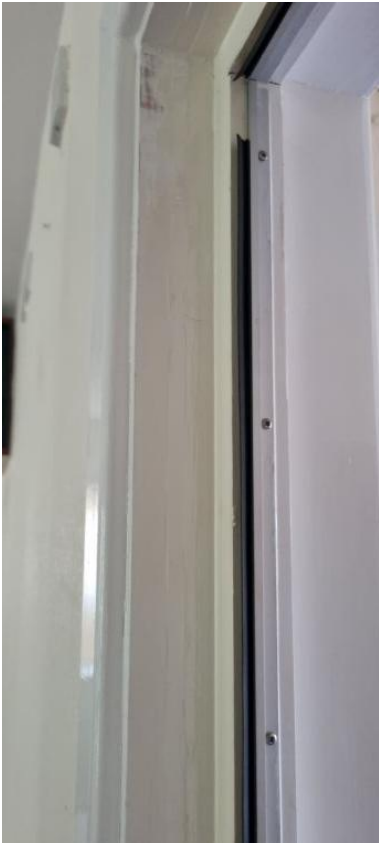
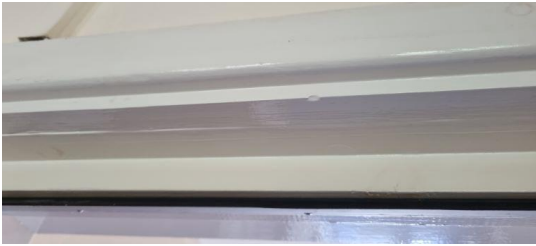
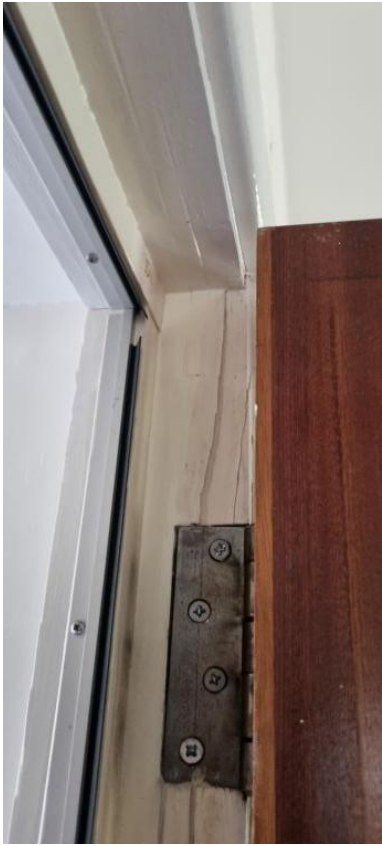
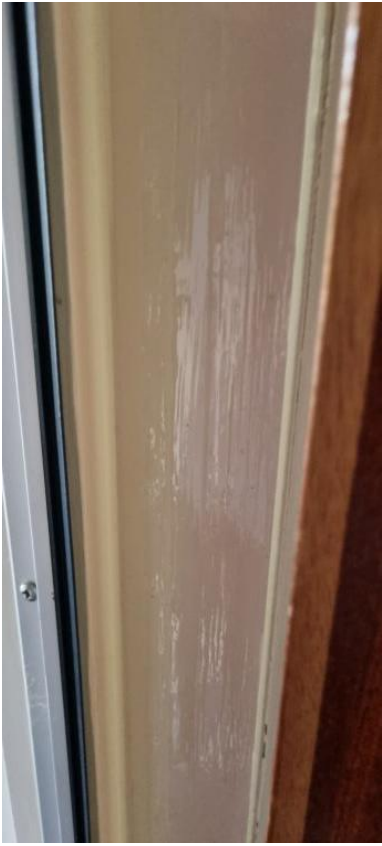
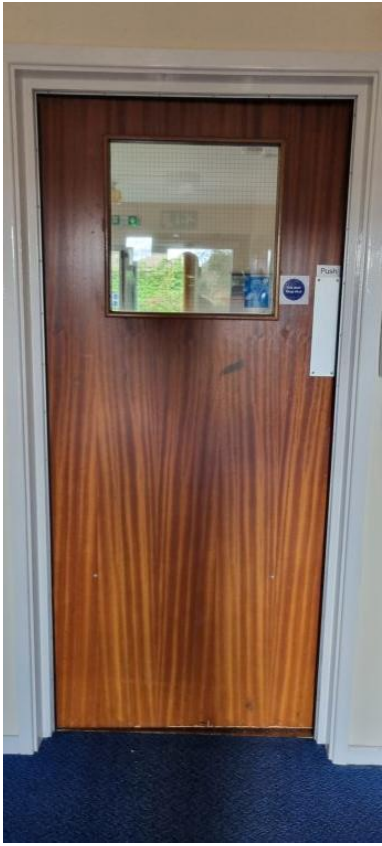
The separating fire door to the foyer and the kitchen door have intumescent strips fitted to the frame and self closure mechanism. Intumescent strips have been painted over which is likely to compromise seal integrity. The door frame to the separating door has some damage to the frame.

Managements should repair or replace fire doors with self closing certified fire door sets to FD30 specification. The assessor has placed a guide for remediation as 12 months as the centre is not used. Remediation should be completed with 3 months if there are any plans to use the community centre.

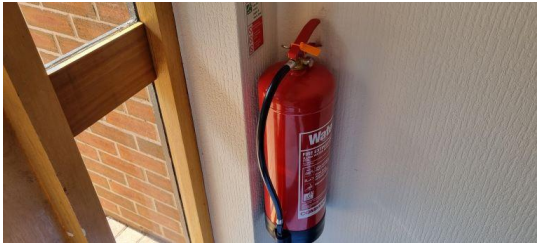
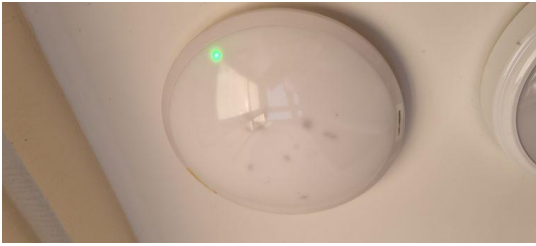
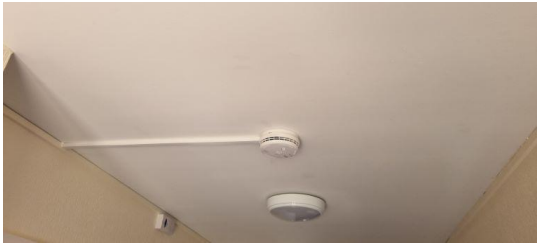
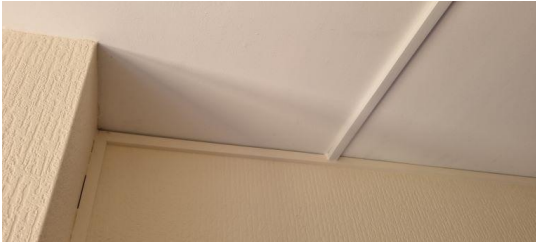
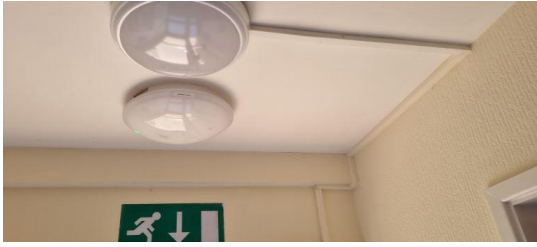
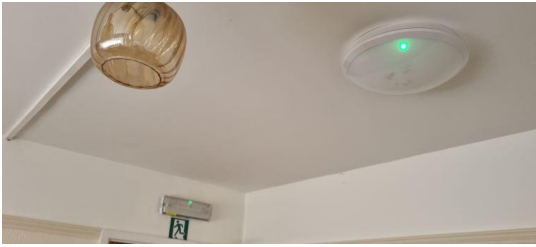
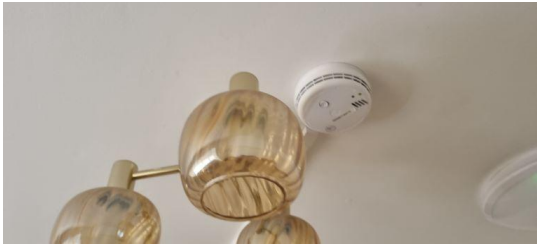
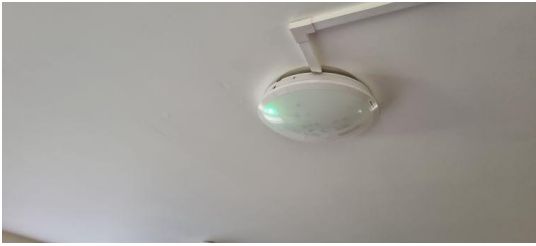
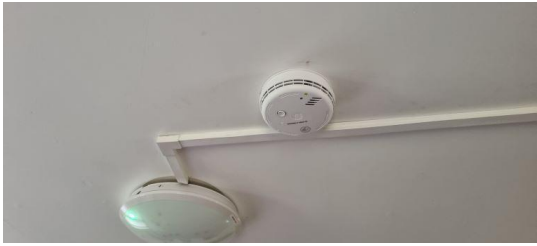
Walls are solid with emulsion painted plaster / wallpaper covering with plaster boarded ceilings and solid floors. No obvious penetrations were identified. It was not possible to determine the level of compartmentation between the community centre and the dwelling above.

Management should ensure that there is adequate compartmentation between the community centre and dwelling above.
