Futures Fire Risk Assessment

Futures Homeway, Flats 11-14 Blake
Close: NN11 4LW, - UPRN: 1370000 /
171943 / QA Approved / Piotr Iwan

**Futures Homeway, Flats 11-14
Blake Close: NN11 4LW, - UPRN:
1370000, Fire Risk Assessments,
Futures Homeway**

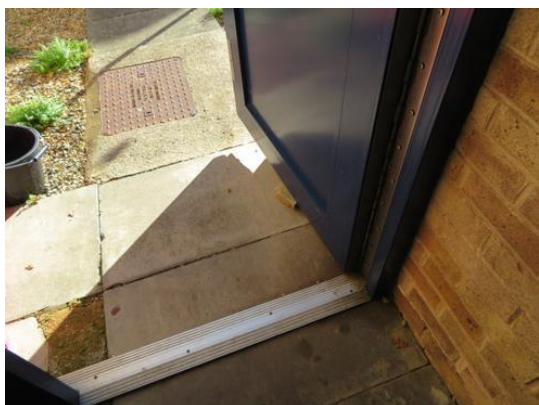
Photo 5

The block rear entrance door was noted to be wedge open at the time of the assessment.

The block entrance doors should remain closed at all times when not in use. Residents should be reminded that block entrance doors should never be wedged open. Regular checks should be conducted to ensure compliance.

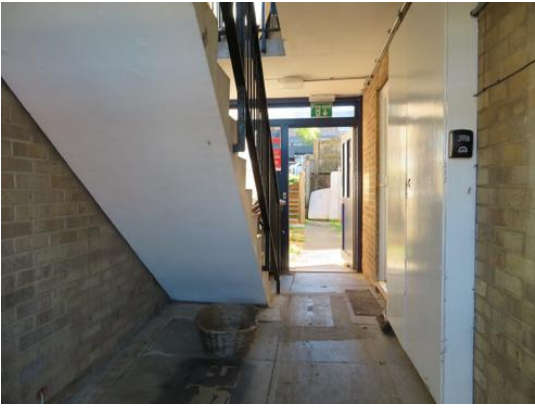
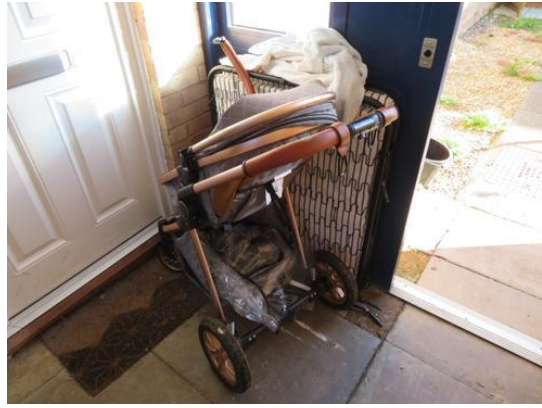
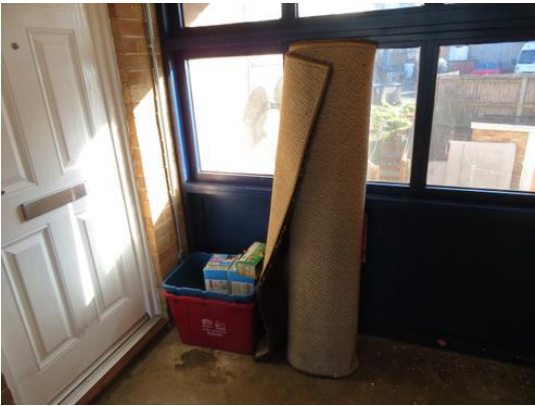
The common escape routes were clear of combustibile materials, trip hazards and waste at the time of inspection with the exception of a wicker basket under the stairs on the ground floor, buggy and personal items outside of flat 11 entrance door and carpet and recycling outside of flat 13 on the first floor.

Items noted should be removed from the communal areas as soon as is reasonably practicable. Residents should be informed that items must not be stored in the communal areas at any time. Regular checks should be conducted to ensure compliance.

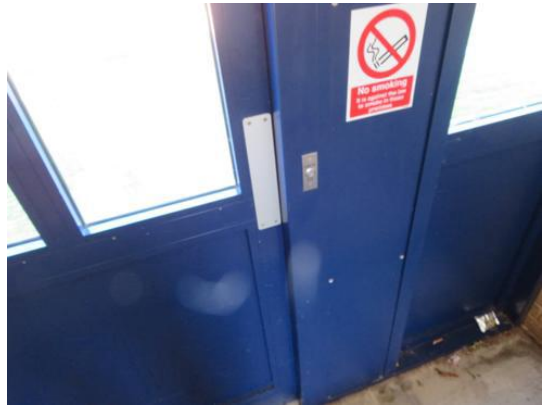
Photo 10

Push to exit release buttons are installed to the front and rear entrance doors for the block.

The client should conform that the exit system defaults to an open position in the event of a power failure, or that it is installed with a battery backup power supply. The omission of a manual override in accordance with BS7273-4 is noted and acceptable if the above is confirmed and if malicious activation risk is high. If the risk of malicious activation is deemed to be low, the client should consider the installation of manual override systems to the entrance doors of the block.

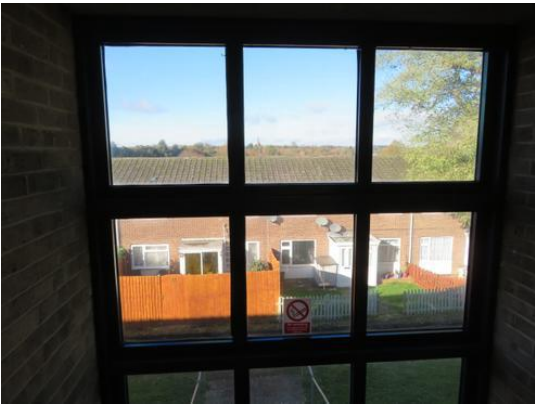
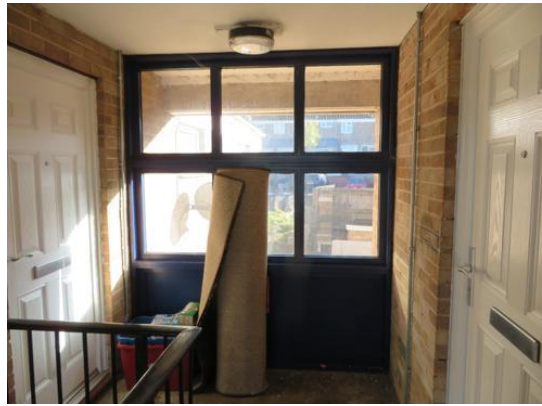
The block appears to have originally been designed as an open deck approach but subsequently has been enclosed. There are no means of ventilated the block on the first floor with fixed window units now in place.

The ventilation arrangements within the first floor should be assessed against the fire strategy document and the building regulations at the time of construction. Remedial works should be completed to ensure that the block is adequately ventilated if it does not meet the standard detailed above.

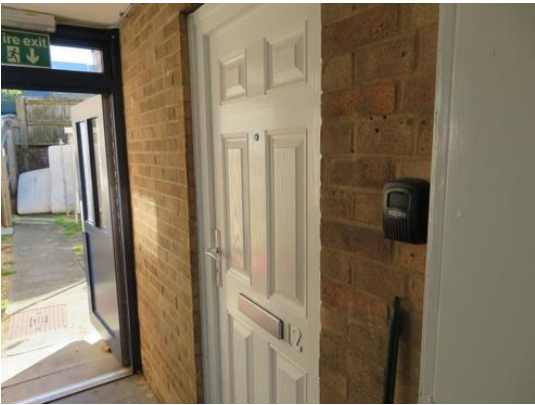
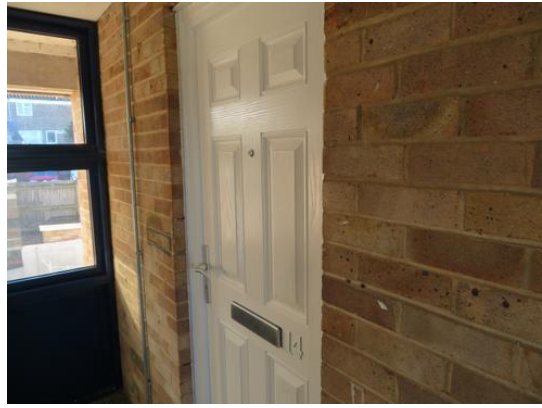
Flat entrance doors appeared to be replacement certified FD30 fire doors. (NB. - from limited visual inspection, certification not seen; adequacy of installation not confirmed).

No flats available for sample inspection at the time of the assessment.

Management should establish an ongoing programme of rolling checks to flat entrance doors to ensure they are installed with combined intumescent strips/cold smoke seals and positive action self-closing devices.

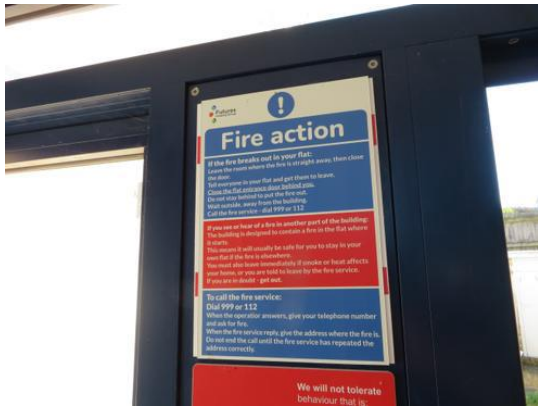
A fire action notice was installed to the common areas of the block denoting a 'Stay Put' evacuation strategy.

Fire door signage was not installed to the electrical intake door.

'Fire Door - Keep Locked Shut' signage should be installed to the electrical intake cupboard doors on the outer face of both leaves.

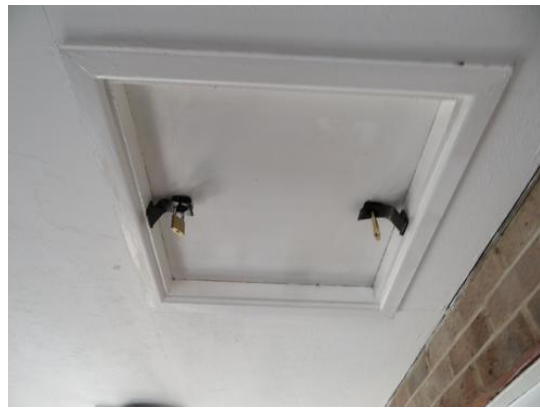
Photo 26

Compartmentation within the roof space could not be checked at the time of the assessment due to non-standard locks being installed to the hatch.

The loft space should be checked to ensure that there is adequate compartmentation is in place in the roof space between flats and the common areas.
