## Futures Fire Risk Assessment

Futures Homeway, Flats 36-39 Nene Walk: NN11 4QH, - UPRN: 2330000 / 171957 / QA Approved / Piotr Iwan

Futures Homeway, Flats 36-39  
Nene Walk: NN11 4QH, - UPRN:  
2330000, Fire Risk Assessments,  
Futures Homeway

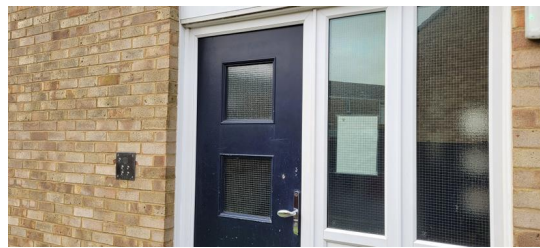
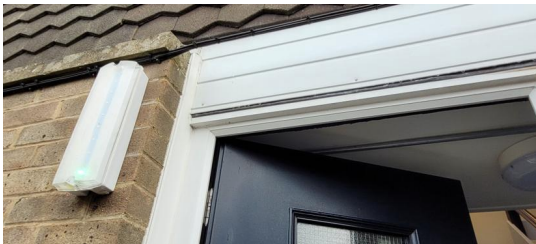
The block is installed with an access control system.

The block entrance doors are not self closing to prevent unauthorised access.

It is recommended that overhead positive action self closing devices are installed to the block entrance doors to prevent unauthorised access.

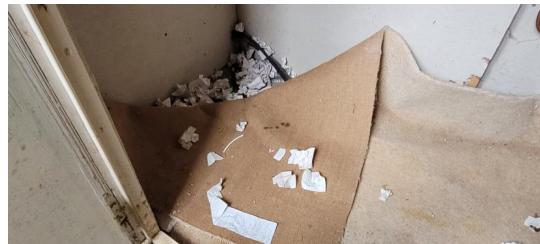
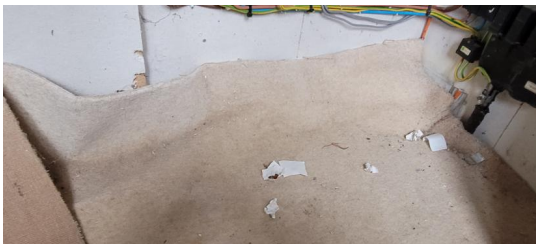
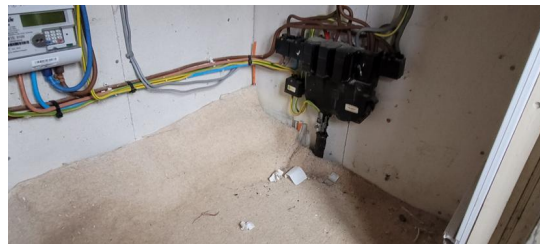
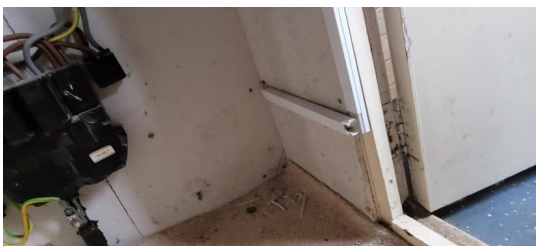
The electrical intake cupboard was noted to have carpet loosely installed to the floor. There were also loose pieces of paper on the floor of the cupboard.

It is recommended that the carpet and paper is removed from the electrical intake cupboard. Regular checks for combustible materials should be made to ensure compliance.

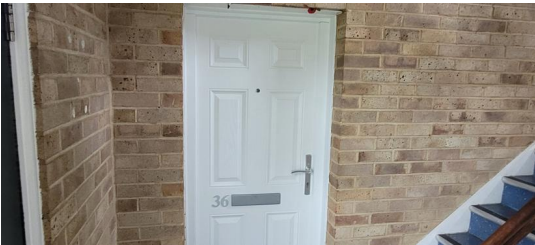
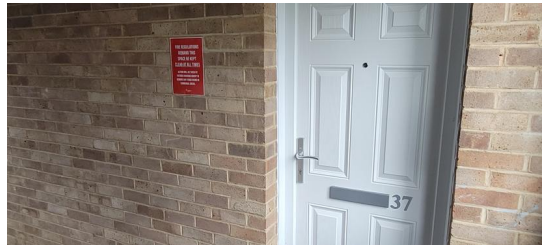
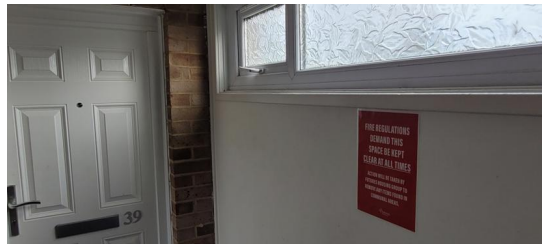
Flat entrance doors appeared to be replacement FD30 timber fire doors. (NB. - from limited visual inspection, certification not seen; adequacy of installation not confirmed).

No flats available for sample inspection at the time of the assessment.

Management should establish an ongoing programme of rolling checks to flat entrance doors to ensure they are installed with combined intumescent strips/cold smoke seals and positive action self-closing devices.

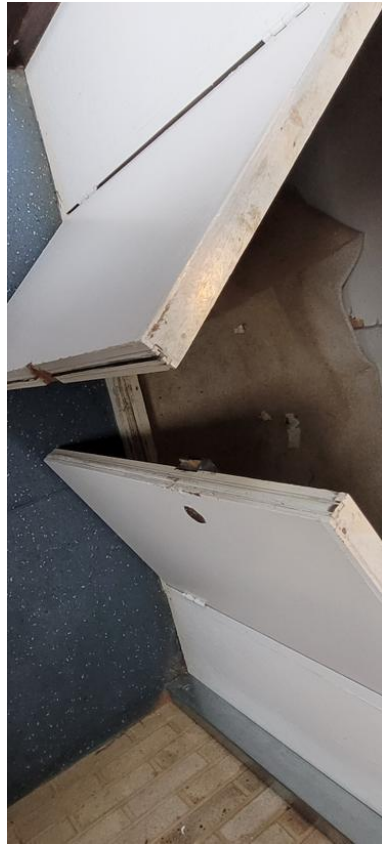
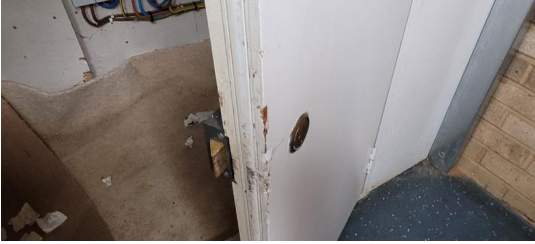
The fire doors installed to the electrical intake cupboard under the stairs were noted to be 44mm thick solid core timber fire doors installed with combined intumescent strips and cold smoke seals.

The doors were in good condition at the time of the assessment with the exception of a small amount of damage to the door faces and edges requiring repair. The damage appears to be caused by the locking mechanism in place.

The doors were kept locked at the time of the assessment.

The damage noted to communal doors should be repaired. Repair works should also be performed to the locking mechanism with the installation of a stake plate to prevent further and future damage to the doors.

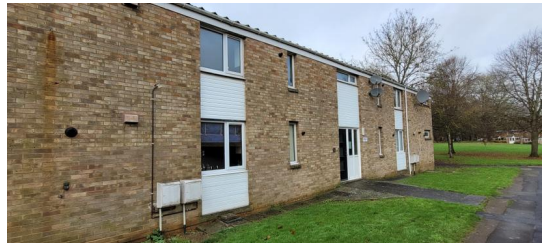
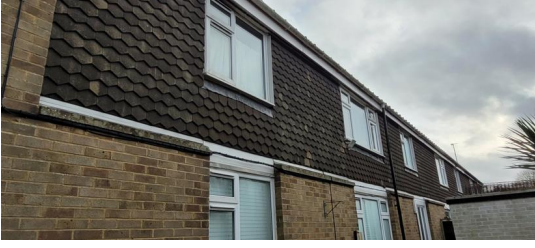
The external walls were noted to have uPVC panels installed between the ground and first floor windows which could lead to external fire spread between floors.

Clay tiles are installed to the external wall at the rear of the block on top of an unknown substrate.

It is recommended that the client commission an FRAEW to determine the combustibility of the external wall systems installed to the building and to determine any remedial works that may be required.
