Futures Fire Risk Assessment

Futures Homescape, Community Centre Pennytown Court: DE55 4TB, - UPRN: 9 / 173530 / QA Approved / Andy Cloke

UPRN:	9
JOB NUMBER:	173530
FRA COMPLETED BY:	Pennington Choices Limited
FIRE RISK ASSESSOR NAME:	Adrian Gallimore
INSPECTION DATE:	22 Aug 2023
REPORT STATUS:	QA Approved
REASSESSMENT PRIORITY	Medium - 2 Years
VALID TO: (QA Use Only)	8 Sep 2025
VALIDATION DATE: (QA Use Only)	8 Sep 2023
VALIDATED BY: (QA Use Only)	Andy Cloke

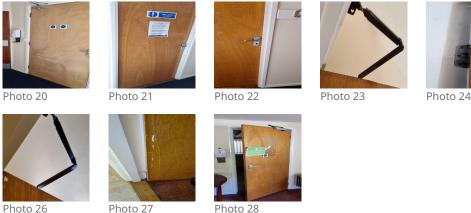
Photo 26

It was not possible to establish fire rating of the laundry and kitchen door. Doors are of 40mm width with self closure devices fitted. There is some damage to the laundry door by the door handle and hinges do not appear to be fire rated. There is also door labelled as a fire door off the foyer that was not accessible (see G1).

Management should confirm fire rating of the kitchen and laundry doors. Where doors are found not to be fire rated, there should be replaced with certified self closing fire door sets to FD30 specification. Any installation or repair should only be conducted by a certified third-party contractor.

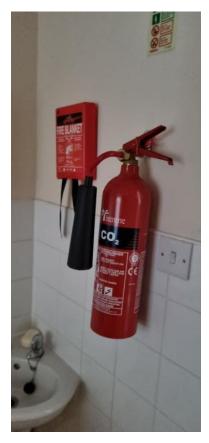
Photo 47

There is 1 x 27A 9L Water and 2 x 2KG CO2 units installed. Extinguishers are maintained under service contract with Harmony. The last service was completed 02/23. In addition, community centre users are unlikely to be trained on the use of FFE and no signage is displayed to state 'only to be used by trained persons'.

Management should display signage at fire points to state 'extinguishers should only be used by trained persons'.
