Futures Fire Risk Assessment

Futures Homescape, Community Centre
Providence Place: DE55 7AZ, - UPRN: 17 / 173533 /
QA Approved / Andy Cloke

Futures Homescape,
Community Centre Providence
Place: DE55 7AZ, - UPRN: 17,
Fire Risk Assessments, Futures
Homescape

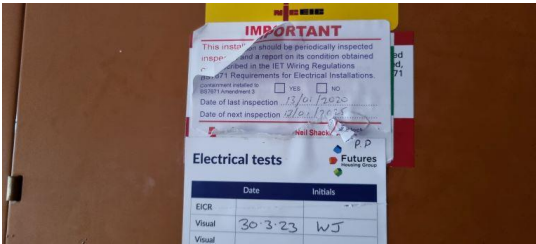
Photo 3

There is a small cupboard within the entrance foyer that has a label on that confirms that the fixed wiring was last tested on 13/01/2020.

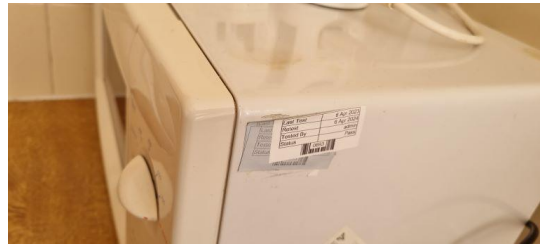
Photo 4

Labels on portable electrical appliances confirmed that PAT testing was last completed on 6/04/2023.

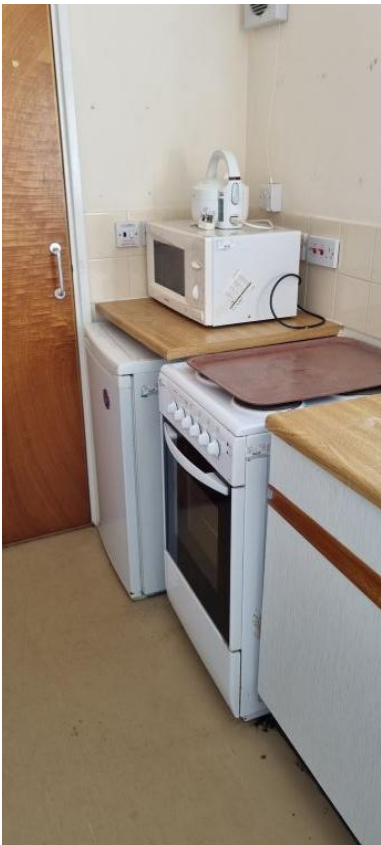
Photo 9

There is an electrical cooker within the community centre kitchen. It was not possible to establish how often the kitchen is used or what rules are in place for cooking etc.

Management should consider removing the electric cooker in favour of a microwave only if cooking is not frequent. Where the cooker is to remain it is advisable that it is only used for low risk activities and that high risk (deep fat frying etc) is prohibited. Rules for the use of the kitchen should be disseminated to users.

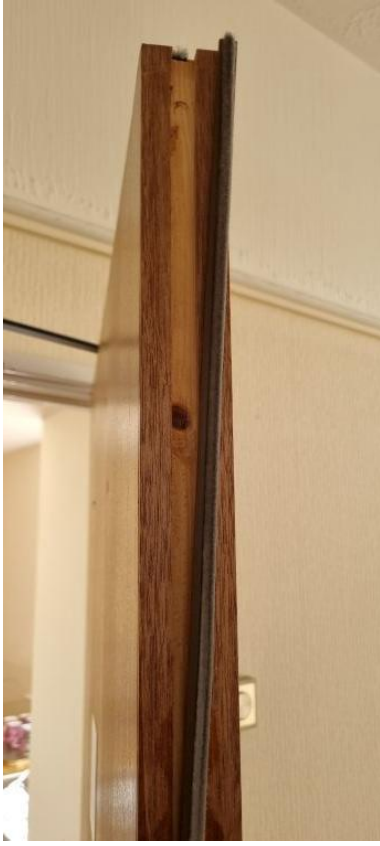
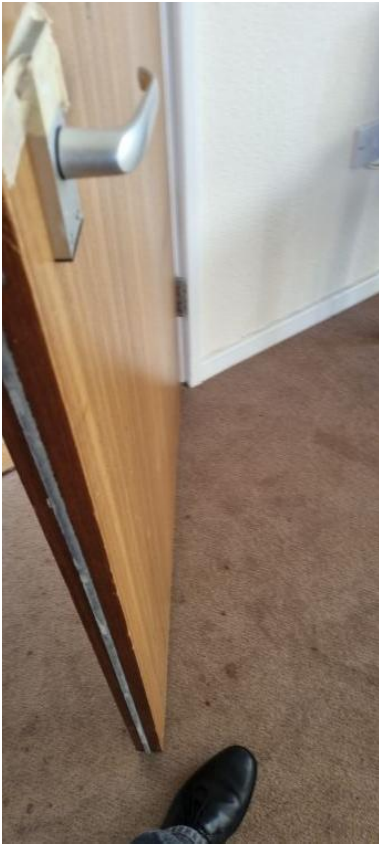
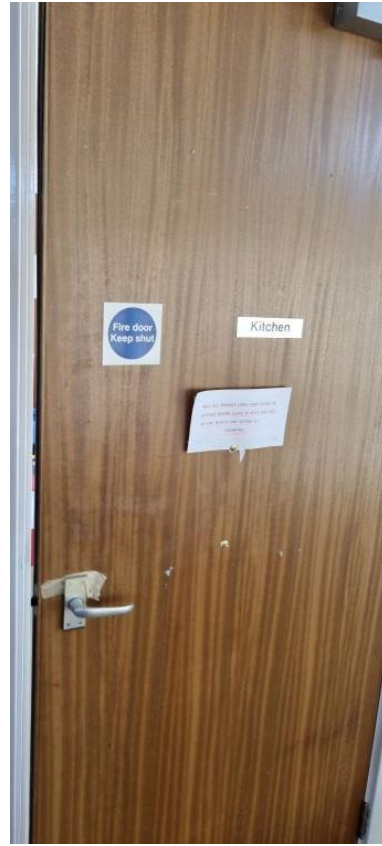
The kitchen door intumescent strip is damaged.

The kitchen door should be repaired. Any repair should be completed by a certified third-party contractor.

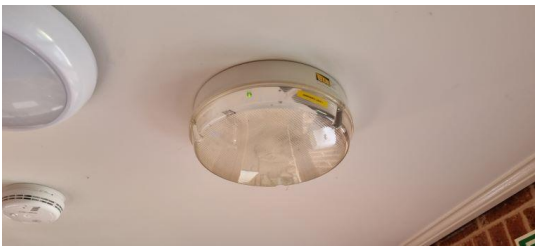
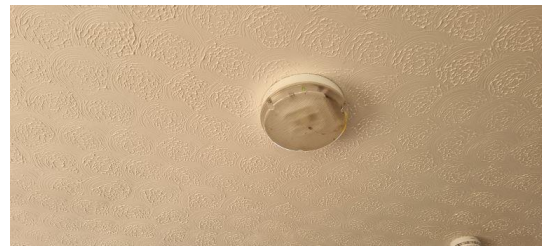
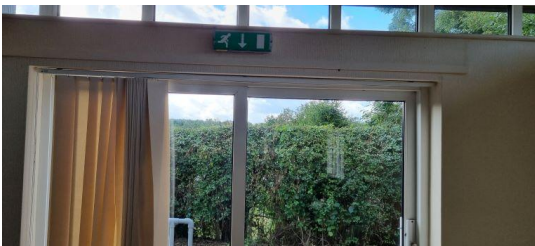
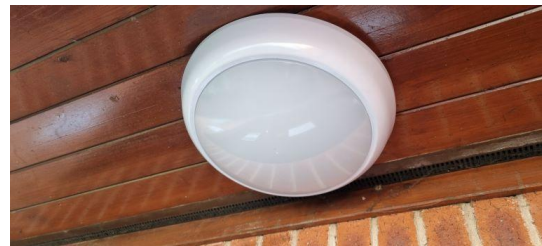
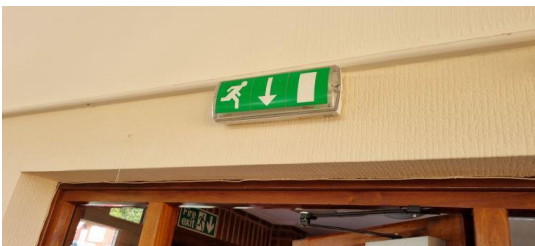
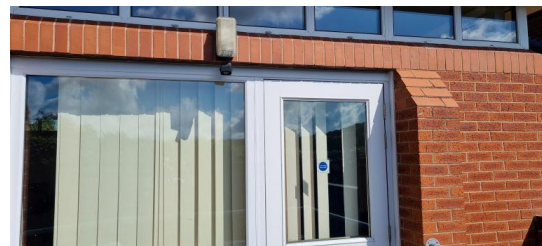
Emergency lighting is installed and appears adequate. Defective units were identified within the sitting room. In addition, the external unit to the front of the premise was defective and no emergency light is present to the rear.

Management should ensure that emergency lighting is inspected and any defects repaired. An additional light unit is required to the rear exit.

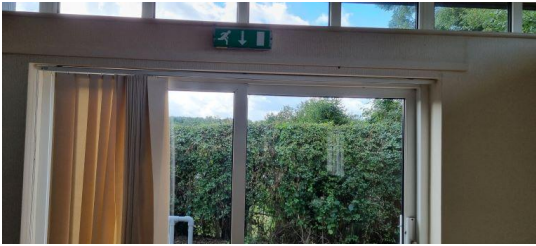
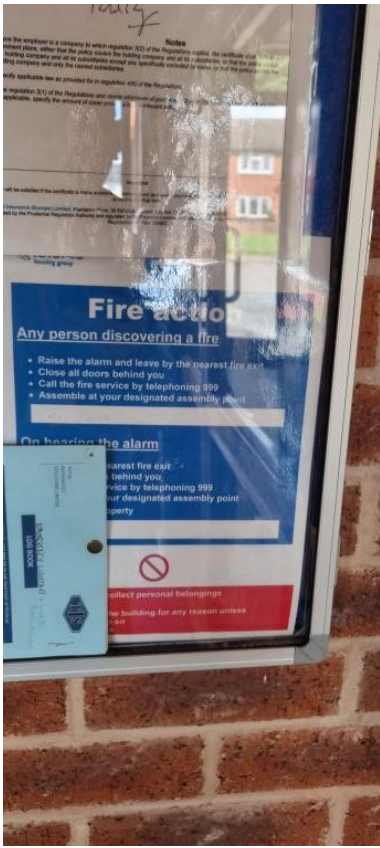
Illuminated signs are installed by exits however the rear sign appeared to be defective (refer to N1). There is a Fire Action Notice displayed however it has not been completed and it is obscured.

The Fire Action Notice requires completing with all the relevant information. The sign should be relocated or notices obscuring it should be removed.

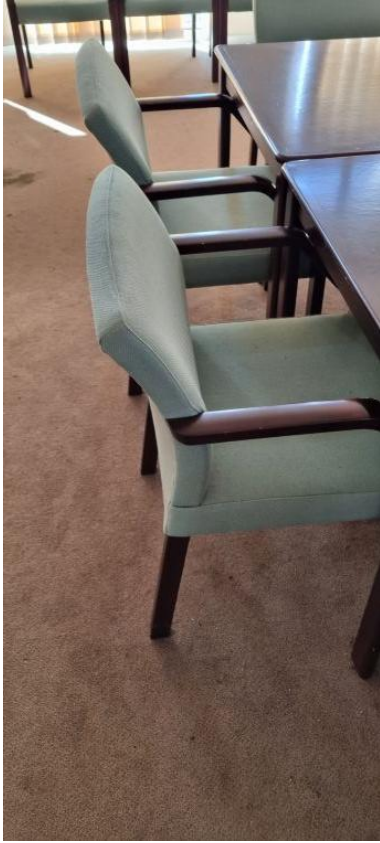
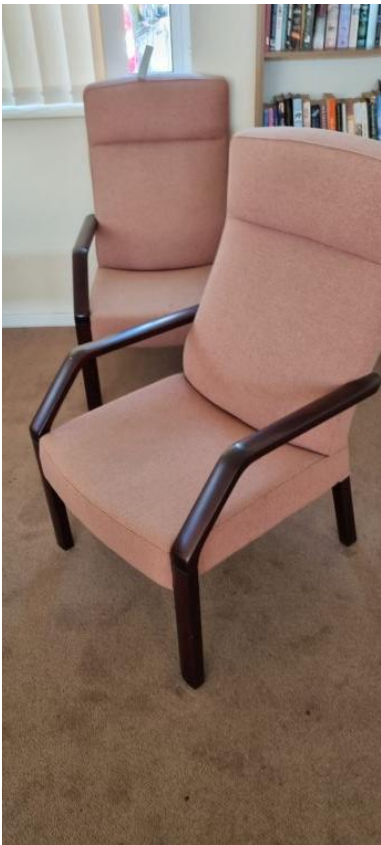
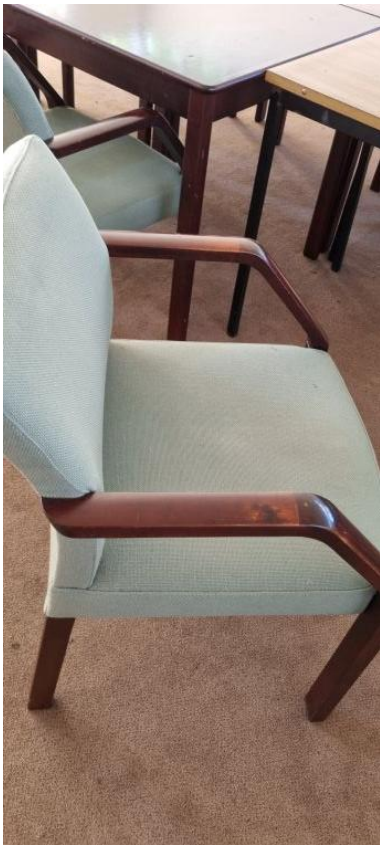
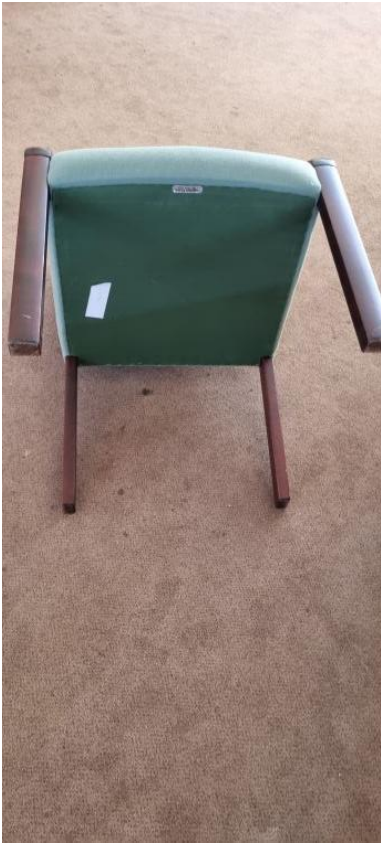
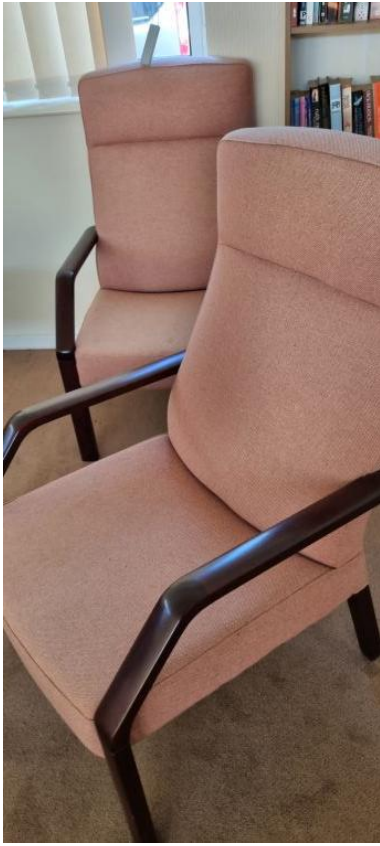
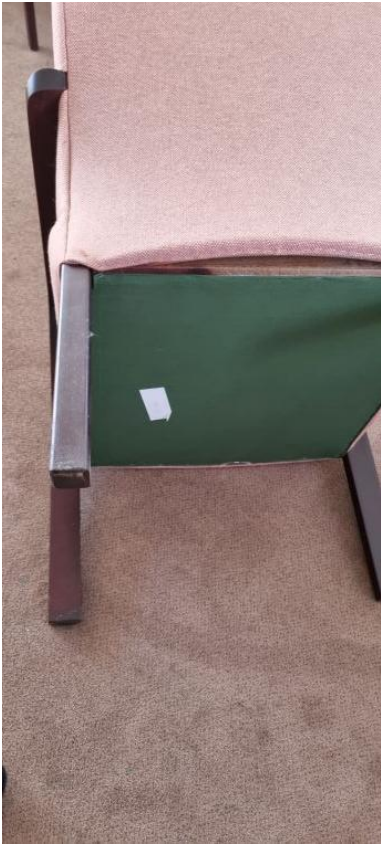
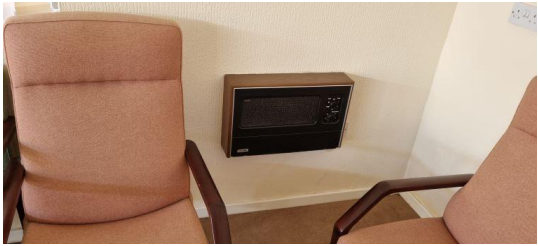
Soft furnishings were not labelled and it was not possible to establish if the material is fire retardant.

Management should confirm if soft furnishings are of fire retardant material. Where furniture is not fire retardant, it should be replaced with within fire retardant type.
