Futures Fire Risk Assessment

Futures Homeway, Flats 19-25 Riverside Drive:
NN7 4RJ,-UPRN: 5960000 / 171923 / QA Approved
/ Andy Cloke

Futures Homeway, Flats 19-25
Riverside Drive: NN7
4RJ,-UPRN: 5960000, Fire Risk
Assessments, Futures
Homeway

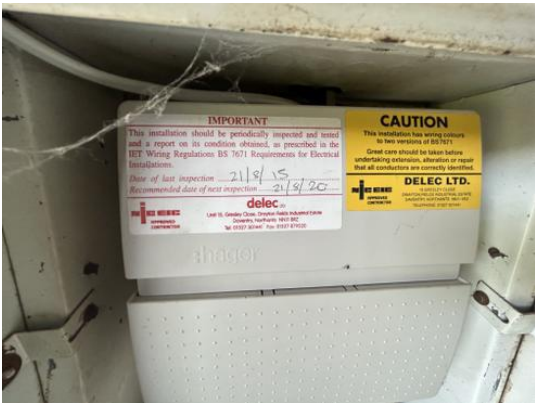
Photo 3

The communal distribution board had a sticker affixed that showed an expiry date of 21/08/2020.

Ensure that the 5 yearly periodic electrical inspection within the communal areas is current. If not, instruct a competent electrical contractor to carry out this work to BS 7671 and ensure that an "Electrical Installation Condition Report (EICR)" is obtained. Any remedial works identified should be actioned and completed.

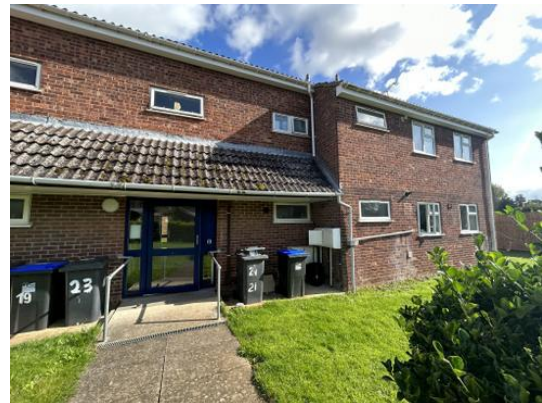
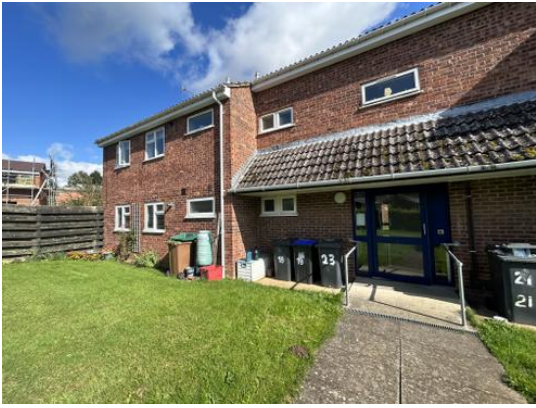
Photo 6

At the time of the inspection, domestic wheelie bins were seen to be stored to the rear of the block adjacent to the final exit door.

The wheelie bins noted should be relocated away from the building a minimum of 2 meters. Ideally bins should be placed in a secure bin store. Regular checks should be conducted by the client to ensure that bins remain away from the building in their designated storage area.

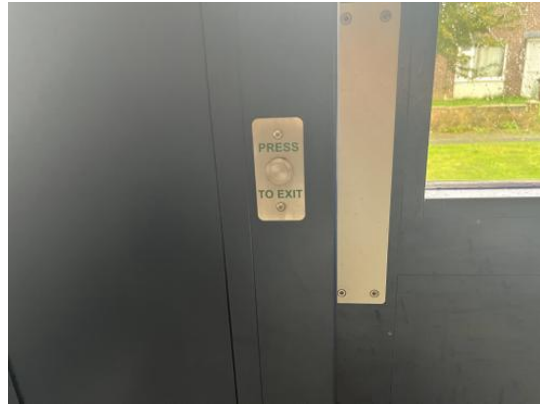
Photo 8

Push to exit release buttons are installed to the front and rear entrance doors for the block.

The client should confirm that the exit system defaults to an open position in the event of a power failure, or that it is installed with a battery backup power supply. The omission of a manual override in accordance with BS7273-4 is noted and acceptable if the above is confirmed and if malicious activation risk is high. If the risk of malicious activation is deemed to be low, the client should consider the installation of manual override systems to the entrance doors of the block.

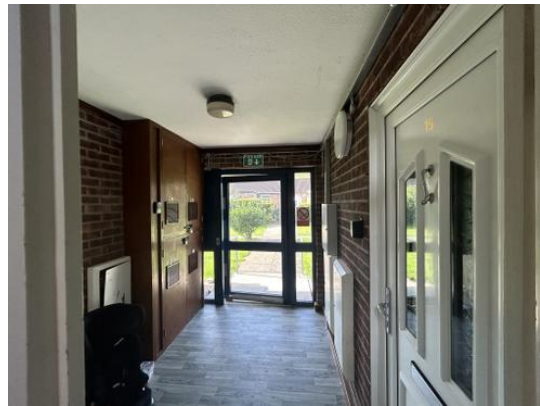
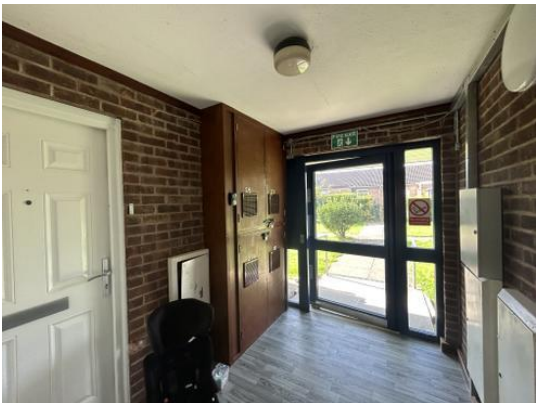
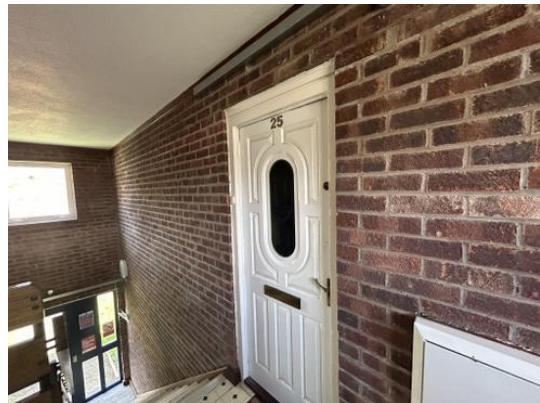
Photo 12

Flat entrance doors were a combination of replacement timber doors and replacement uPVC doors and certified timber fire doors installed to composite frames. (NB. - from limited visual inspection, certification not seen; adequacy of installation not confirmed).

Management should establish an ongoing programme of rolling checks to flat entrance doors to ensure they are installed with combined intumescent strips/cold smoke seals and positive action self-closing devices.

As flat entrances have been fitted with composite/uPVC doorsets/frames, these should have test evidence demonstrating they meet the performance requirement in Building Regulations guidance for fire resistance and smoke control from the flat side only. Management should confirm that suitable fire door test certificates are held and that these relate to the doors fitted. If adequacy cannot be confirmed it may be necessary for doorsets/frames to be replaced under a risk-based programme.

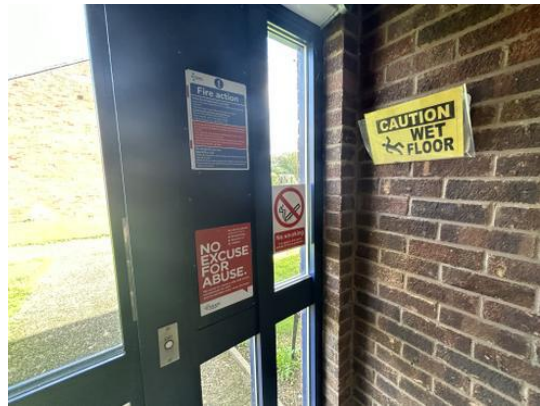
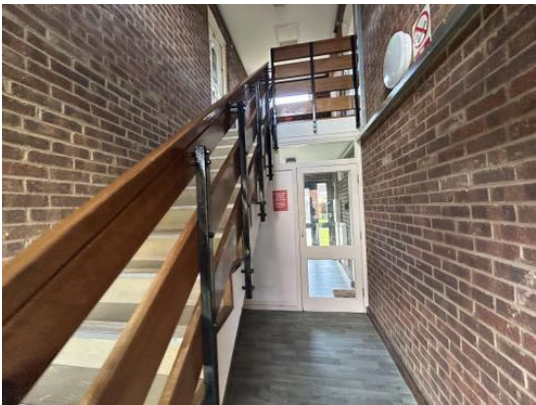
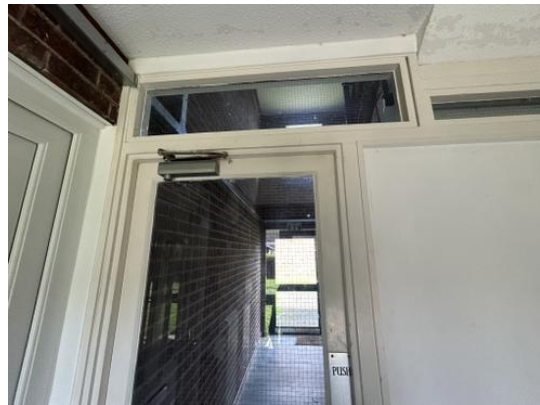
Photo 20

A fire action notice was installed to the common areas of the block denoting a 'Stay Put' evacuation strategy.

Fire door signage was not installed to the ground floor lobby door.

Fire Door - 'Keep Locked Shut' signage should be installed to both sides of the ground floor lobby door.

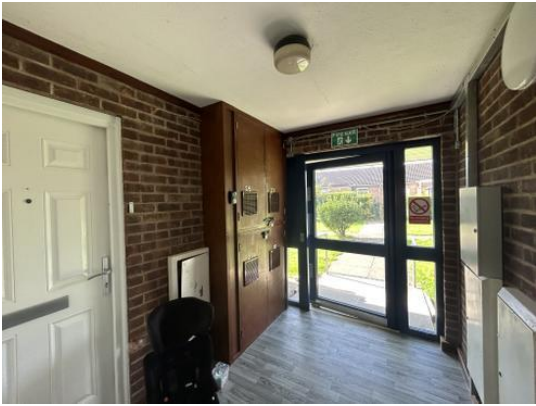
Photo 23

Locked cupboards noted on the ground floor could not be determined as adequately fire resisting or fire stopped.

The cupboards noted should be checked to ensure they are adequately fire resisting and that all penetrating services are fire stopped from both sides where required. If the cupboards contain sources of ignition then the cupboards should be capable of achieving a minimum of 30 minutes fire resistance. Any remedial works required should be conducted by a competent third party accredited contractor.

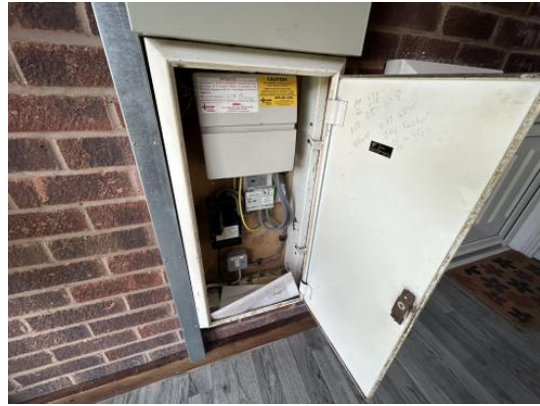
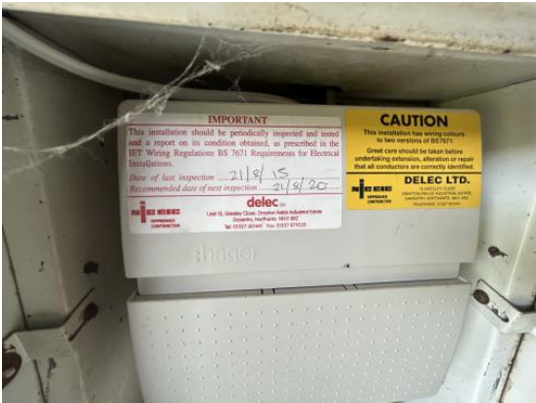
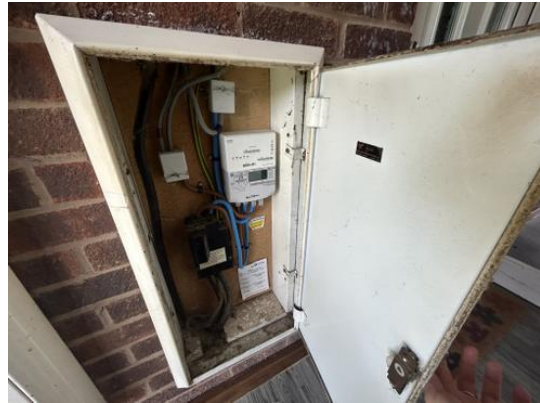
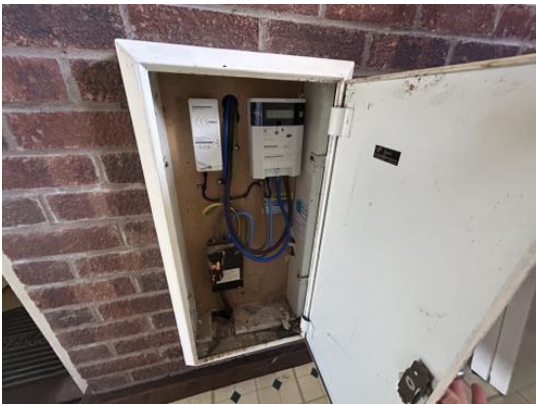
Photo 24

Recessed meter enclosures containing domestic meters and the communal electrical distribution board located in the common areas were not found to be fire resisting or fire stopped.

The recessed meter enclosures noted that house the communal distribution board and domestic meters should be upgraded to offer 30 minutes of fire resistance. Alternatively, the enclosures can be installed with 30 minute fire rated overboxes. All penetrating services between compartments should be fire stopped. Remedial works should be completed by a competent third-party
