Futures Fire Risk Assessment

Futures Homescape, Flats 1-4 & Laundry
Holme Close 1 - 4 & Laundry: DE4 5BE, -
UPRN: FB123 / 173574 / QA Approved /
Piotr Iwan

**Futures Homescape, Flats 1-4 &
Laundry Holme Close 1 - 4 &
Laundry: DE4 5BE, - UPRN:
FB123, Fire Risk Assessments,
Futures Homescape**

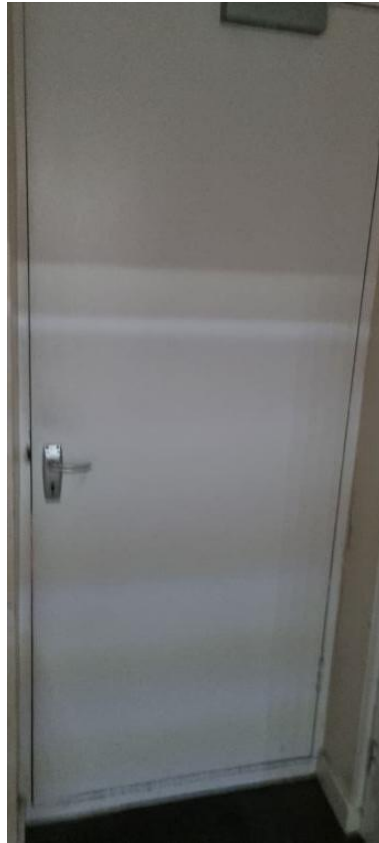
Photo 13

There is unprotected / uncovered strip lighting to the first floor of the common area.

The strip light to the first floor should be covered or replaced with protected lighting.

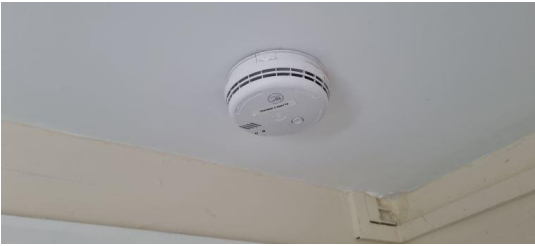
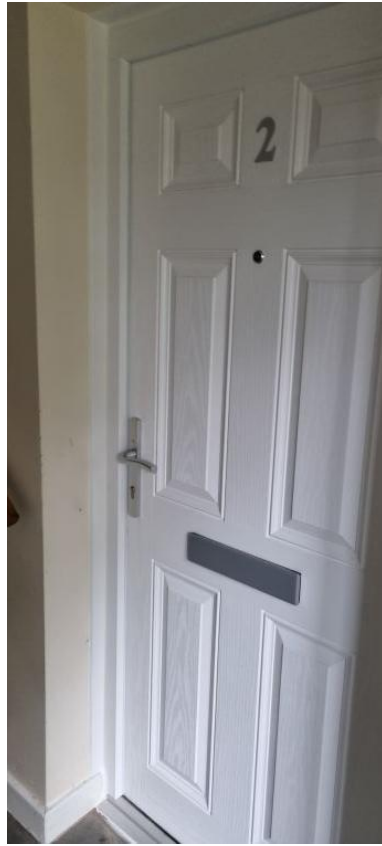
Conduit and cables were noted throughout the common area and it was not possible to confirm that the requirements of Regulation 521.10.202 of the BS 7671 - 18th Edition of The IET Wiring Regulations, which requires all cables to be adequately supported using non-combustible fixings to prevent premature collapse in the event of a fire. The new regulation is not applied retrospectively so any wiring systems fitted before 2019 do not need to be immediately updated.

Any new installation or additions and alterations to existing systems, including temporary wiring, have to comply with the regulations.

Management is to consider the requirements of the Regulation 521.10.202 of the BS 7671 - 18th Edition The IET Wiring Regulations which requires all cables to be adequately supported using non-combustible fixings to prevent premature collapse in the event of a fire albeit not retrospective and seek the advice of a suitably qualified competent person or organisation and undertake any remediation identified by the aforementioned competent person or organisation.

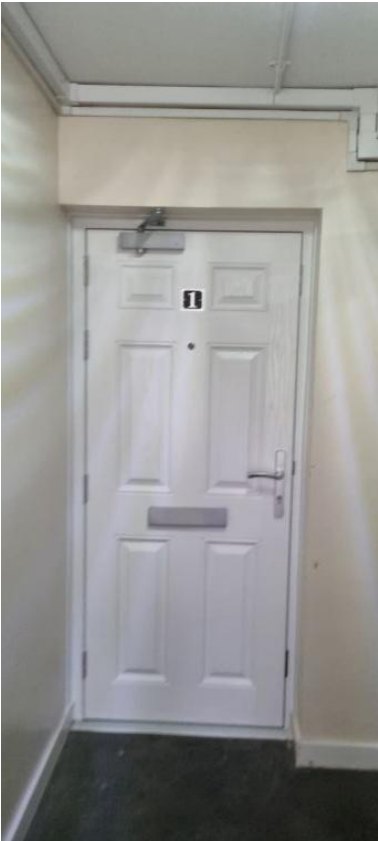
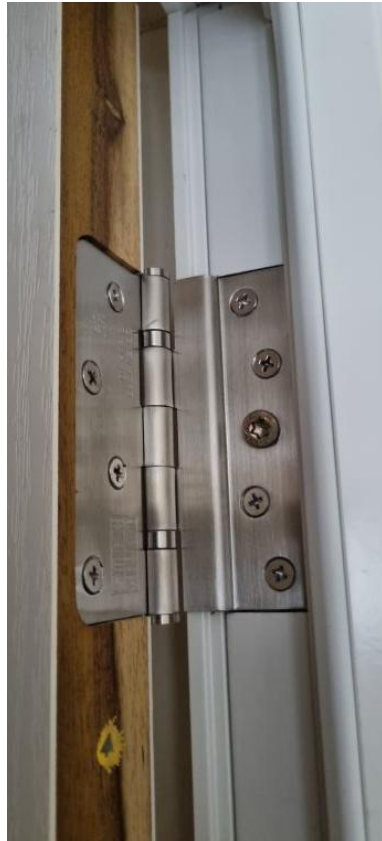
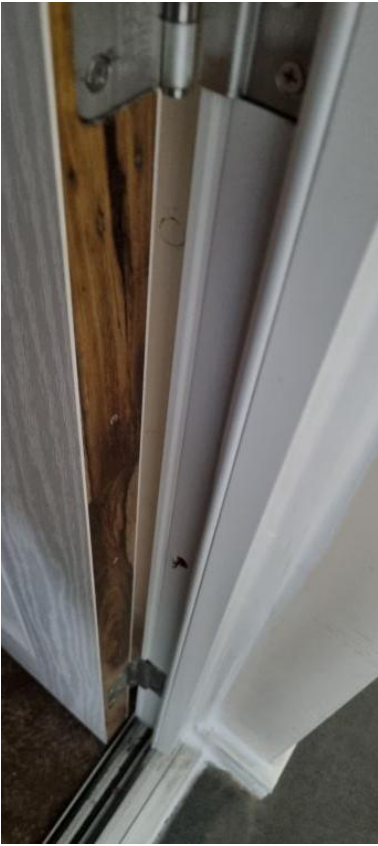
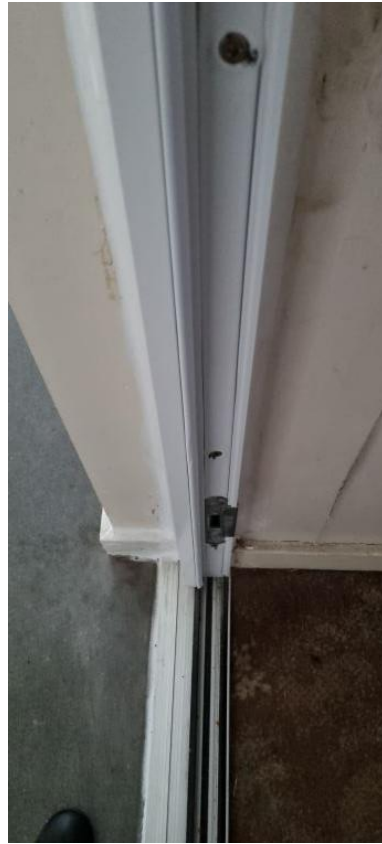
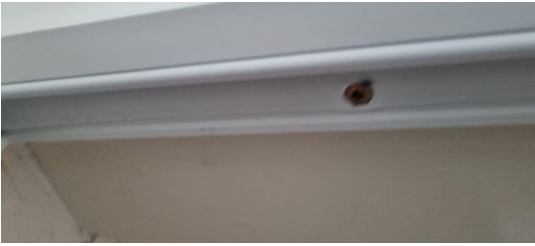
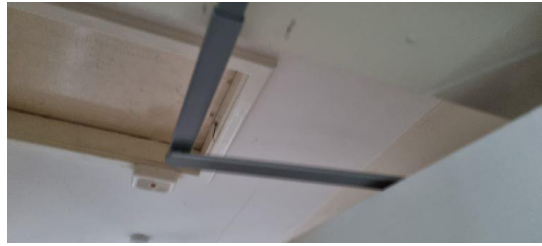
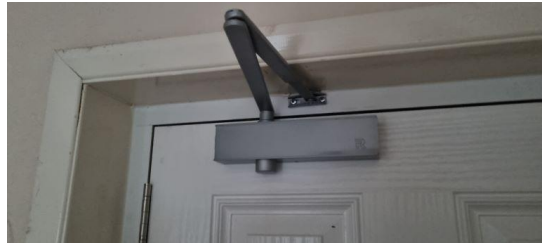
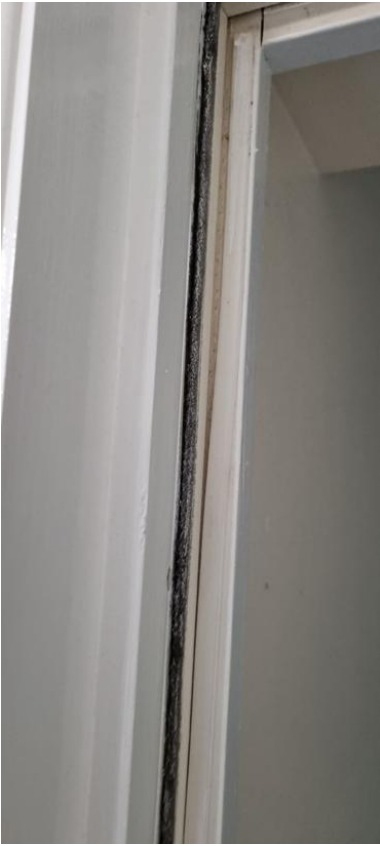
Flat 3 was sampled. The door was in good condition and labelled to confirm that it is a BM Trada certified fire door to FD60 specification. Intumescent strips and a self closure device is fitted. Doors to other dwellings were not accessible and it was not possible to establish fire rating or condition.

Management should inspect all other dwelling doors to establish fire rating and condition. Where doors do not conform to a minimum of FD30S specification, they should be replaced with certified self-closing fire door sets to a minimum of FD30S specification. Any repairs or installation should only be completed by a certified third-party contractor.

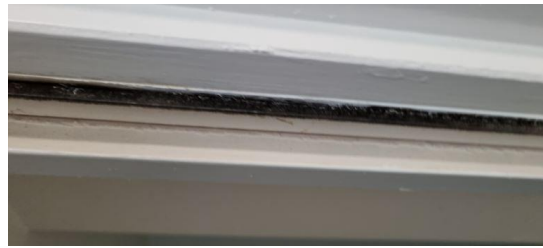
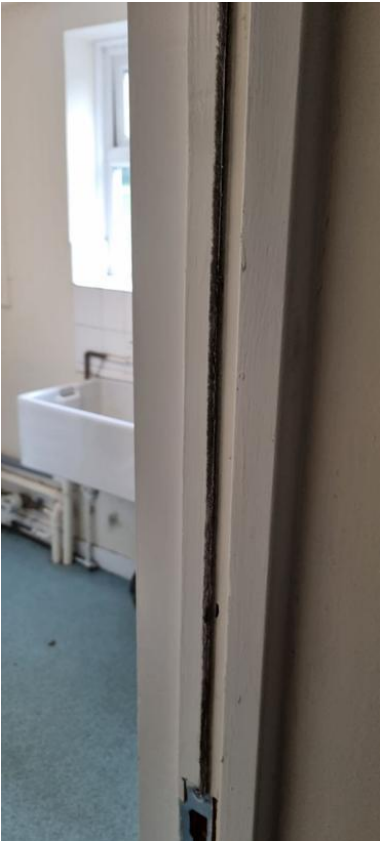
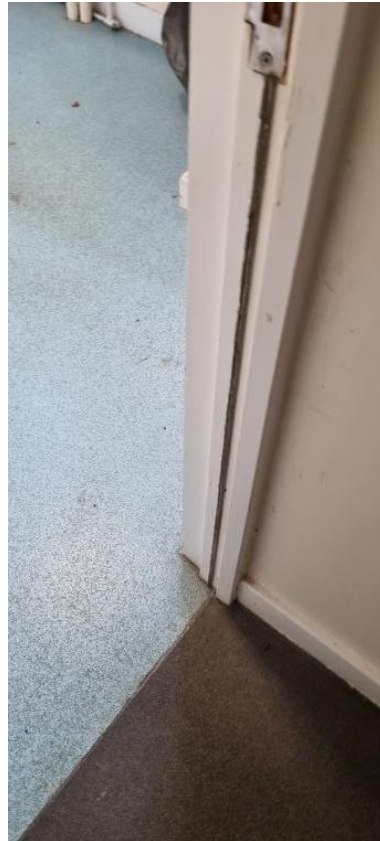
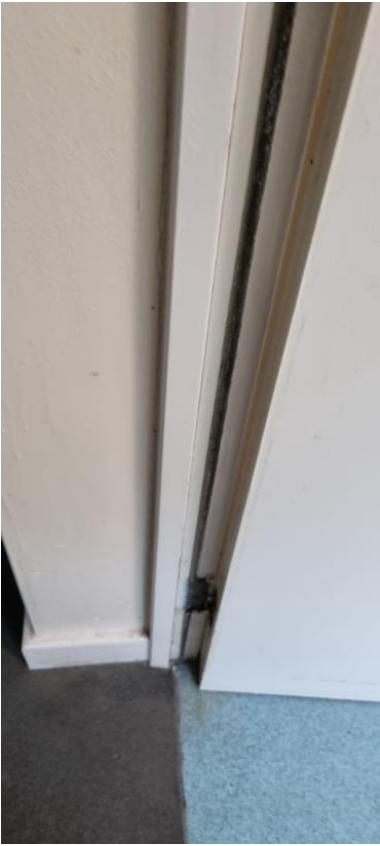
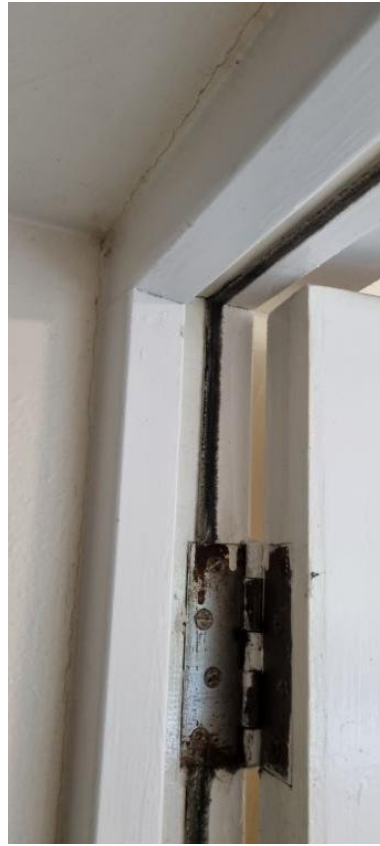
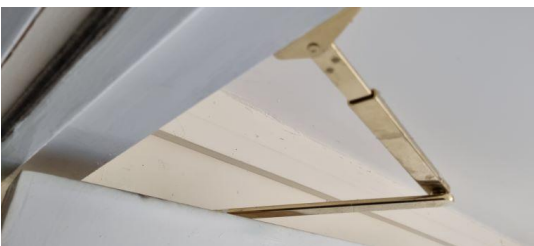
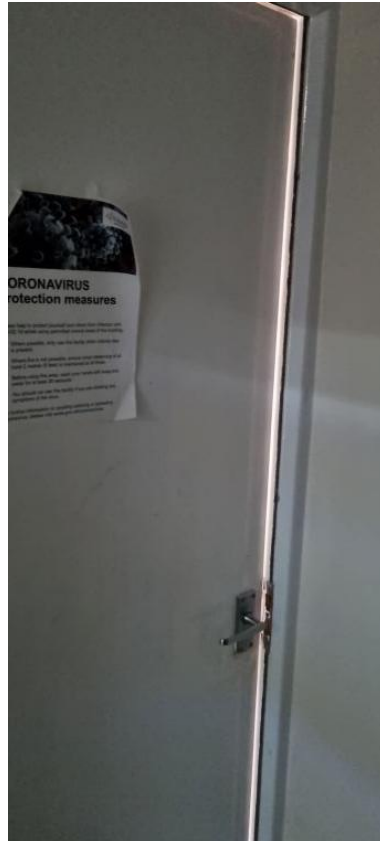
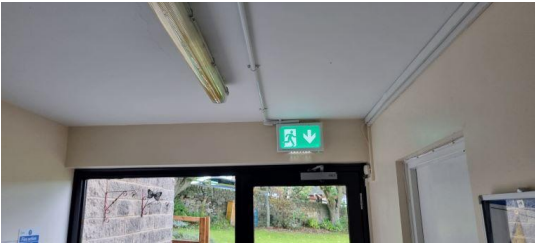
There is a fire door fitted to the communal laundry however it is not labelled and it was not possible to confirm fire rating. The intumescent strip has been painted over in parts and the door does not close properly.

Management should repair or replace the door to the laundry with a self closing fire door set to FD30S specification. Any installation or repair should only be completed by a certified third-party contractor.

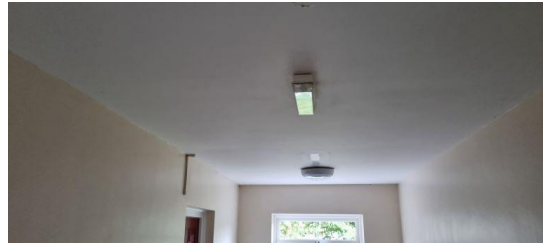
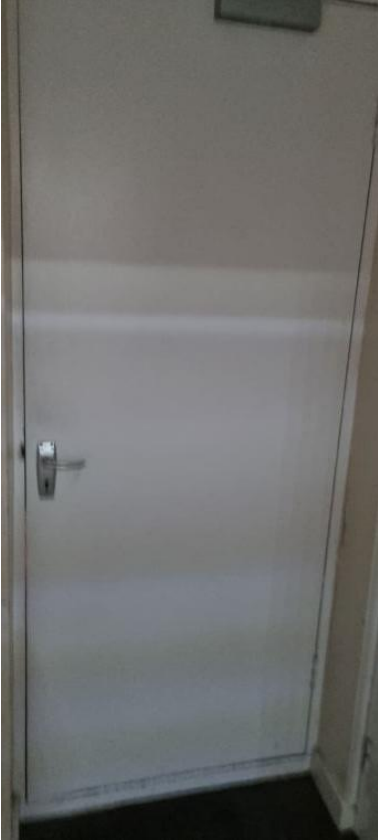
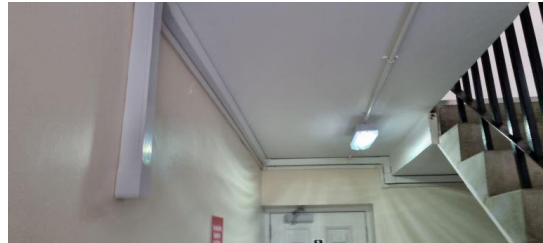
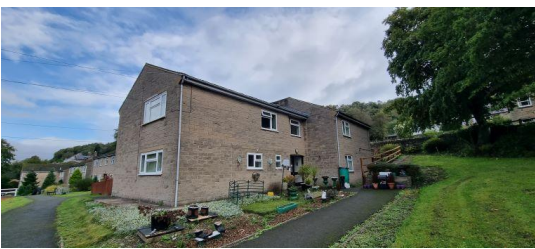
Emergency lighting is installed to the common area. The area to the rear exit has insufficient coverage and there is no emergency lighting to the laundry.

Additional emergency lighting should be installed over the rear exit and within the laundry.

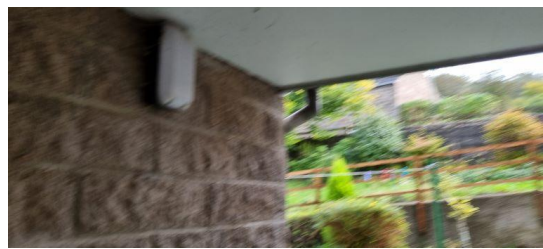
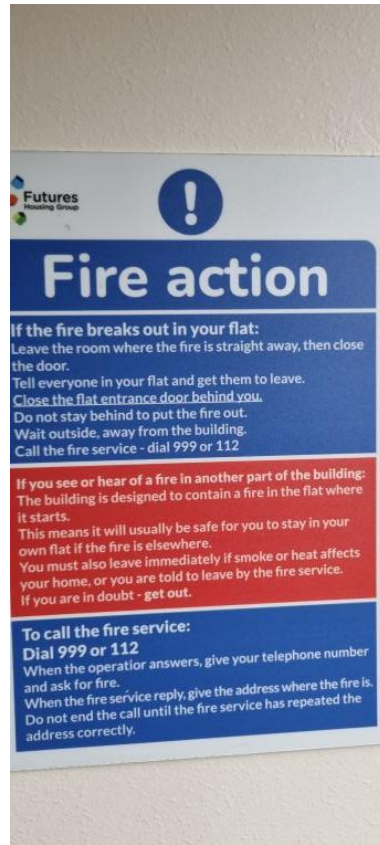
No external emergency lighting was detected.

Management should install external emergency lighting above exits.

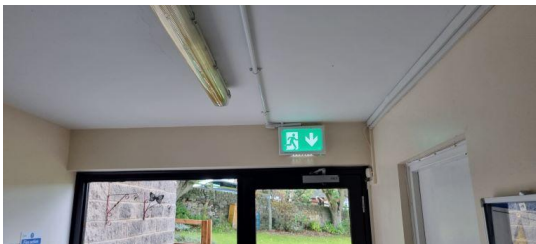
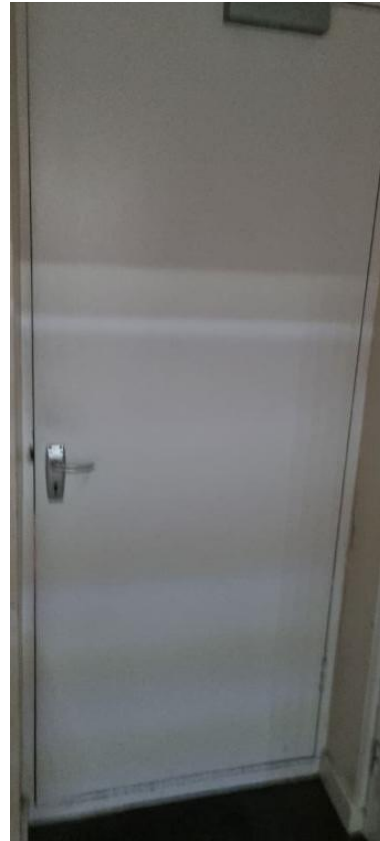
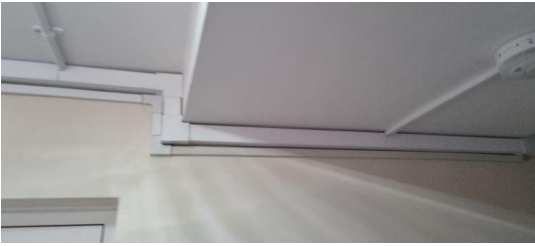
There is an illuminated sign to the front exit however, there is no exit sign above the rear exit. Fire Action Notices are displayed within the common area. There are no fire door signs attached to the laundry cupboard within the common area.

Managements should display a fire exit sign to the rear exit. Fire door signs should be displayed to the cupboard door and to both sides of the laundry door.

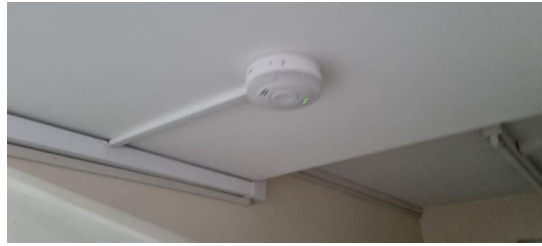
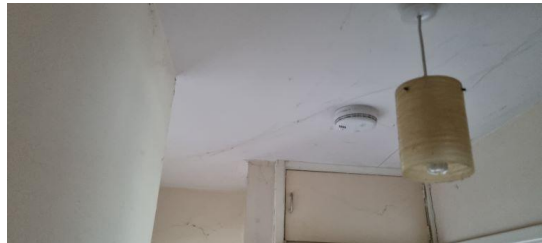
There is no manual fire alarm system however hard wired AFD is installed to common areas including the laundry. "Section 20.4 of the guidance used highlights how in 'general needs' blocks designed to support a 'stay put' policy, it is unnecessary and undesirable for a fire alarm system to be provided. A communal fire detection and alarm system will inevitably lead to a proliferation of false alarms. This will impose a burden on fire and rescue services and lead to residents ignoring warnings of genuine fires. This is dependent on compartmentation within the block

Responsible person to confirm that the installed alarm system is warranted, appropriate and effective. Depending on the outcome modify system accordingly.
