Futures Fire Risk Assessment

Futures Homescape, 3 Hathern Close:
NG10 1AJ, - UPRN: IL11517 / 173571 / QA
Approved / Piotr Iwan

**Futures Homescape, 3 Hathern
Close: NG10 1AJ, - UPRN:
IL11517, Fire Risk Assessments,
Futures Homescape**

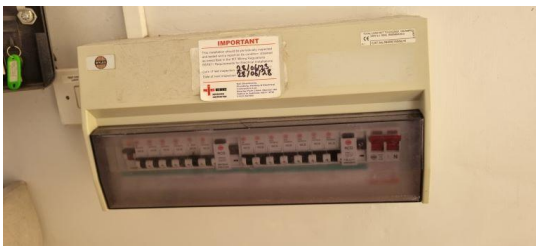
Photo 3

The label on the consumer unit confirmed that the fixed wiring was last tested on 28/06/23.

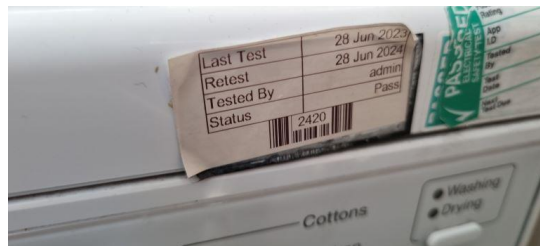
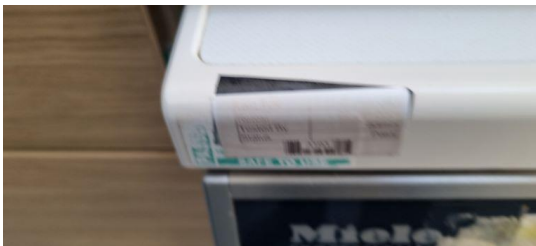
Labels on portable electrical appliances confirmed that PAT testing was last completed in June 2023.

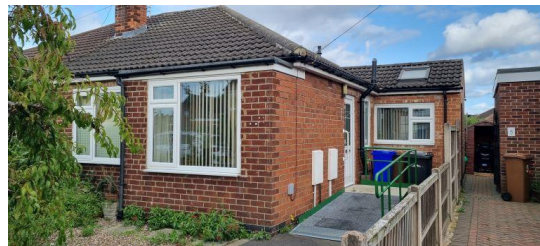
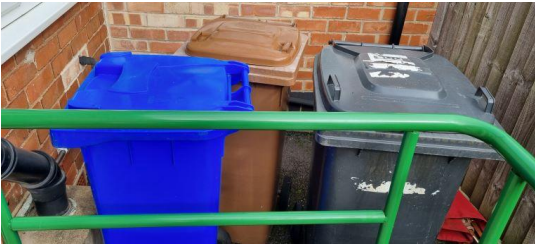
There is a designated area at the front of the building for general waste and recycling wheelie bins.

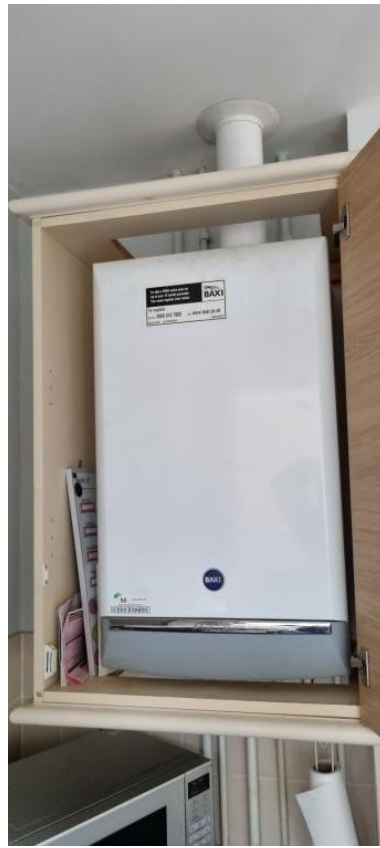
Photo 8

There is a domestic gas boiler to the residence. Staff did not have a copy of the Landlord's Certificate. Refer to Policy Principle.

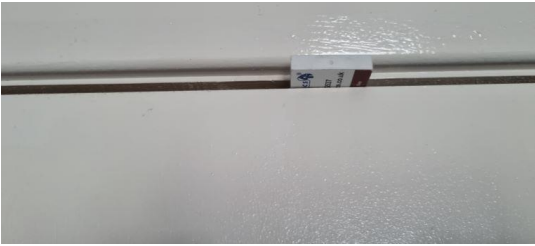
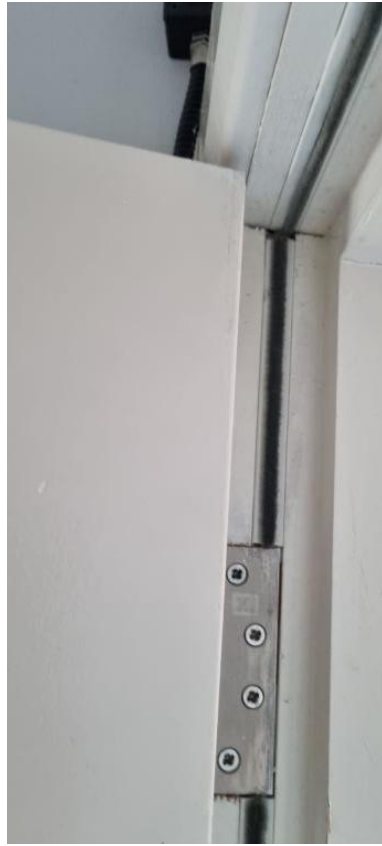
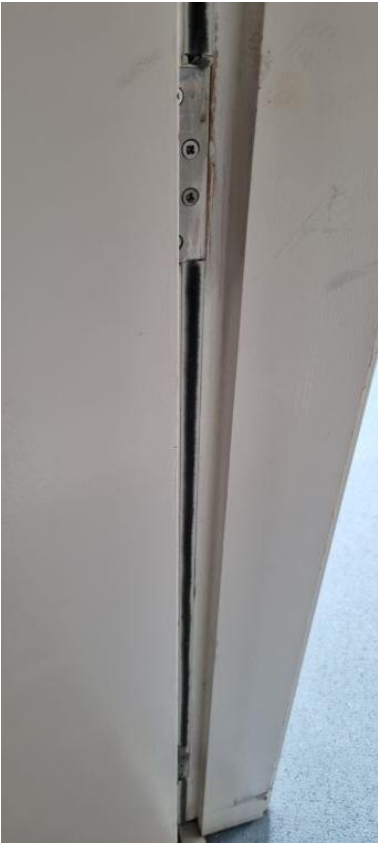
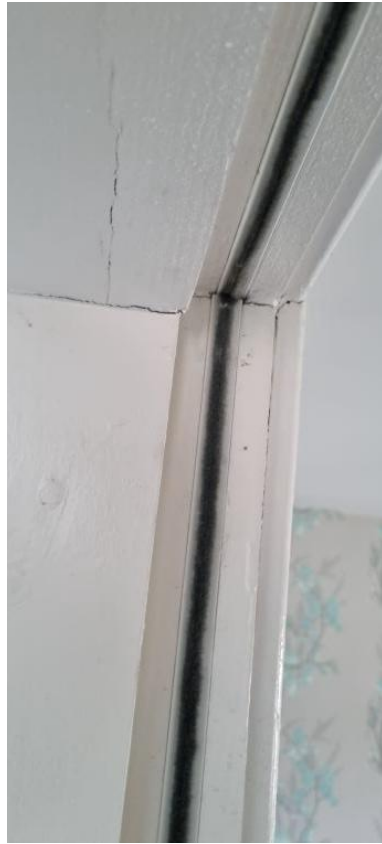
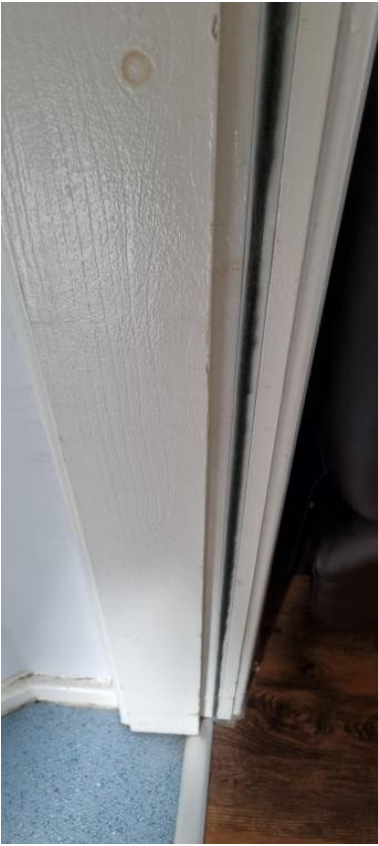
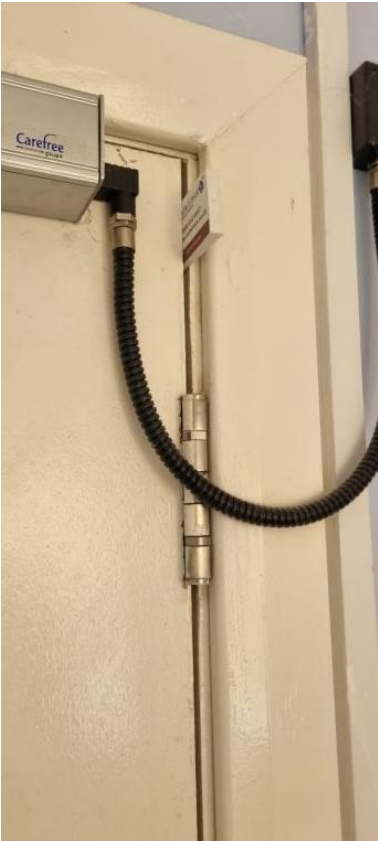
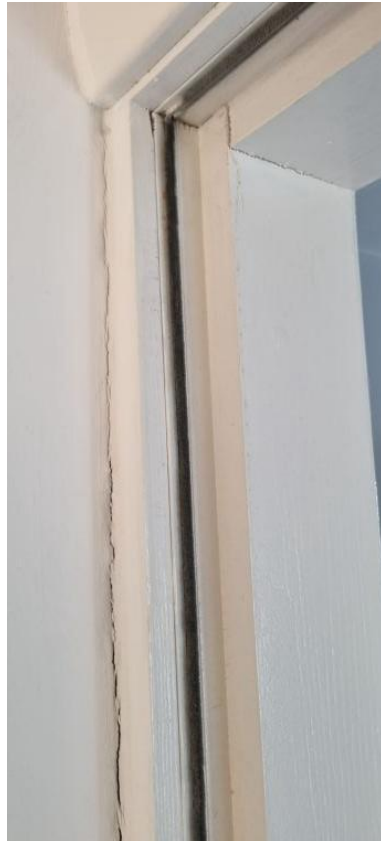
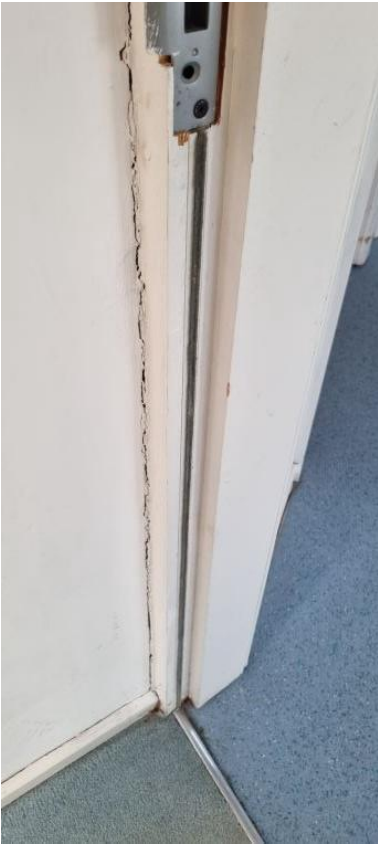
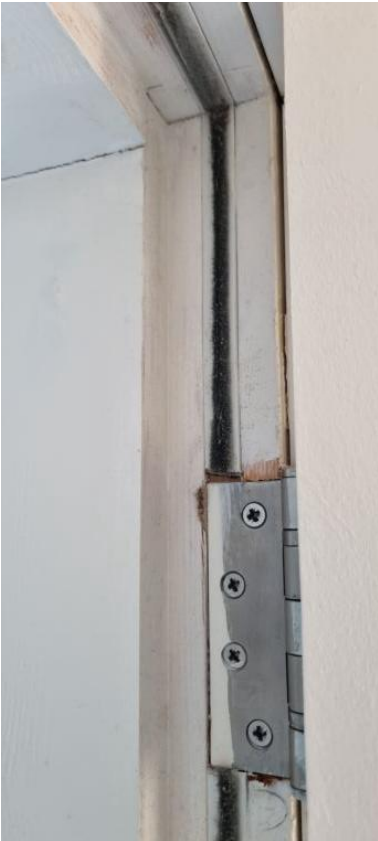
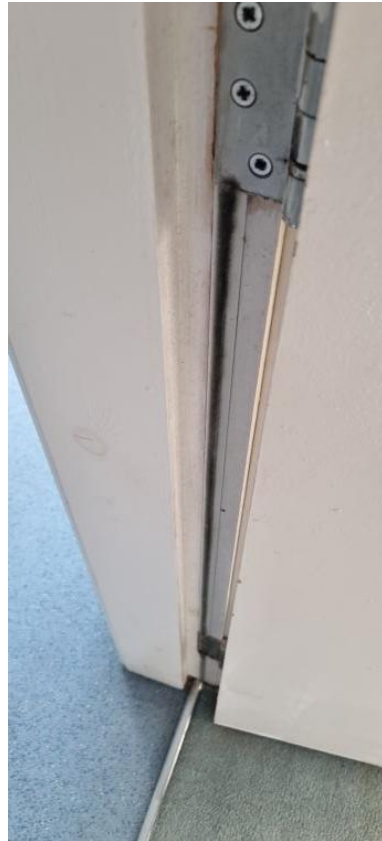
Fire doors are fitted to bedrooms and the main reception rooms. Doors are fitted within intumescent strips and auto operated self closure devices. Doors are not labelled and it was not possible to establish fire rating. Gaps to doors exceed the 4 mm tolerance.

Management should ensure that fire doors are fire rated to a minimum of FD30S specification. Where doors do not conform, they should be replaced with certified self closing fire door sets to FD30S specification. Where current fire doors conform to fire rating, doors should be adjusted / repaired in order that gaps do not exceed 4mm tolerance. Any installation or repairs should only be conducted by a certified third party fire door contractor.

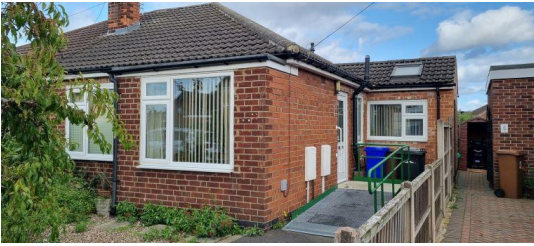
Photo 35

It was not possible to establish if compartmentation is adequate within the roof space as there is no roof space access hatch.

Management should ensure that there is adequate compartmentation between the adjacent property within the roof space and that it is maintained.
