Futures Fire Risk Assessment

Futures Homeway, Highfields Close &
Highfield Mews 1 - 7: NN6 9FF, - UPRN:
HIG602-BLK / 171942 / QA Approved /
Piotr Iwan

**Futures Homeway, Highfields
Close & Highfield Mews 1 - 7:
NN6 9FF, - UPRN: HIG602-BLK,
Fire Risk Assessments, Futures
Homeway**

INSPECTION DATE: **20 Oct 2023**

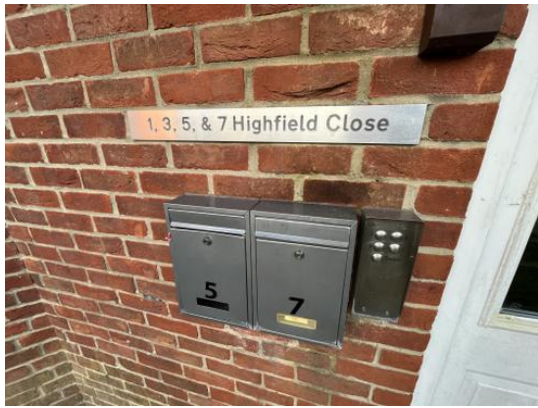
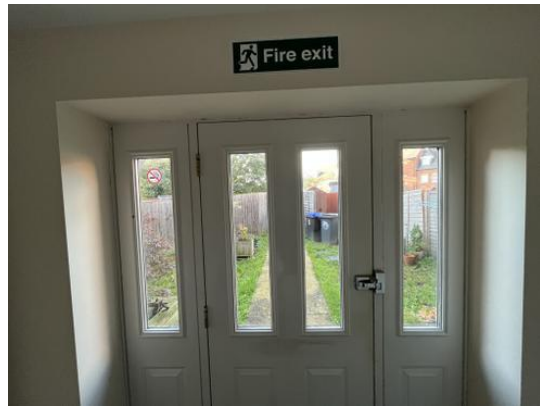
The block is installed with an access control system.

The entrance door was not seen to be self closing.

It is recommended that a positive action self closing device is installed to the block front entrance door to prevent unauthorised access.

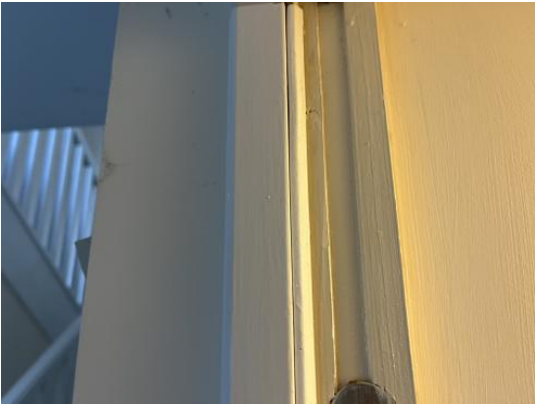
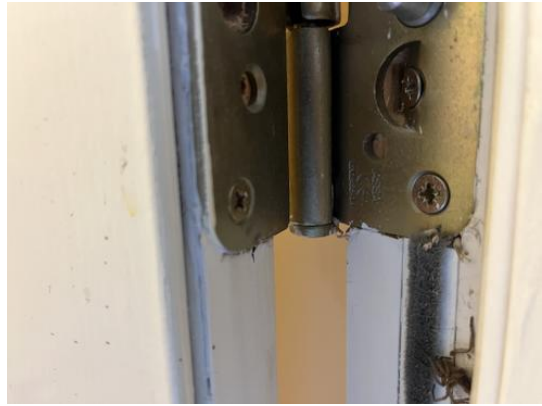
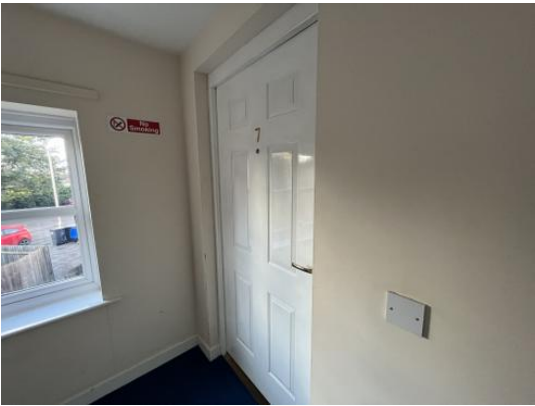
Flat entrance doors appeared to be certified timber fire doors. (NB. - from limited visual inspection, certification not seen; adequacy of installation not confirmed).

Sample inspection of Flat 1 entrance door found the door to be 44mm thick solid core timber fire door. The door was installed with combined intumescent strips and cold smoke seals. It was noted that the door was missing a section of combined strip and seal. The door was also not seen to be installed with an adequate self closing device.

Management should establish an ongoing programme of rolling checks to flat entrance doors to ensure they are installed with combined intumescent strips/cold smoke seals and positive action self-closing devices.

The entire combined strip and seals for flat 1 entrance door should be replaced. This is to ensure compatibility is maintained. It is also recommended that an overhead positive action self closing device is installed to Flat 1 entrance door. The device should be capable of closing the door fully from all angles. Any works must be completed by a third party accredited contractor.

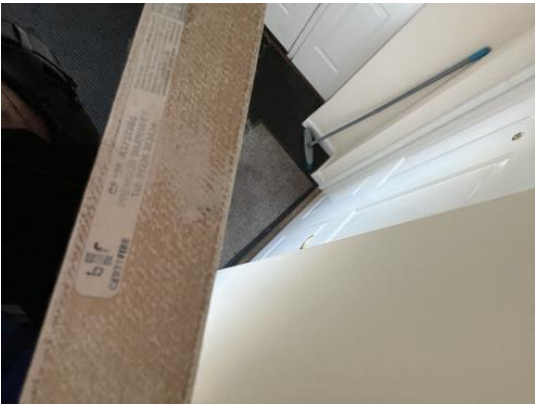
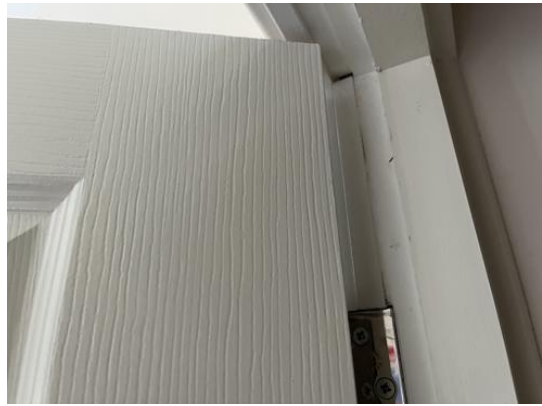
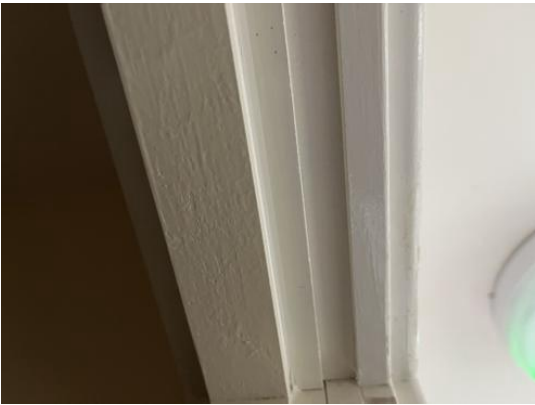
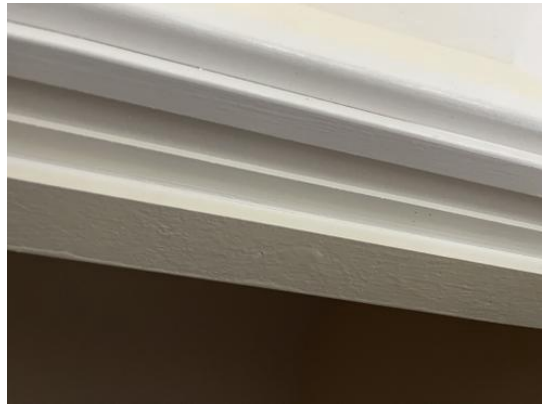
The door to the electrical intake cupboard was noted to be a solid core 44mm thick timber fire door. The frame was installed with intumescent strips only. A section of strip was missing from the top of the frame.

The electrical intake cupboard was not locked at the time of the assessment.

No other communal fire doors noted in the block.

The intumescent strips installed to the electrical intake cupboard should be replaced along the entire frames edge with combined intumescent strips/cold smoke seals. This is to ensure compatibility is maintained. The cupboard should also remain locked at all times when not in use. Regular checks should be conducted to ensure compliance.

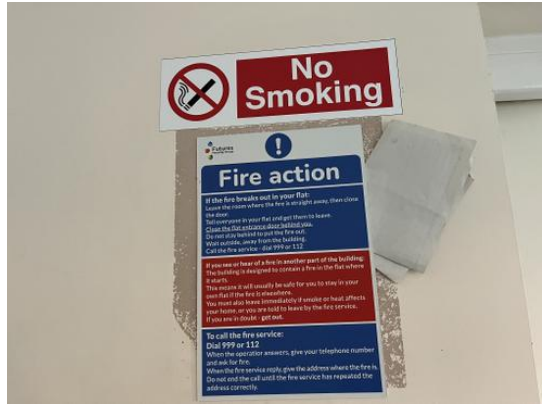
A fire action notice was installed to the common areas of the block denoting a 'Stay Put' evacuation strategy.

Fire door signage was not installed to the electrical intake cupboard.

'Fire Door - Keep Locked Shut' signage should be installed to the outer face of the electrical intake cupboard.

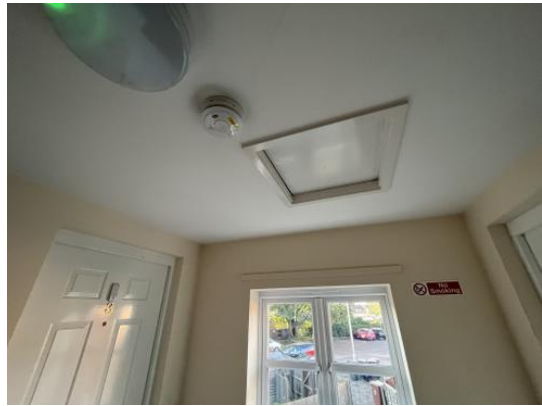
Photo 26

A grade D smoke detector was installed to the 1st floor common area. This conflicts with the Stay Put evacuation strategy in place for this purpose built block of flats.

It is recommended that the Grade D smoke detector head is removed from the communal area. There is no requirement in Building Regulations or guidance documents for the installation of automatic detection and warning systems in purpose built blocks of flats.
