Futures Fire Risk Assessment

Futures Homeway, Flats 1-17 Perceval
House: NN3 5GL, - UPRN: PER601-BLK /
171968 / QA Approved / Rizwan Tanveer

INSPECTION DATE: 14 Mar 2024

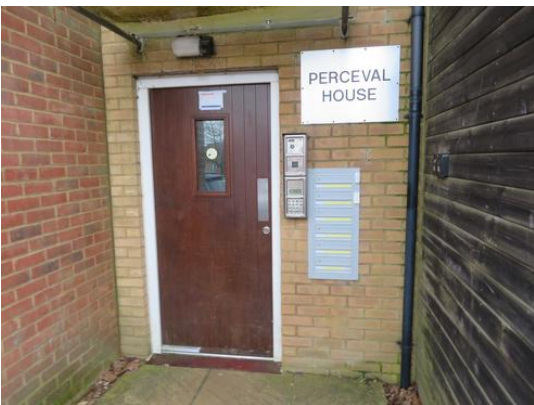
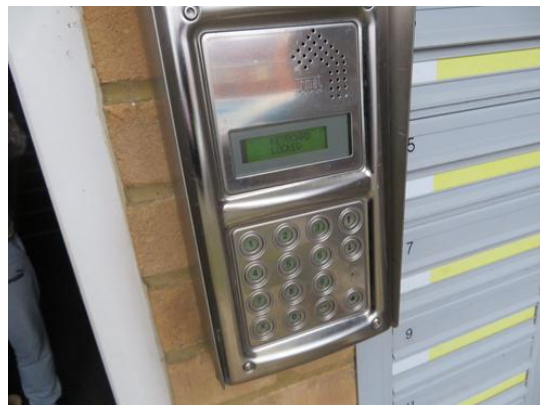
It was noted that the entry control panel was defective at the time of the assessment requiring residents to use manual keys, and guests not to be able to buzz resident flats.

The entry control system should be repaired or replaced.

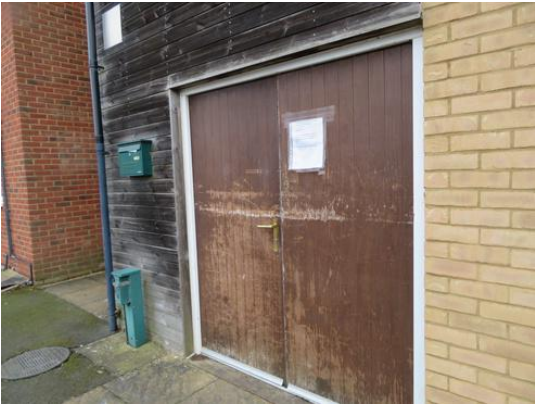
The bin room was not locked at the time of the assessment.

It is advised that the bin store doors are installed with positive action self closing devices and a coded locking mechanism to prevent unauthorised access.

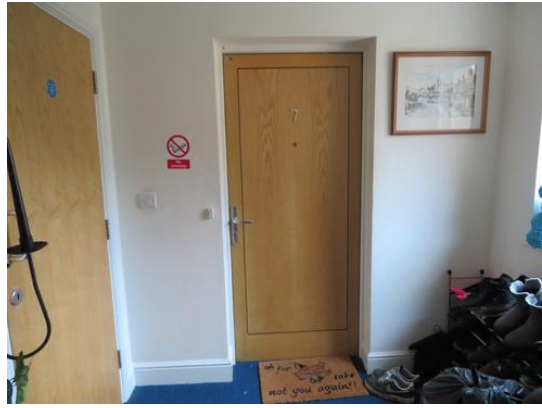
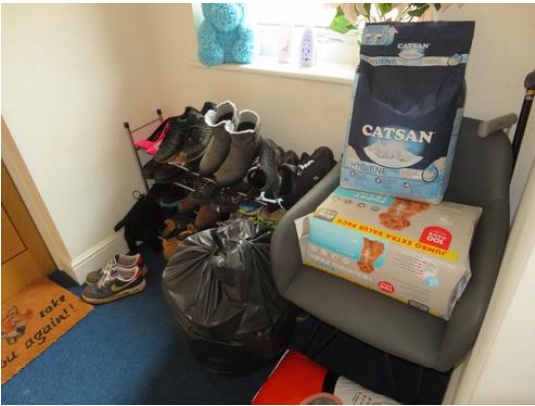
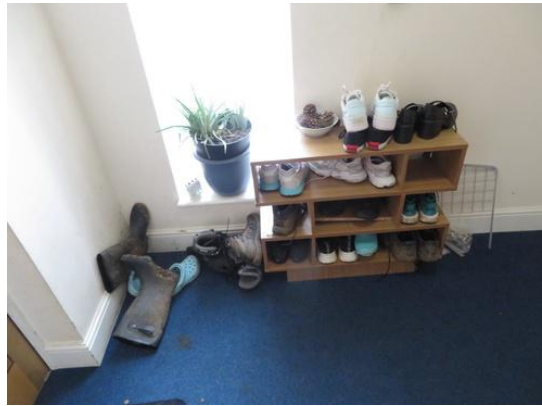
- A shoe rack was noted outside of flat 9 entrance door.
- The resident of flat 7 has used their access lobby as an extension of their private demise, using it for storage of a significant number of personal items.

Items noted should be removed from the communal areas as soon as is reasonably practicable. Residents should be informed that items must not be stored in the communal areas at any time. Regular checks should be conducted to ensure compliance.

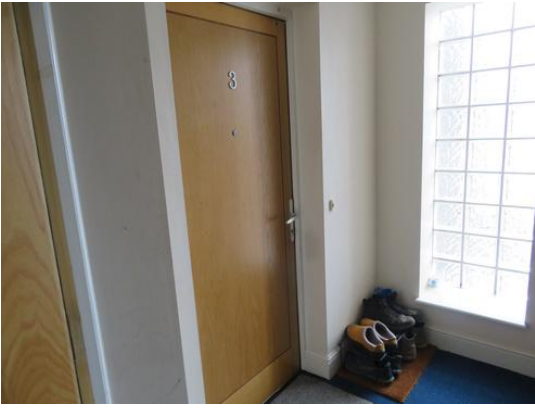
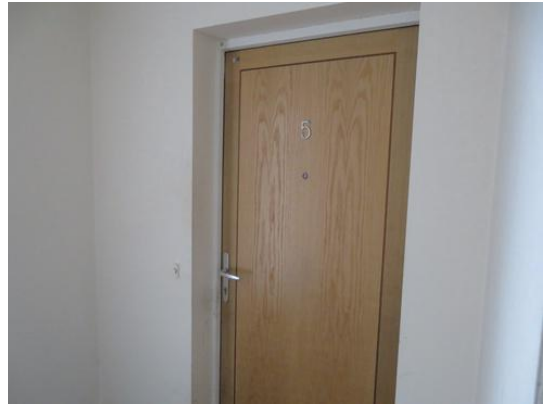
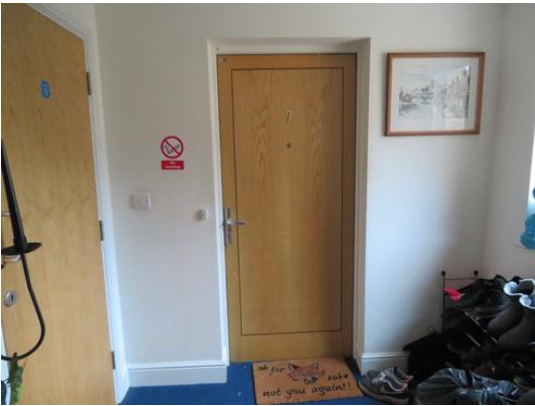
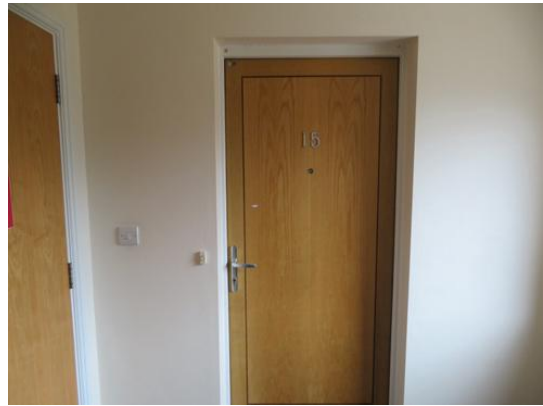
The front entrance doors appear to be 30 minute fire rated doors including three fire rated hinges, strips and seals and a self closer. However, no labels or identification plugs were observed and are considered to be a notional fire door.

Flat entrance doors were seen to be FD30/S timber fire doors. (NB. - from limited visual inspection, certification not seen; adequacy of installation not confirmed).

Management should establish an ongoing programme of rolling checks to flat entrance doors to ensure they are installed with combined intumescent strips/cold smoke seals and positive action self-closing devices.

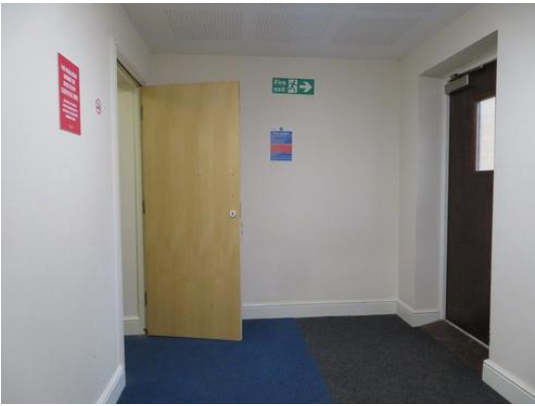
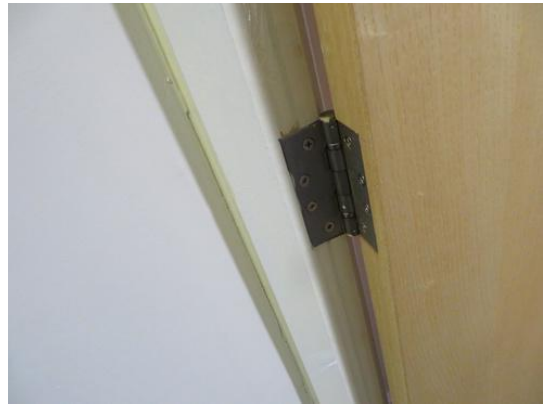
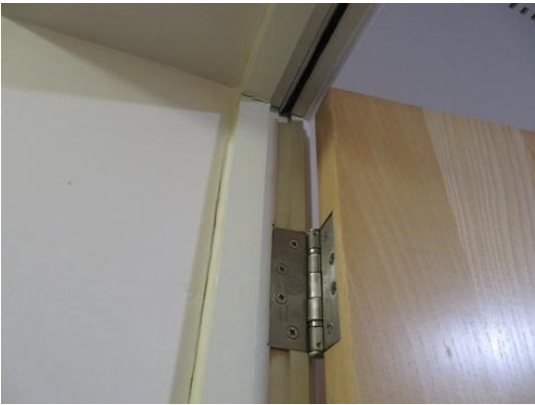
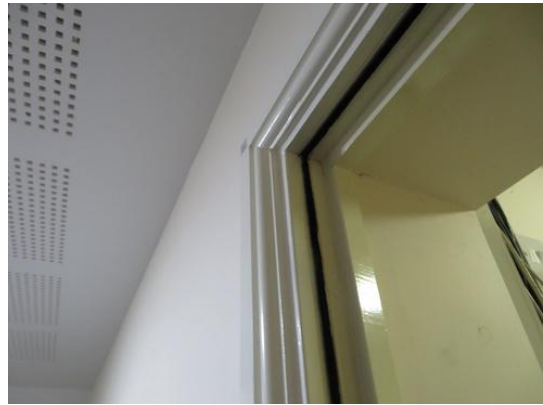
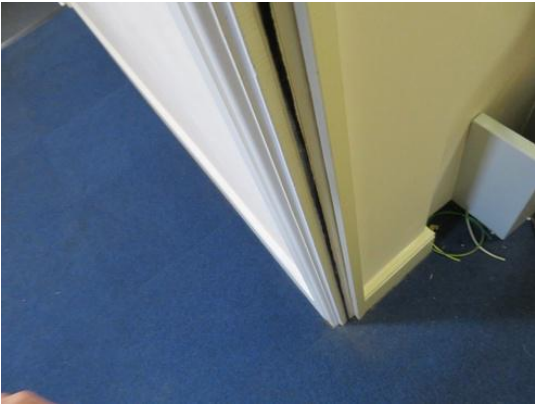
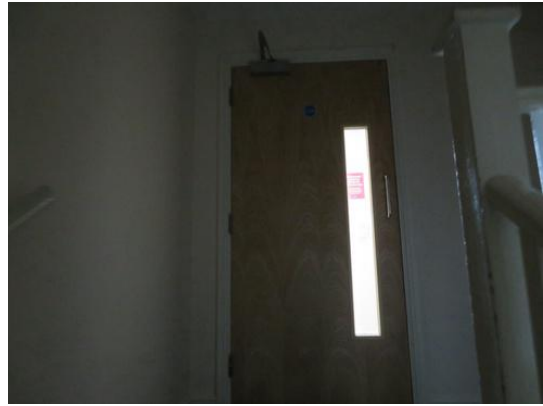
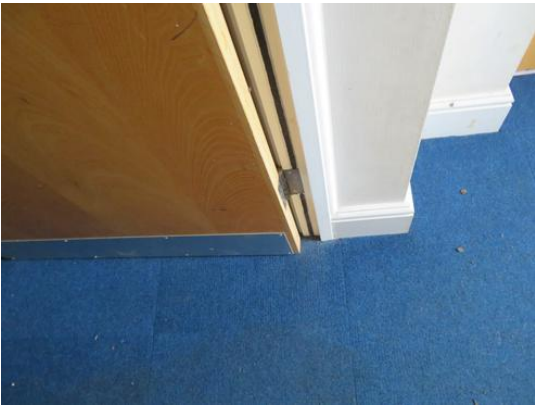
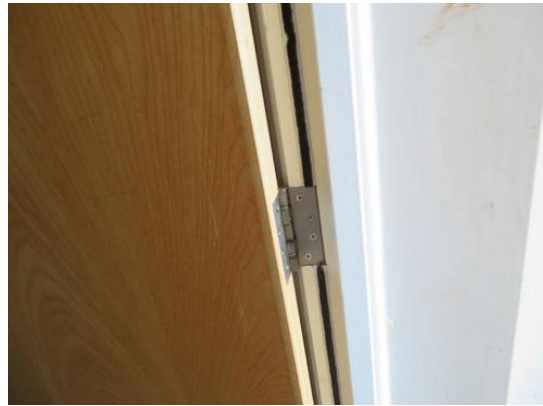
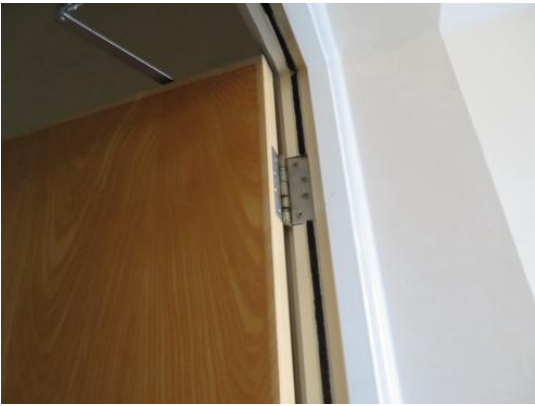
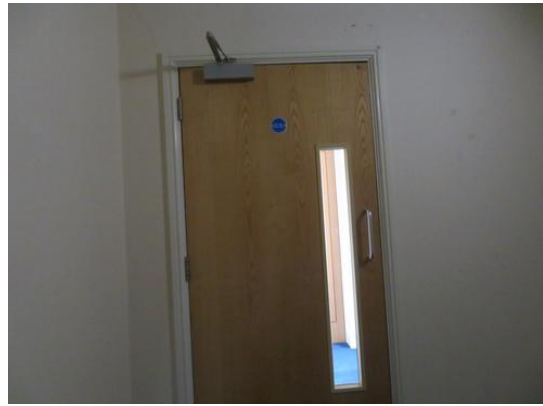
The common area doors appear to be 30 minute fire rated doors including three fire rated hinges, strips and seals and a self closer. However, no labels or identification plugs were observed and are considered to be a notional fire door.

- The electrical intake cupboard door was missing sections of combined strips/seals.

The fire door noted should have the strips and seals replaced on all edges. This is to ensure compatibility is maintained. Work should be carried out by a competent third party accredited contractor.

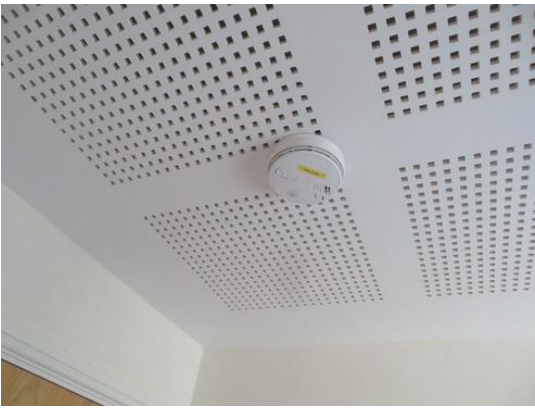
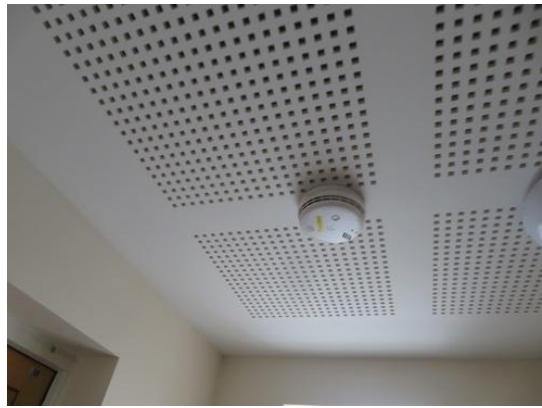
Although this is a purpose built block of flats, it was noted that Grade D smoke detection was installed to the communal areas in accordance with BS5839:6. This is contradictory to the Stay Put strategy as is stated in the Purpose Built blocks of flats guidance.

Management to ensure that the Grade D smoke detection system is removed from the common areas to avoid confusion of the evacuation strategy in place.

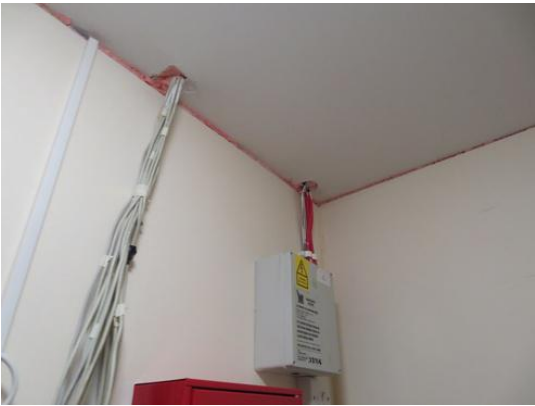
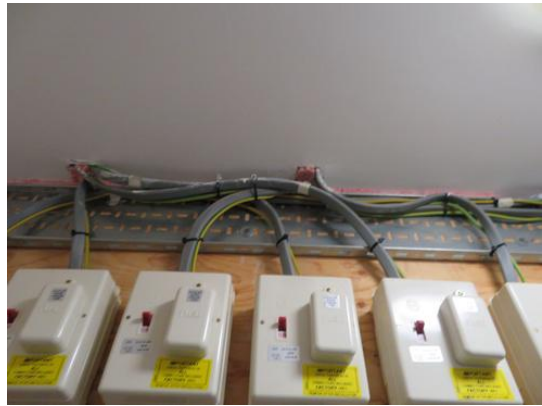
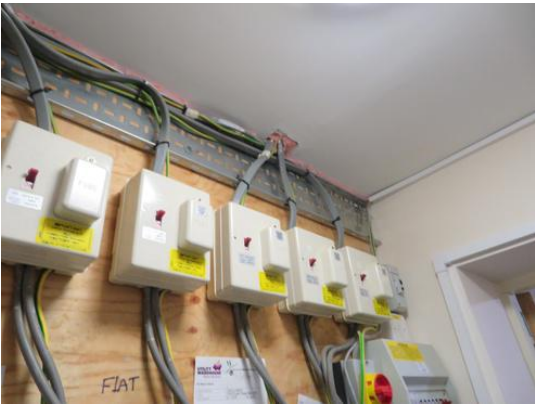
Penetrating services within the electrical intake cupboard were noted to be poorly fire stopped using pink expanding foam.

Penetrating services in the electrical intake cupboard should be adequately fire stopped using proprietary materials designed for use in fire stopping purposes. This should be completed by a competent third party accredited contractor.
