Futures Fire Risk Assessment

Futures Homescape, Community Centre
 Highfields: DE5 9SB, - UPRN: 18 / 173521 / QA
 Approved / Andy Cloke

Futures Homescape,
 Community Centre Highfields:
 DE5 9SB, - UPRN: 18, Fire Risk
 Assessments, Futures
 Homescape

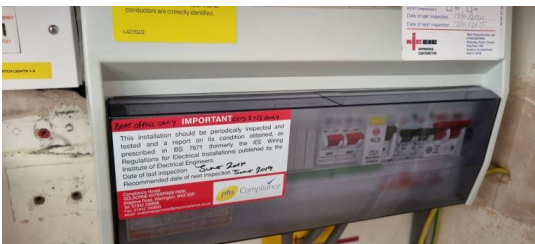
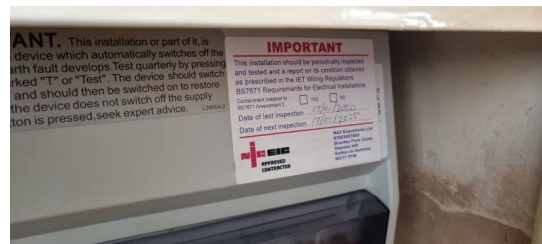
Photo 3

The label on the consumer unit confirms that the fixed wiring was last tested on 17/01/2020.

Policy Principle: FHG complete Fixed wire testing in line with current regulations every 5 years and complete an annual visual inspection on all properties.

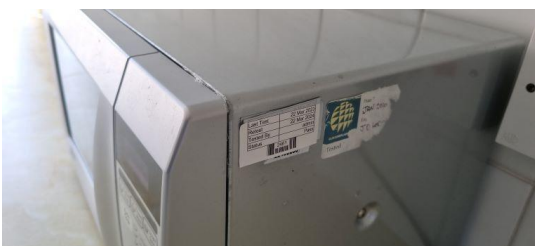
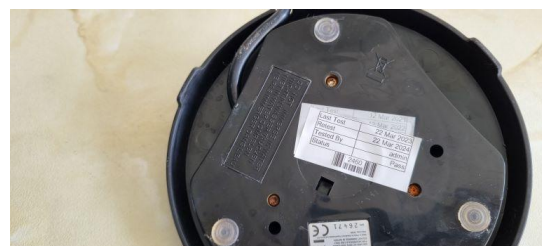
Photo 5

Labels on portable electrical appliances confirmed that PAT testing was last completed on 22/03/2023

Policy Principle: PAT testing is complete at the time of the visual inspection as mentioned above. All items in the communal areas will be tested.

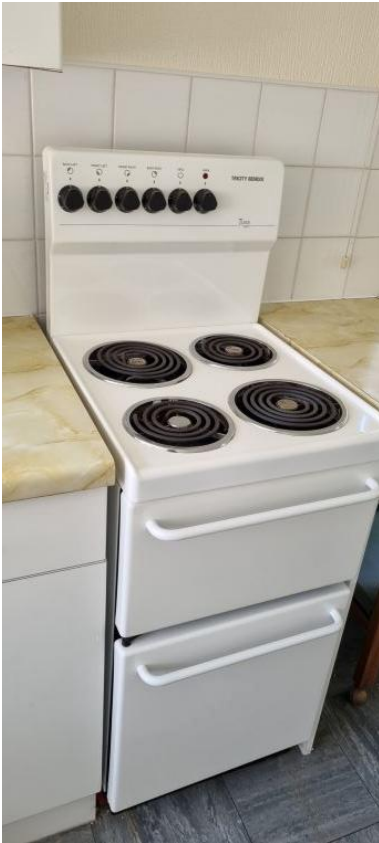
Photo 7

There is an electrical cooker within the community centre kitchen. It was not possible to establish how often the kitchen is used or what rules are in place for cooking etc.

Management should consider removing the electric cooker in favour of a microwave only if cooking is not frequent. Where the cooker is to remain it is advisable that it is only used for low risk activities and that high risk (deep fat frying etc) is prohibited. Rules for the use of the kitchen should be disseminated to users.

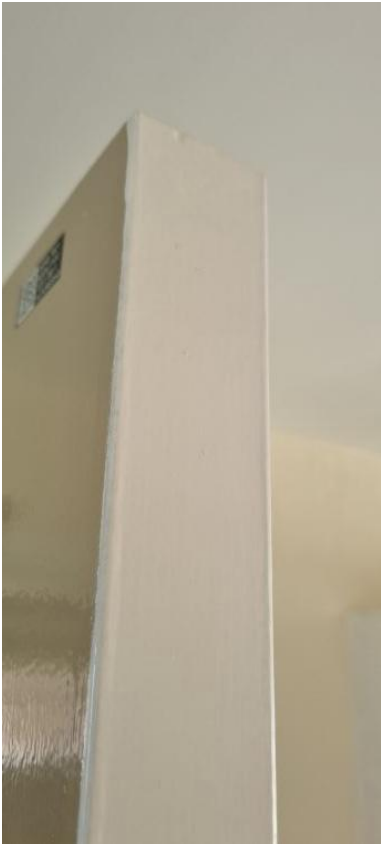
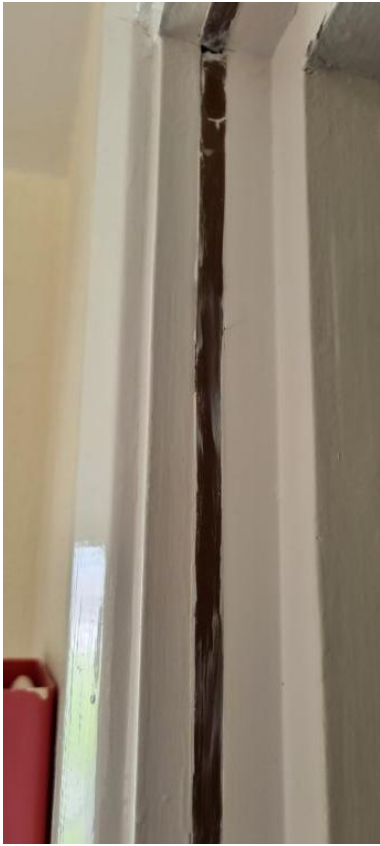
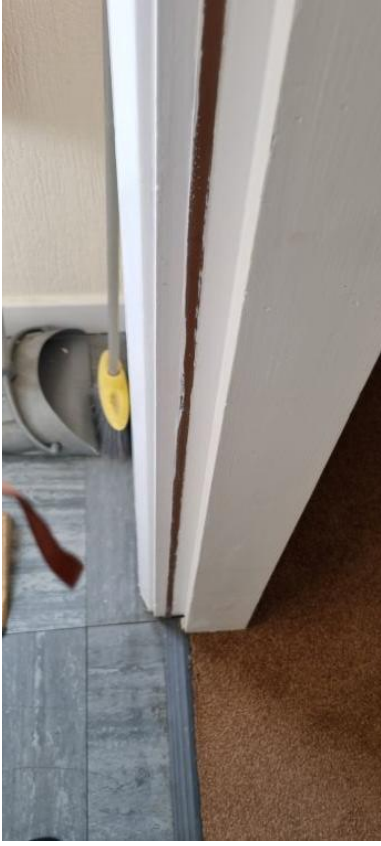
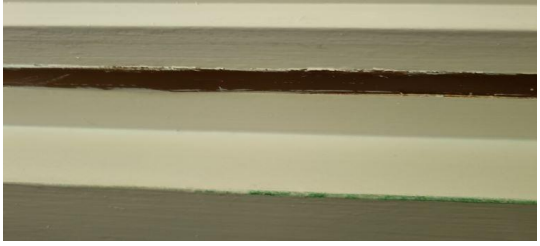
Photo 11

The kitchen door has intumescent strips fitted however they have been painted over which is likely to affect door seal integrity.

Management should repair intumescent seals to the kitchen door.

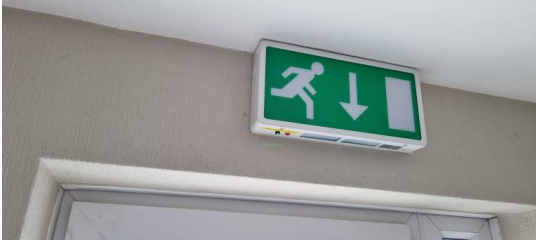
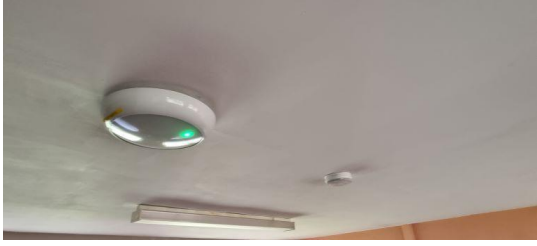
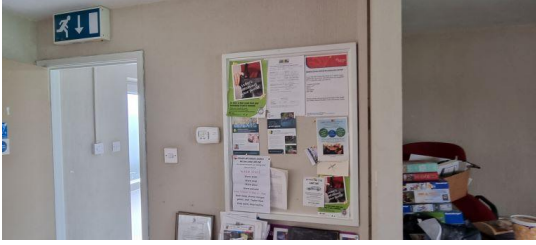
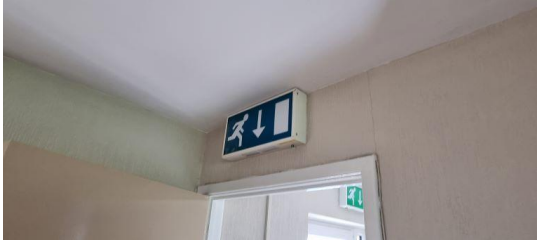
Photo 15

Emergency lighting is provided and appears adequate. The unit above the door to the entrance foyer from the sitting room appeared to be defective.

Management should inspect emergency lighting and ensure that any defects identified are repaired.

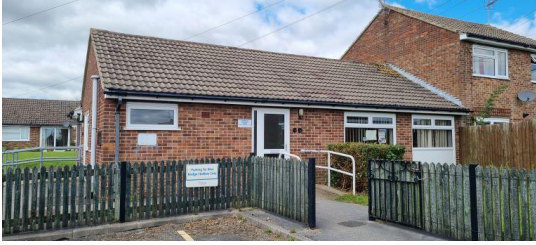
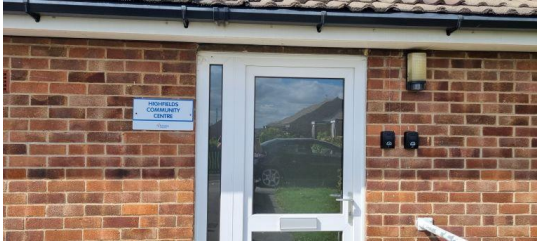
Photo 19

There is no external emergency lighting fitted. It was not possible to establish if borrowed lighting is sufficient as the assessment was conducted during daylight hours.

Management should install external emergency lighting above exits.

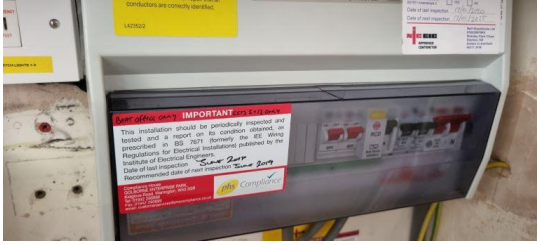
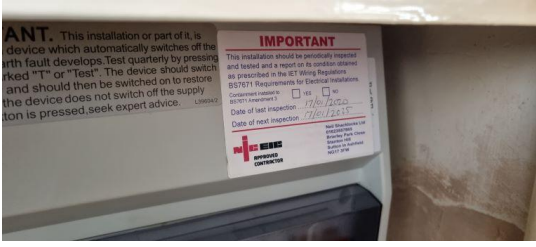
Photo 32

The electrical consumer unit is located with a wooden cabinet that does not appear to be fire rated.

The cabinet around the electrical consumer unit should be removed or replaced with a fire rated type.

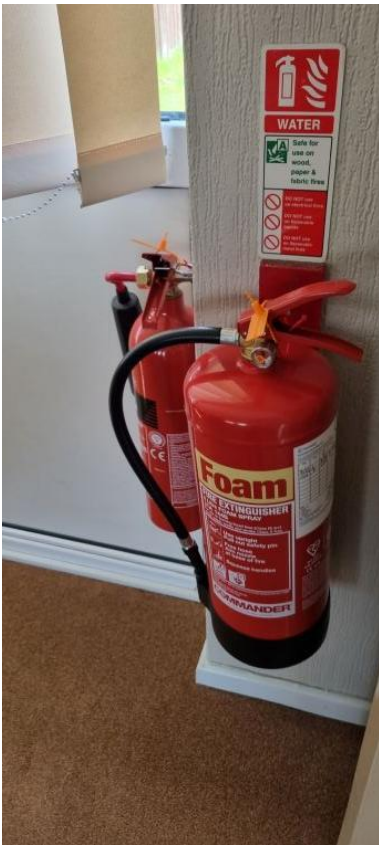
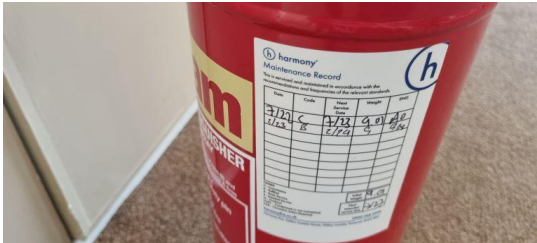
Photo 35

There is 1 x 6L 21 A rated Foam and 2 x 2KG CO2 units installed. BS5306: Part 8 requires that a minimum of 2 x 13A rated units are provided for compartments of up to 400 square metres. In addition, community centre users are unlikely to be trained on the use of FFE and no signage is displayed to state 'only to be used by trained persons'. Extinguishers are maintained under service contract with Harmony with the last inspection completed 03/23.

Management should display signage at fire points to state 'extinguishers should only be used by trained persons'. An addition 6L 13A Water / Foam unit should be installed in order to comply with BS5306: Part 8.
