Futures Fire Risk Assessment

Futures Homeway, Flats 2-8 (Evens)
Queens Road : NN11 5BN, - UPRN:
2390001 / 171947 / QA Approved / Andy
Cloke

**Futures Homeway, Flats 2-8
(Evens) Queens Road : NN11
5BN, - UPRN: 2390001, Fire Risk
Assessments, Futures Homeway**

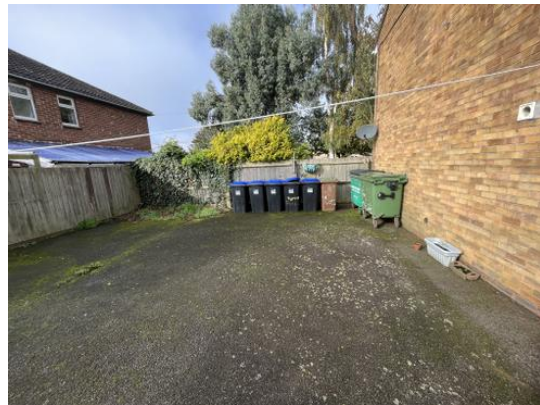
Photo 4

Domestic and paladin wheelie bins were located to the rear of the block close to the wall of the building.

The wheelie bins noted should be relocated away from the building a minimum of 2 meters. Ideally bins should be placed in a secure bin store. Regular checks should be conducted by the client to ensure that bins remain away from the building in their designated storage area.

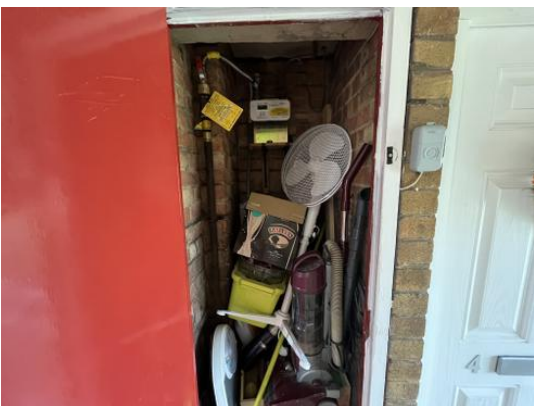
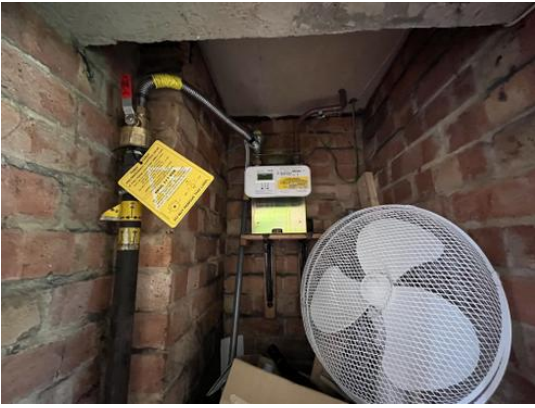
Resident storage cupboards located adjacent to flat entrance doors were noted to contain gas meters. The cupboards are being used for storage purposes by residents.

It is recommended that the cupboards are not used for the storage of combustible items. A policy should be implemented instructing residents that combustible items must not be stored in the cupboards. Regular checks should be conducted to ensure compliance.

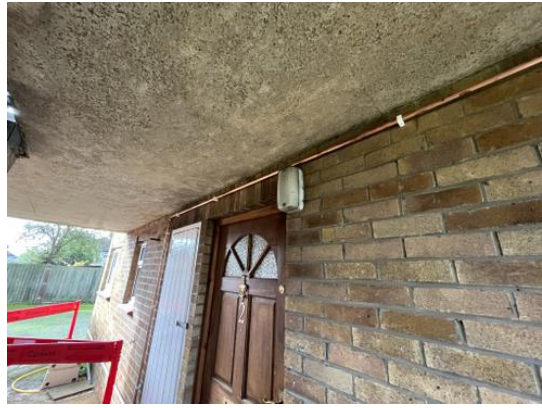
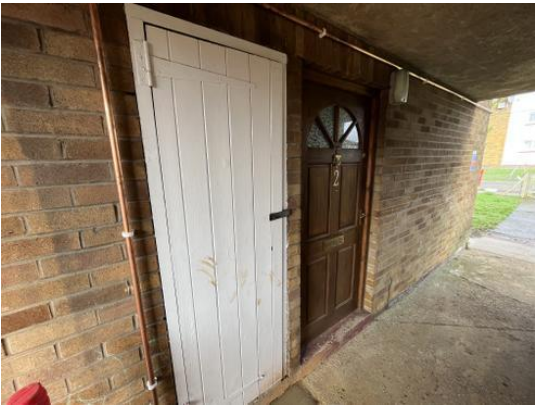
Exposed copper gas pipes were noted in the common area on the ground floor. These are liable to accidental damage.

The gas pipe noted should be enclosed to prevent accidental damage.

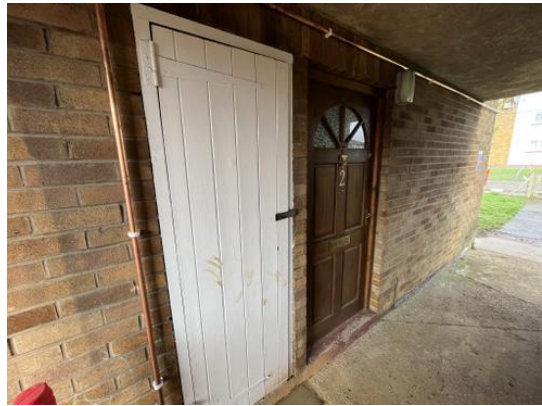
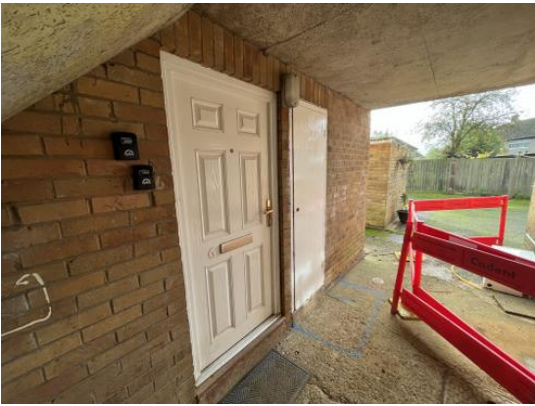
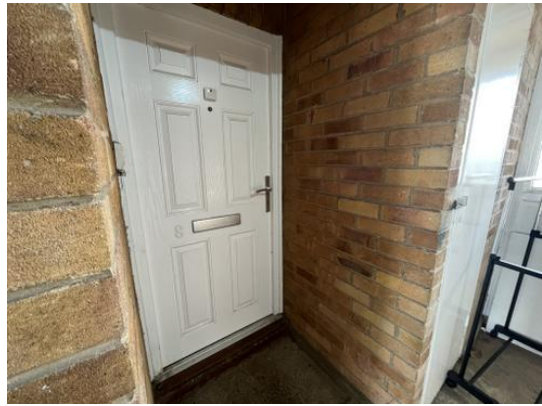
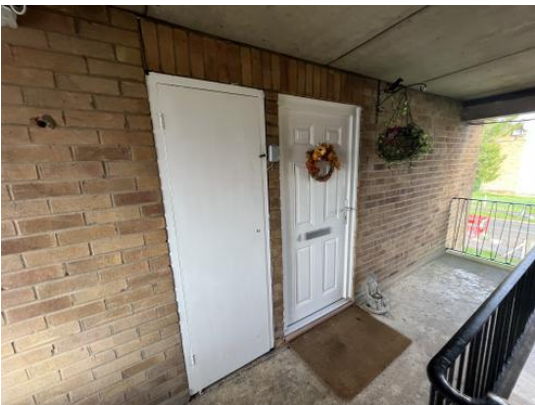
Flat entrance doors appeared to be a combination of certified timber fire doors and replacement timber panel doors. (NB. - from limited visual inspection, certification not seen; adequacy of installation not confirmed).

Flat 2 door is a replacement timber panel door. These are not usually known to be fire rated. As doors on the ground floor have two directions of travel, and do not appear to pose a passing risk to residents escaping in the event of a fire situation, this is deemed acceptable.

Management should establish an ongoing programme of rolling checks to flat entrance doors to ensure they are installed with combined intumescent strips/cold smoke seals and positive action self-closing devices.

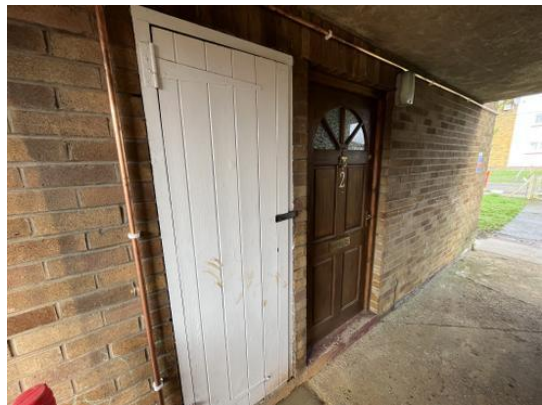
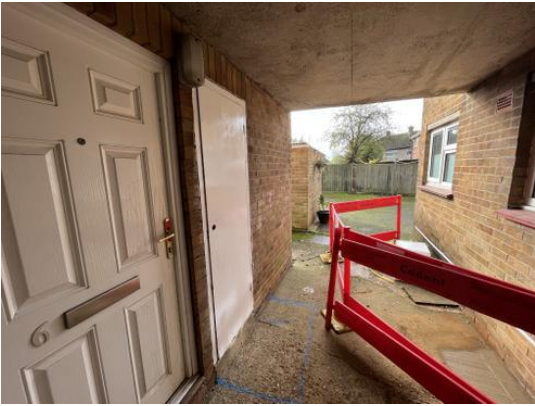
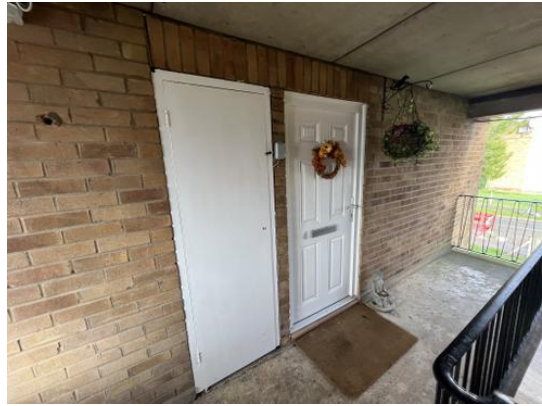
Resident stores did not appear to be adequately fire resisting from a sample inspection.

As resident stores are housing gas meters, it is recommended that they are FD30/S (or equivalent) fire resisting.

The doors to the resident stores should be upgraded or replaced to an FD30/S standard. The doors should also be kept locked when not in use.

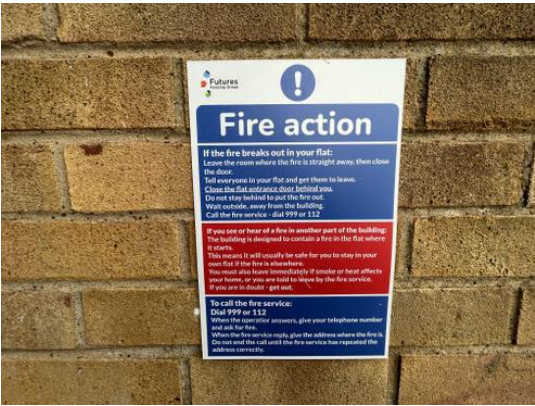
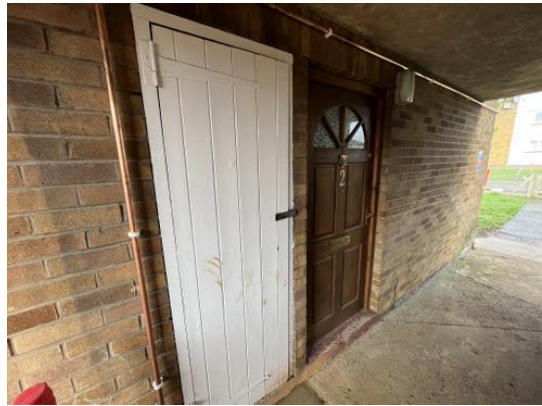
Fire action notices installed denoting the Stay Put evacuation strategy for the building.

Fire door signage is not installed to the resident storage cupboards.

It is recommended that 'Fire Door - Keep Locked Shut' signage is installed to the resident store cupboards on the outer face of the door.
