Futures Fire Risk Assessment

Futures Homeway, Flats 33-49 Hamtun House: NN3 5GB, - UPRN: HAM601-BLK / 171967 / QA Approved / Andy Cloke

Futures Homeway, Flats 33-49
Hamtun House: NN3 5GB, - UPRN:
HAM601-BLK, Fire Risk
Assessments, Futures Homeway

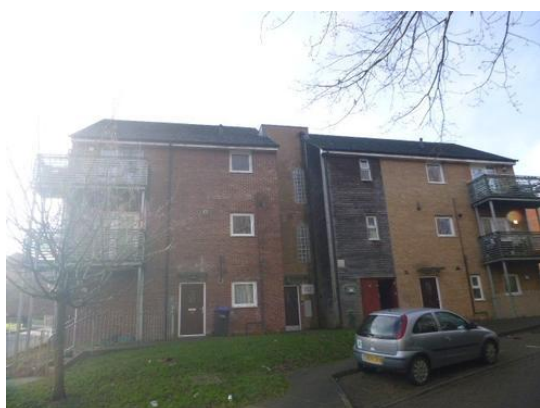
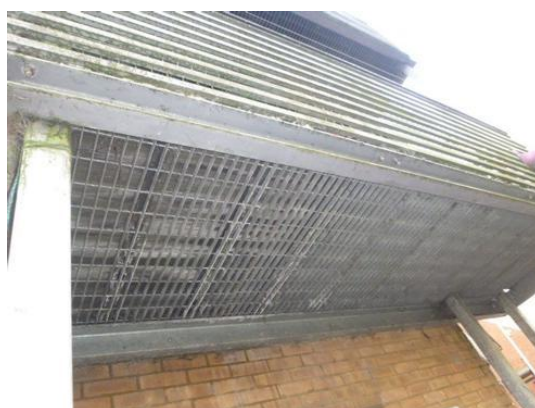
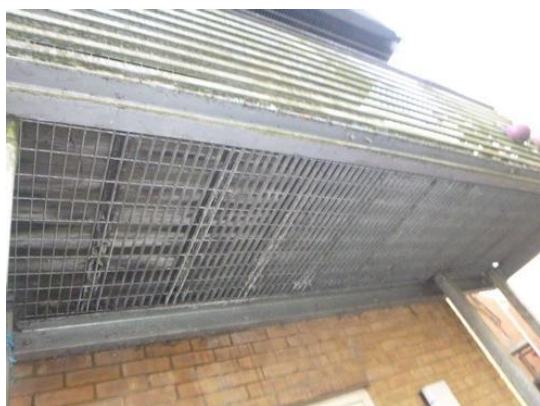
Appears to be a brick built building with timber staircase and floors with internal plastered walls with a painted finish. The building is provided with a pitched timber roof with tiles and a flat roof over the common area and has some timber cladding to the external fascia and balconies with what appears to be steel mesh floors clad with timber.

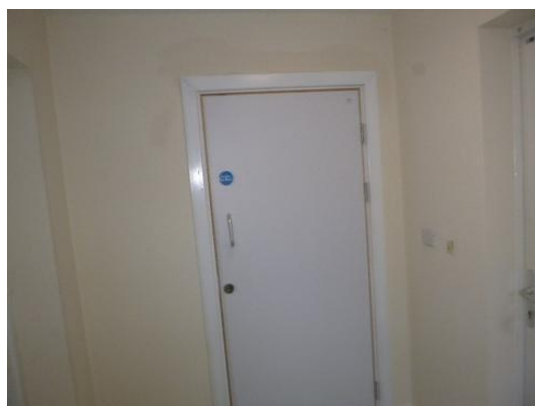
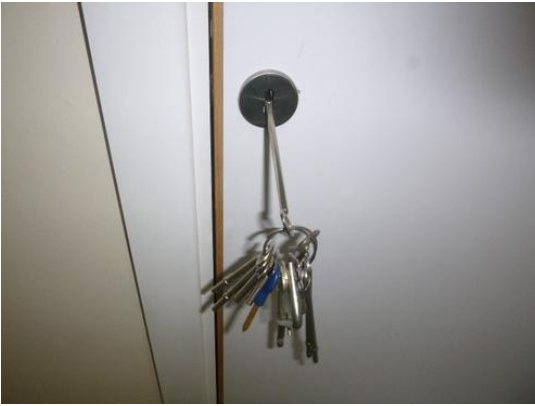
Riser/store cupboards on each floor level - secured with non standard locking mechanisms.

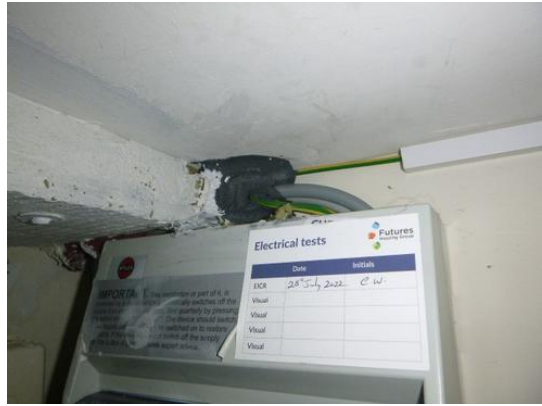
Photo 8

Labeling on the electrical intake equipment indicates the date of the current periodic electrical test being completed in July 2022. In addition refer to principle.

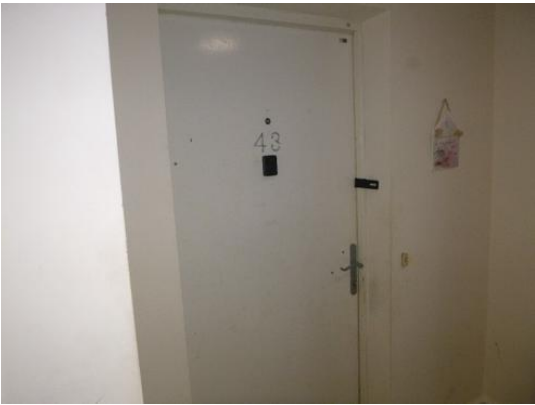
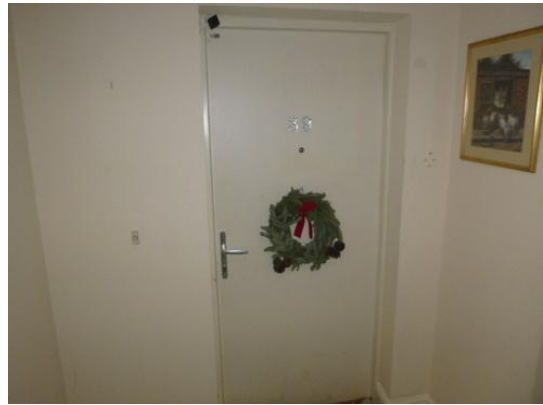
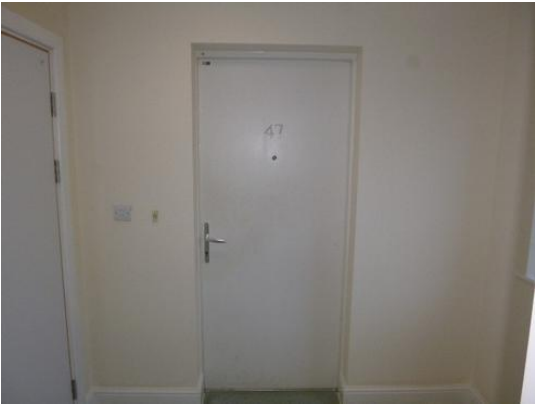
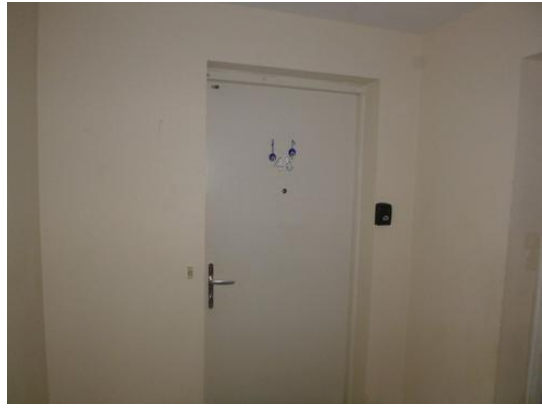
It was unable to be confirmed if flat entrance doors offer 30 minutes fire resistance. Ineffective flat entrance doors in a fire condition may allow smoke heat and fire to spread; this may impede escape and may cause physical harm to the occupants of the building

Management to confirm that adequate FD30S certification is present for the flat entrance doors. If certification is unavailable, then a comprehensive fire door survey should be undertaken to the flat entrance doors by a competent 3rd party accredited company. Any recommendations from such a survey should be implemented as soon as practicable.

Management to confirm that adequate FD30S certification is present for the flat entrance doors. If certification is unavailable, then a comprehensive fire door survey should be undertaken to the flat entrance doors by a competent 3rd party accredited company. Any recommendations from

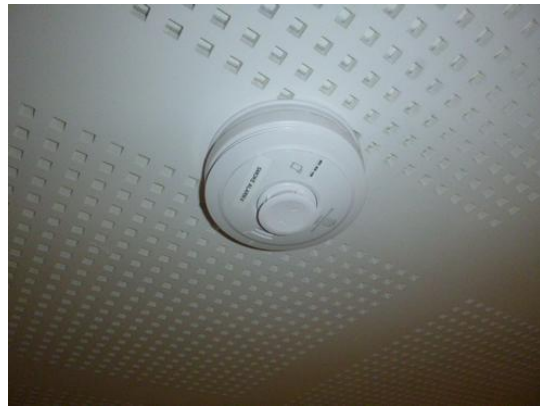
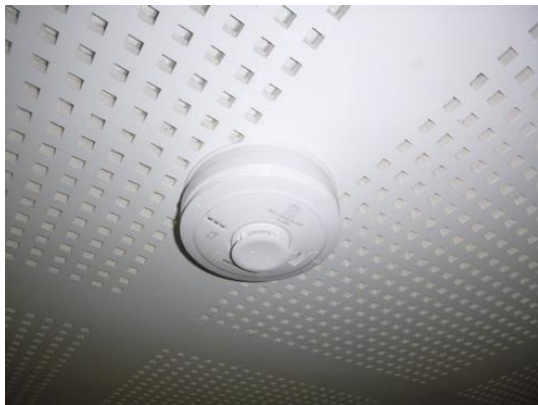
The common area is provided with a Grade D smoke alarm system, the reason for the common area fire

detection and alarm system is unclear as the building is purpose built and should be operating a stay put evacuation strategy.

A cause and effect investigation should be completed to ensure the common area fire detection and alarm system is designed to support the stay put evacuation strategy.

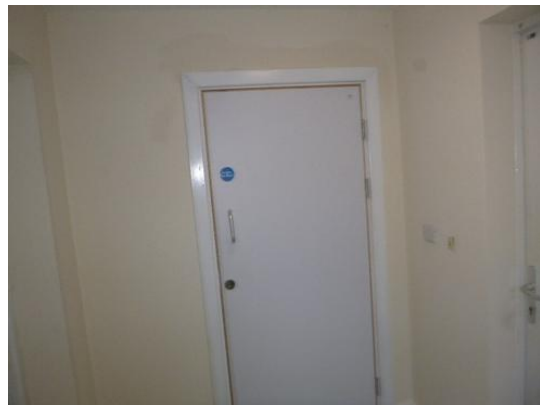
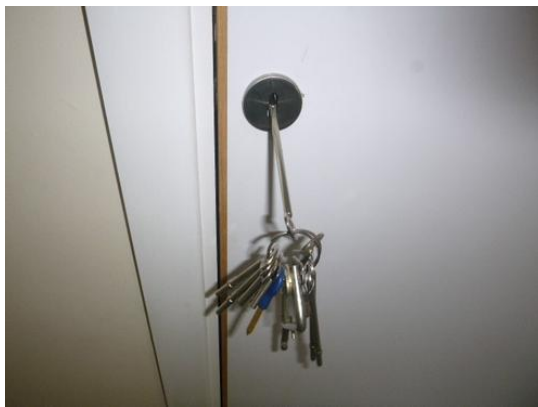
No access to the service riser/store cupboards at time of inspection.

Compartmentation in the riser cupboards as noted should be checked and any deficiencies rectified by a third party competent company.

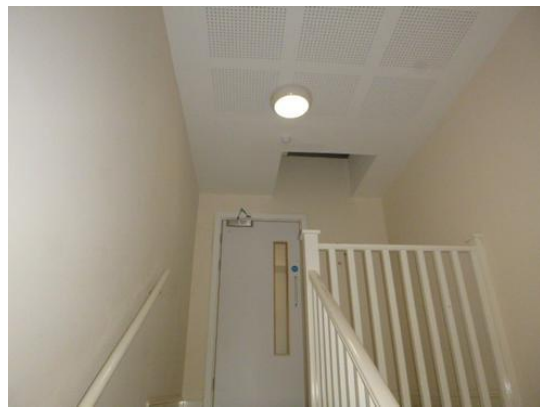
Photo 60

No access to any roof voids at time of inspection.

Management should check compartmentation within the roof space over the common area to confirm that there is adequate separation between the flats and the common area, and where applicable, between individual flats.

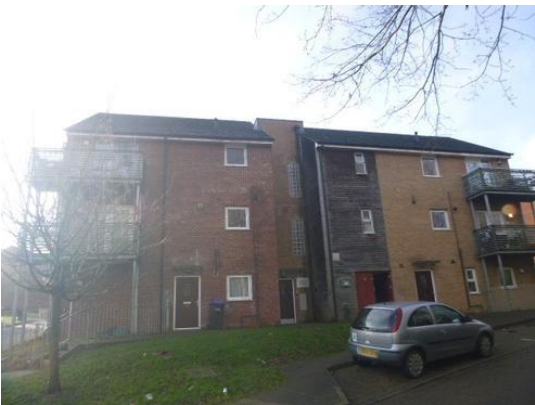
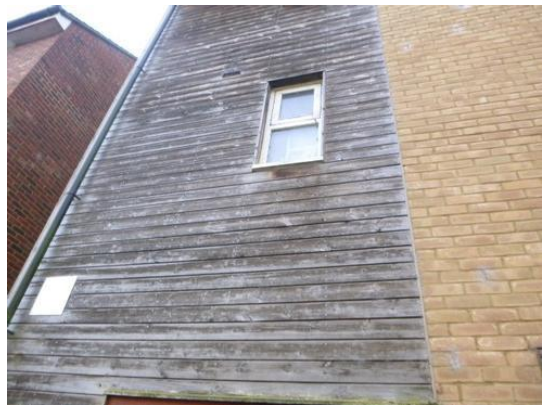
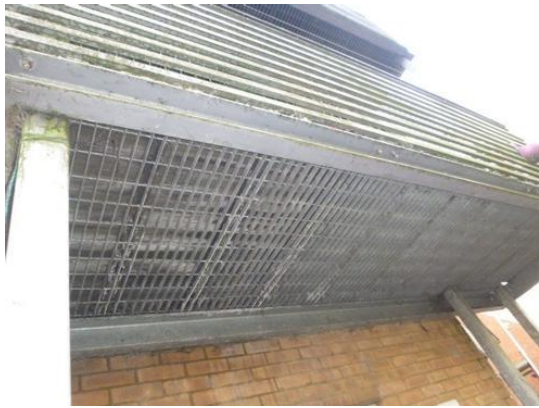
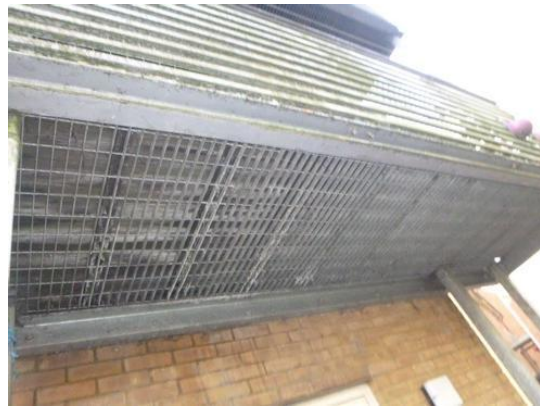
Predominantly brick faced external fascia, however timber cladding was noted to the building fascia and to the floors of the balconies. Balconies storing combustible materials are a potential source of rapid-fire spread on the external wall of residential buildings. A significant number of balcony fires start from the unsafe disposal of smoking materials and the misuse of barbecues.

Building owners should have existing policies in place as to what can and cannot be stored and used on balconies by residents and may need to review these in the light of the materials used in the balcony construction. They may need to communicate with residents to develop their understanding of these risks. Management to confirm the cladding to the building fascia as noted conforms to current guidelines with reference to external spread of flame.
