## Futures Fire Risk Assessment

Futures Homeway, 14- 17Howe Crescent: NN11 4LX, - UPRN: 2030000 / 171930 / QA Approved / Andy Cloke

Futures Homeway, 14- 17Howe Crescent: NN11 4LX, - UPRN: 2030000, Fire Risk Assessments, Futures Homeway

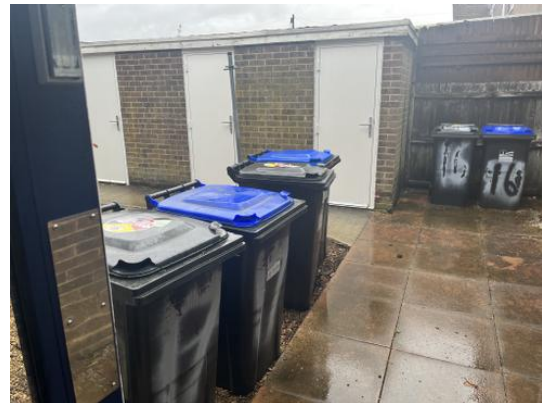
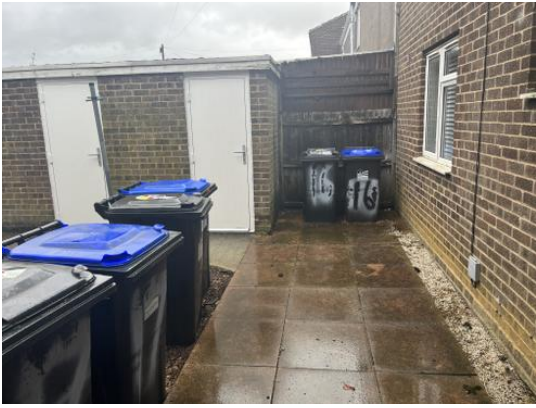
Photo 6

**Are bins secured or fire loading stored in a suitable location? (Please state bin type, location, if and how it is secured)**

At the time of the inspection, domestic wheelie bins were seen to be stored to the rear of the block adjacent to the rear wall and ground floor windows.

Wheelie bins should be stored away from the building, ideally on a purpose built hard standing. Residents should be made aware of the designated bin storage area. Regular checks should be made to ensure compliance of bin storage.

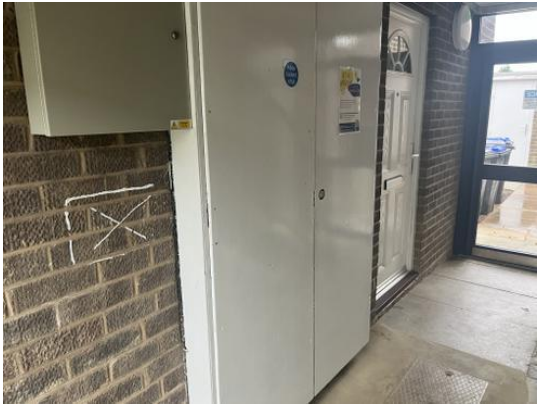
Photo 8

The electrical intake cupboard could not be accessed at the time of the assessment due to non-standard keys being required.

The electrical intake cupboard should be checked for the presence of combustibile materials in the vicinity of sources of ignition.

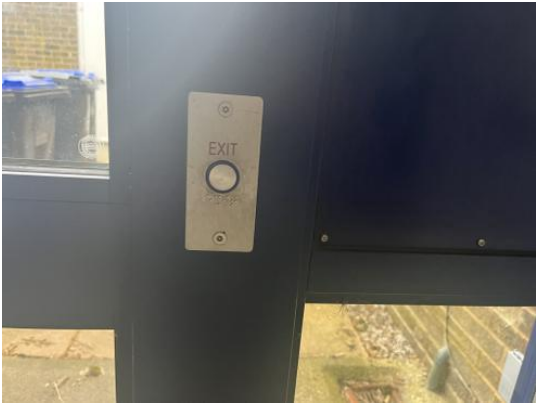
Photo 9

All doors on escape routes are fitted with ironmongery which is easily opened without the use of a key, and there are no sliding or revolving doors.

Push to exit release buttons are installed to the front and rear entrance doors for the block.

The client should conform that the exit system defaults to an open position in the event of a power failure, or that it is installed with a battery backup power supply. The omission of a manual override in accordance with BS7273-4 is noted and acceptable if the above is confirmed and if malicious activation risk is high. If the risk of malicious activation is deemed to be low, the client should consider the installation of manual override systems to the entrance doors of the block.

The client should confirm that the exit system defaults to an open position in the event of a power failure, or that it is installed with a battery backup power supply. The omission of a manual override in accordance with BS7273-4 is noted and acceptable if the above is confirmed and if

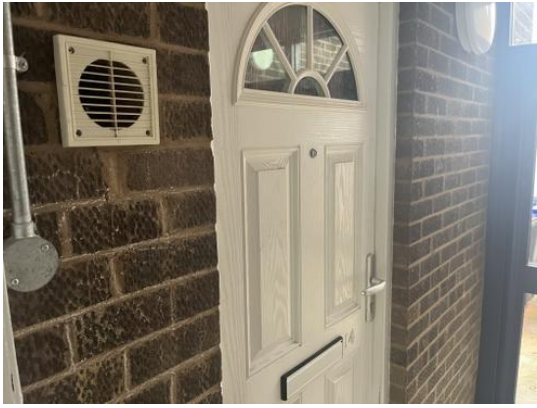
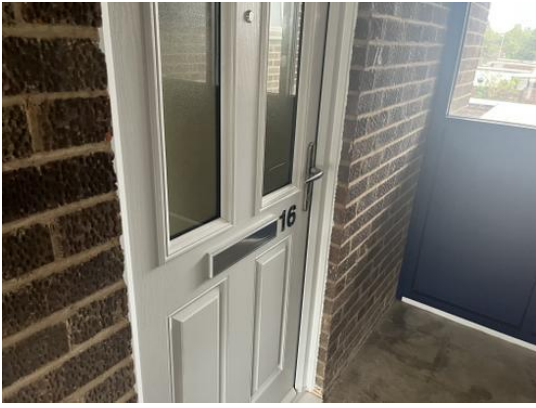
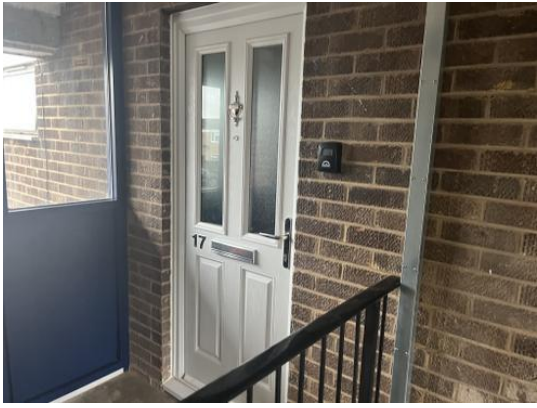
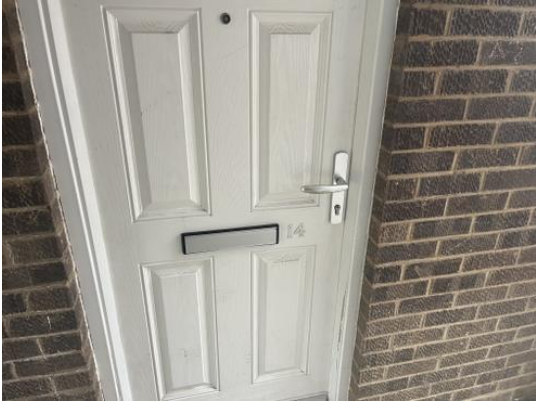
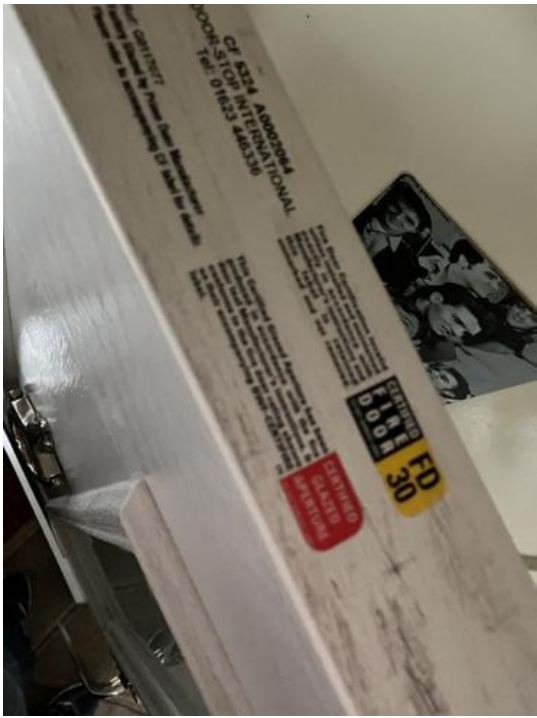
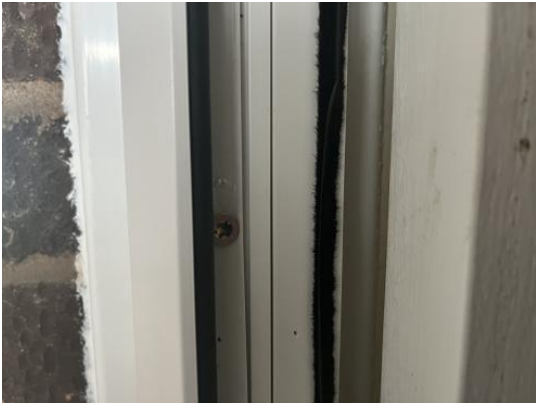
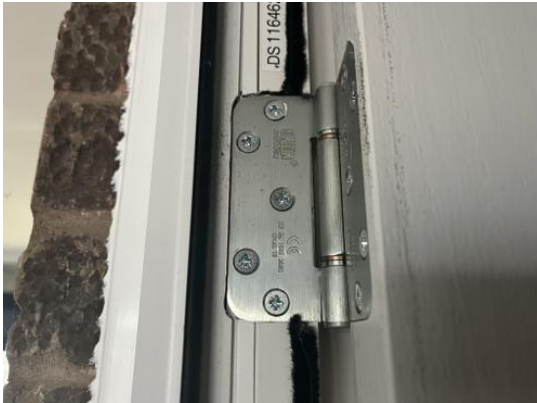
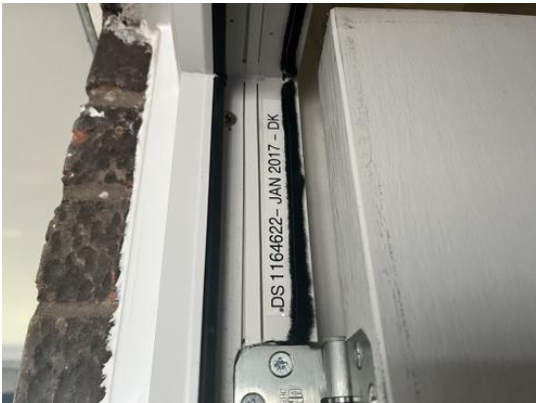
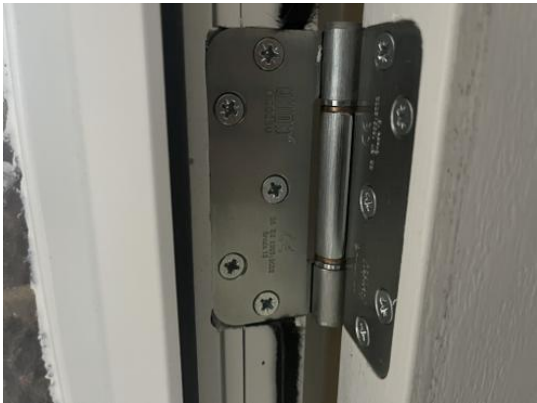
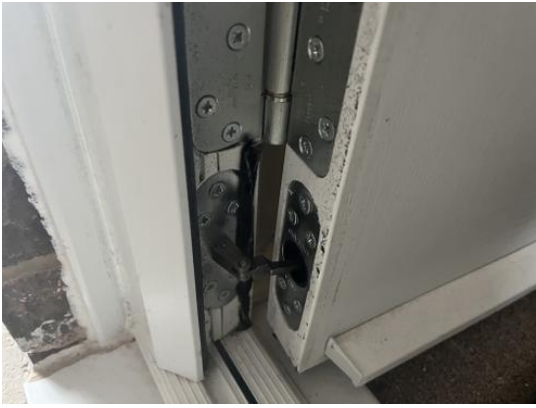
Flat entrance doors were either timber fire rated doors or composite doors all of which appeared to be within composite frames. (NB. - from limited visual inspection, certification not seen; adequacy of installation not confirmed).

Sample inspection of flat 17 found the door to be a certified FD30 door, within a composite or uPVC frame. The door was installed with a closer to the bottom of the frame and strips and seals. Due to the nature of the frame, this could not be confirmed as adequately fire resisting. Remaining doors

within the block appeared to be uniform in design to that of flat 17 and therefore assumed to be the same.

Management should establish an ongoing programme of rolling checks to flat entrance doors to ensure they are installed with combined intumescent strips/cold smoke seals and positive action self closing devices.

As flat entrances have been fitted with composite doorsets/frames, these should have test evidence demonstrating they meet the performance requirement in Building Regulations guidance for fire resistance and smoke control from the flat side only. Management should confirm that suitable fire door test certificates are held and that these relate to the doors/frames fitted. If adequacy cannot be confirmed it may be necessary for doorsets to be replaced under a risk-based programme.

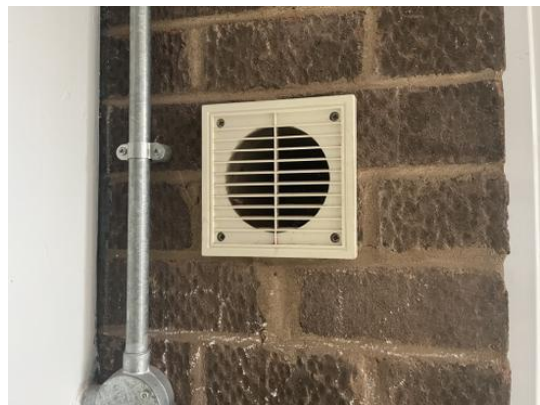
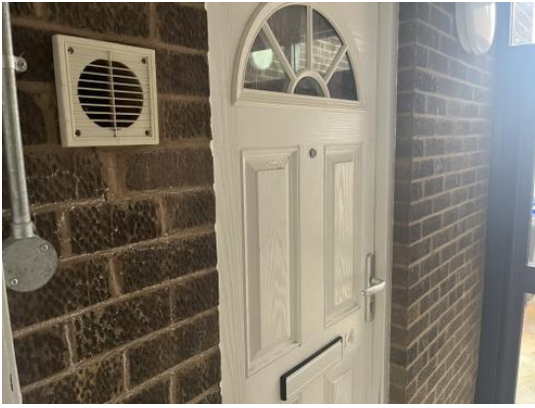
It was noted at the time of the assessment that a vent opened into the common area from flat 14.

The vent noted between flat 14 and the common area should be re-routed to ensure that it does not discharge into the common escape route. The hole in the compartment wall should be re-instated with fire resisting construction.

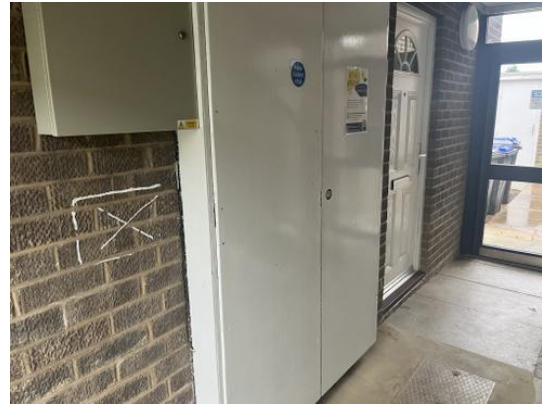
Photo 30

The electrical intake cupboard did not appear to be adequately fire resisting. The cupboard was not available for full inspection at the time of the assessment due to non-standard keys being required.

The doors for the electrical intake from a visual inspection could not be confirmed as adequately fire resisting. The doors also appeared to be damaged and worn around the locking mechanism.

The client should assess the electrical intake cupboard to ensure it is adequately fire resisting. If found not to be fire resisting, the cupboard should be upgraded or replaced to ensure that it offers 30 minutes of fire resistance. This should include the fire sopping of all penetrating services. Remedial works should be completed by a competent contractor.
