## Futures Fire Risk Assessment

Futures Homescape-, Openacre 18-24:  
NG16 5QA, - UPRN: N/A / 335981 / QA  
Approved / Andy Cloke

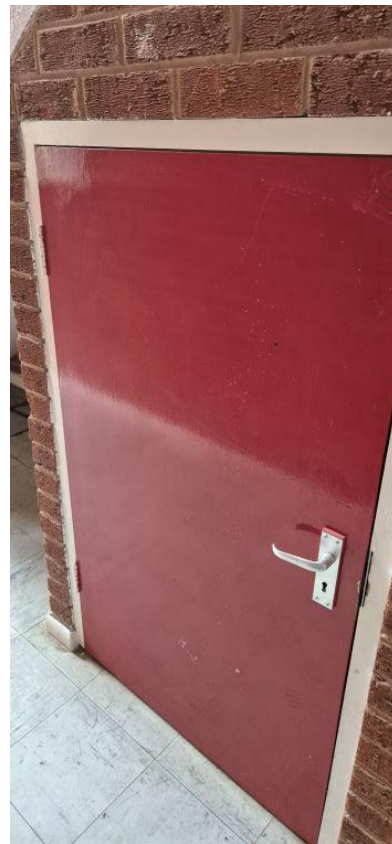
Photo 8

There is an understairs cupboard that was locked and not accessible to the assessor. It was not possible to establish if ignition sources or combustible materials are stored within.

Management should inspect the cupboard to ensure that combustible materials are not stored in proximity of ignition sources within.

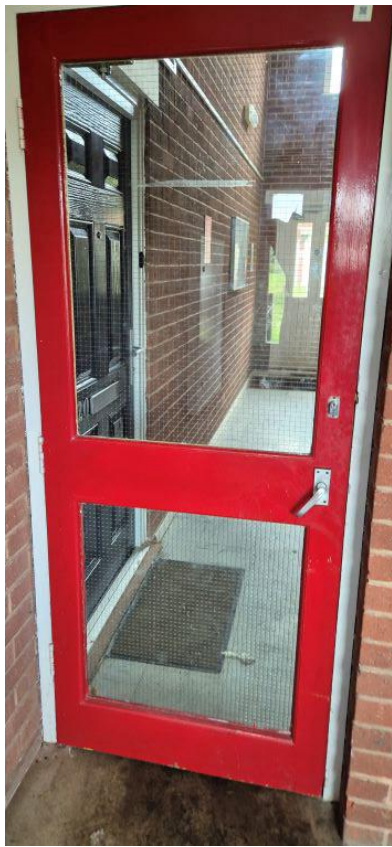
Photo 11

There is a door separating the common area to the ground floor. The door is fitted with self closure device and Georgian reinforced glass. The door was in good condition and shuts close to the frame. There is a key operated lock fitted to the door.

The lock is not required and should be removed as this may compromise / delay safe egress.

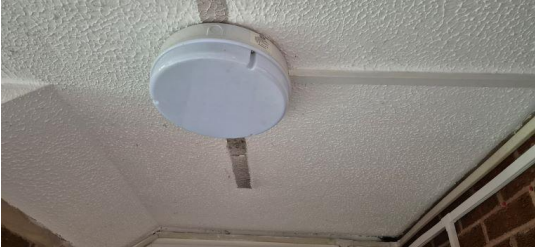
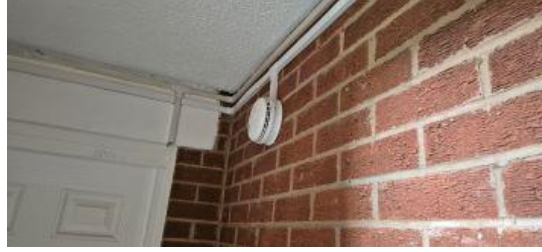
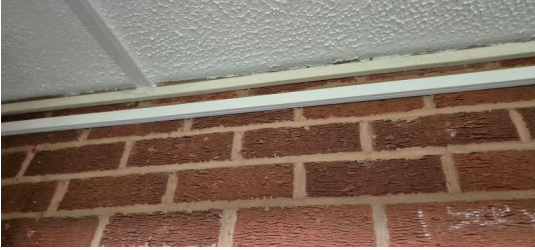
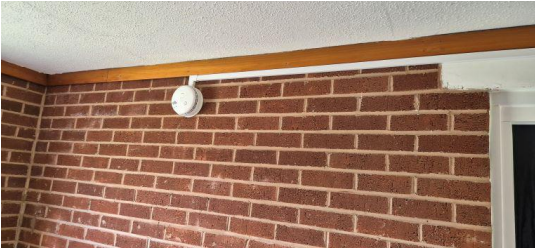
Conduit and cables were noted to the common are and it was not possible to confirm that the requirements of Regulation 521.10.202 of the BS 7671 - 18th Edition of The IET Wiring Regulations, which requires all cables to be adequately supported using non-combustible fixings to prevent premature collapse in the event of a fire. The new regulation is not applied retrospectively so any wiring systems fitted before 2019 do not need to be immediately updated. Any new installation or additions and alterations to existing systems, including temporary wiring, have to comply with the regulations.

Management is to consider the requirements of the Regulation 521.10.202 of the BS 7671 - 18th Edition The IET Wiring Regulations which requires all cables to be adequately supported using non-combustible fixings to prevent premature collapse in the event of a fire albeit not retrospective and seek the advice of a suitably qualified competent person or organisation and undertake any remediation identified by the aforementioned competent person or organisation.

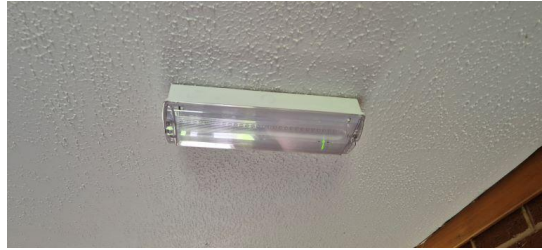
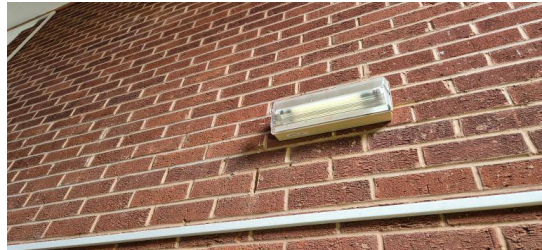
Emergency lighting is installed however, the unit to the ground floor rear had no LED light visible.

Management should inspect the emergency light to the ground floor and repair as required.

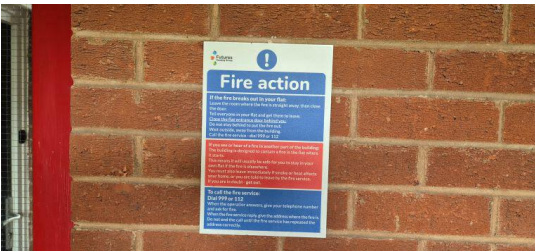
Photo 21

Fire Action Notices are displayed within the common area which advise of a 'Stay Put Policy'. There are no fire doors signs to the common area fire door on the ground floor.

Management should ensure that fire door signage is displayed to both sides of the door (Fire Door Keep Shut).

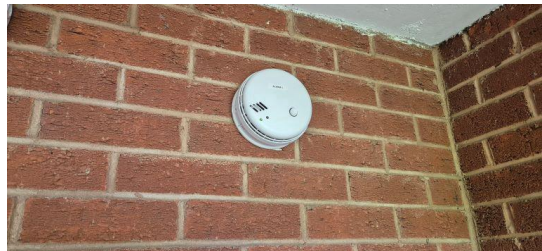
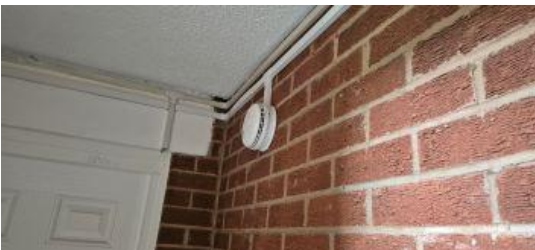
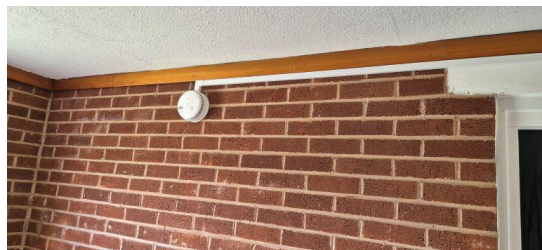
There is no manual alarm system however AFD is installed to common areas. "Section 20.4 of the guidance used highlights how in 'general needs' blocks designed to support a 'stay put' policy, it is unnecessary and undesirable for a fire alarm system to be provided. A communal fire detection and alarm system will inevitably lead to a proliferation of false alarms. This will impose a burden on fire and rescue services and lead to residents ignoring warnings of genuine fires.

Responsible person to confirm that the installed alarm system is warranted, appropriate and effective. Depending on the outcome modify system accordingly.

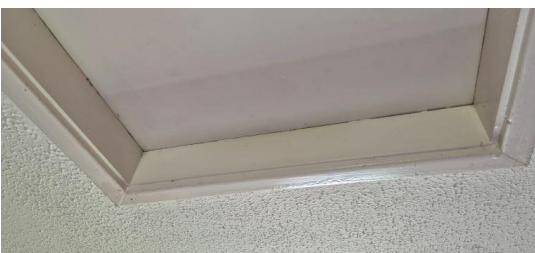
Photo 31

The roof space access hatch could not be opened as it was stuck within the frame. It was not possible to establish the level of compartmentation within the roof space.

Management should ensure that the roof space is inspected by a competent person to ensure that compartmentation is adequate / maintained.

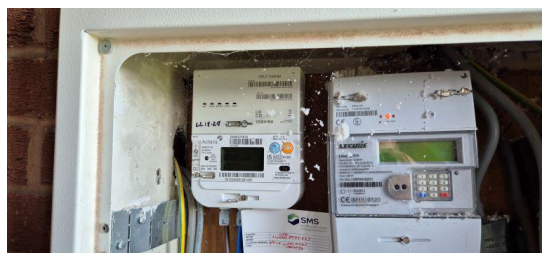
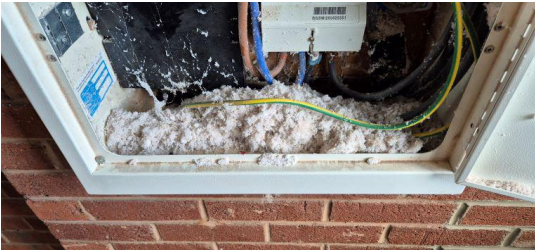
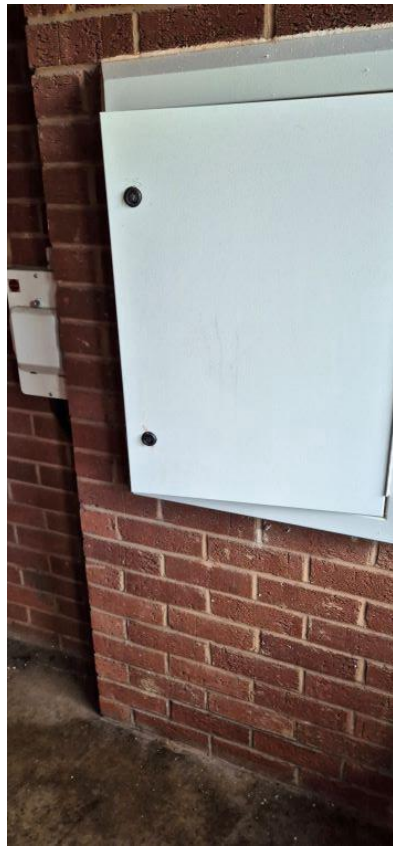
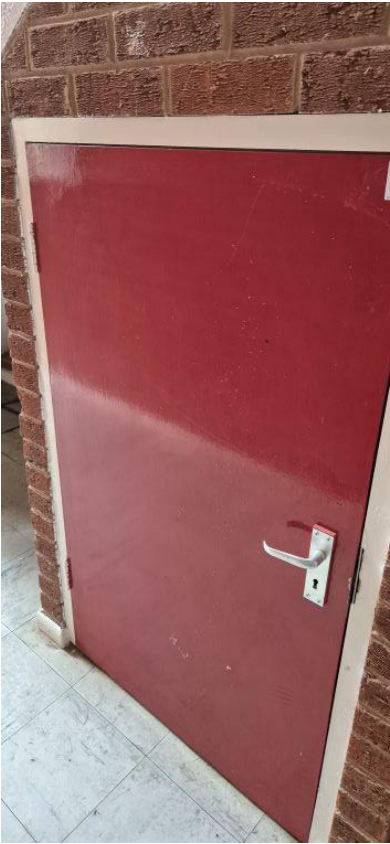
The cupboard under the stairs was not accessible. It was not possible to establish if ignition sources are present or if there are any compartmentation issues within. In addition, the embedded meter enclosure are fire rated however penetrations were identified within. The meter enclosure to the right-hand side of the ground floor (from front of property) appears to have rodent ingress and insulation material has been disturbed / chewed.

Penetrations within embedded meter enclosures should be fire stopped with fire rated building materials. Management should consult with a pest control contractor to establish if rodents are present within and take any actions deemed appropriate.

Where ignition sources are present within the under-stairs cupboard the cupboard and door should be fire rated to FD30s / 30 minutes protected. Any penetrations within should be fire stopped with fire rated building materials.
