Futures Fire Risk Assessment

Futures Homeway, 18-21 Grenville Close: NN11 4LS, - UPRN: 1890001 / 171927 / QA Approved / Andy Cloke

Futures Homeway, 18-21 Grenville Close: NN11 4LS, - UPRN: 1890001, Fire Risk Assessments, Futures Homeway

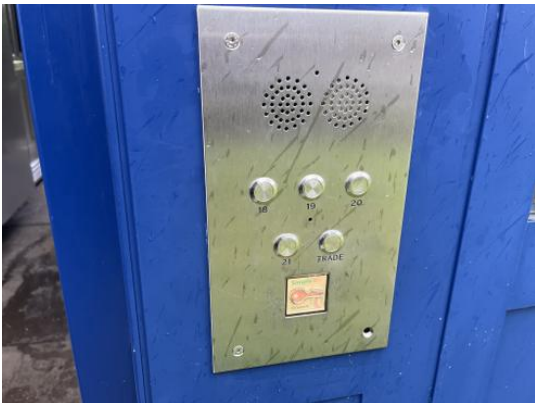
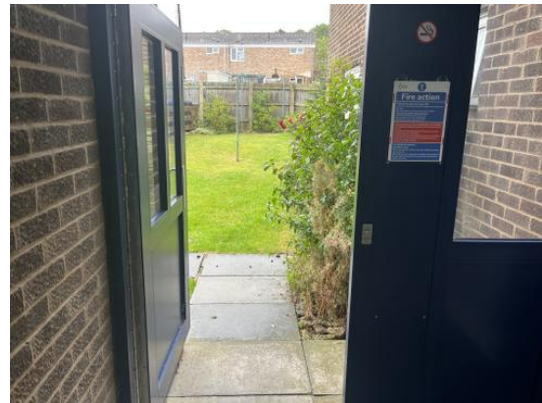
The rear door to the block was wedge open at the time of the assessment leaving the block open to unauthorised access.

Block entrance doors should remain locked shut when not in use. Residents should be made aware that doors are not to be wedge open. Regular checks should be conducted to ensure compliance.

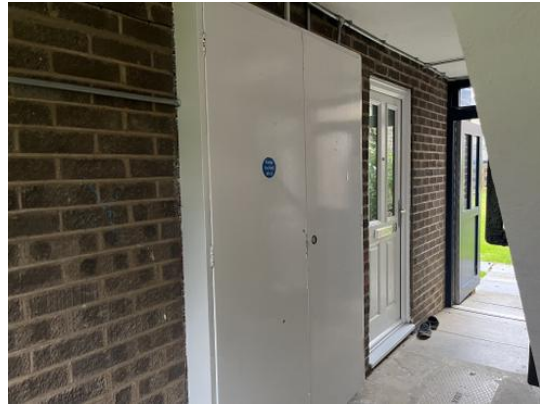
Photo 8

The electrical intake cupboard could not be accessed at the time of the assessment due to non-standard keys being required.

The electrical intake cupboard should be checked for the presence of combustible materials in the vicinity of sources of ignition.

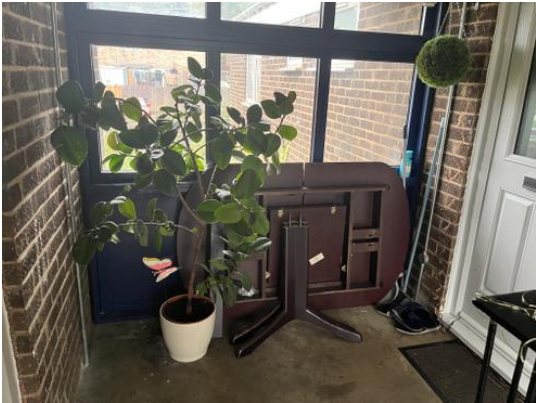
The common escape routes were clear of combustible materials, trip hazards and waste at the time of inspection with the exception of excessive storage of personal items outside of flat 21 on the first floor. The resident was also noted to have attached fairy lights to the handrail.

The fairy lights installed to the handrail of the stairs should be removed as soon as is reasonably practicable. Residents should be made aware that no personal decorative items are to be installed to the common areas of the block.

Items noted should be removed from the communal areas as soon as is reasonably practicable. Residents should be informed that items must not be stored in the communal areas at any time. Regular checks should be conducted to ensure compliance.

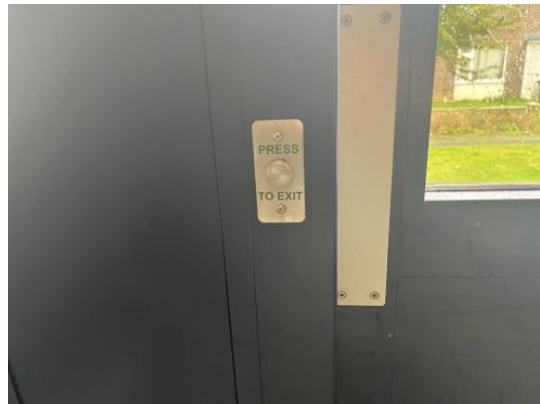
Photo 12

Push to exit release buttons are installed to the front and rear entrance doors for the block.

The client should conform that the exit system defaults to an open position in the event of a power failure, or that it is installed with a battery backup power supply. The omission of a manual override in accordance with BS7273-4 is noted and acceptable if the above is confirmed and if malicious activation risk is high. If the risk of malicious activation is deemed to be low, the client should consider the installation of manual override systems to the entrance doors of the block.

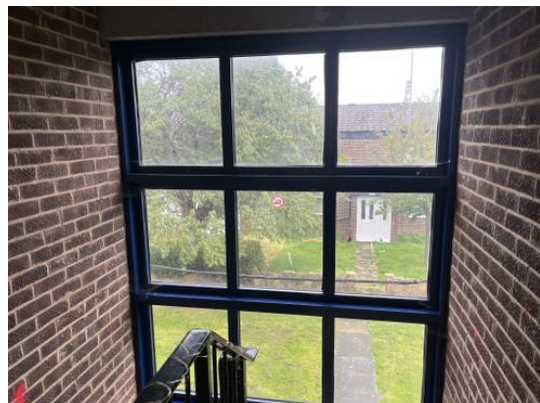
The block appears to have originally been designed as an open deck approach but subsequently has been enclosed. There are no means of ventilated the block on the first floor with fixed window units now in place.

The ventilation arrangements within the first floor should be assessed against the fire strategy document and the building regulations at the time of construction. Remedial works should be completed to ensure that the block is adequately ventilated if it does not meet the standard detailed above.

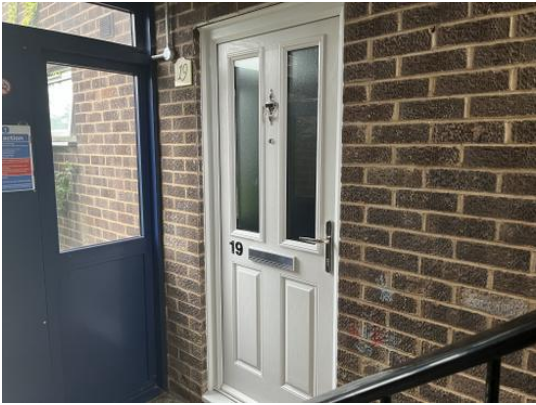
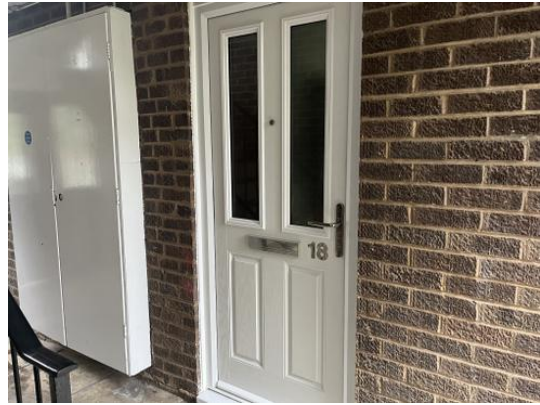
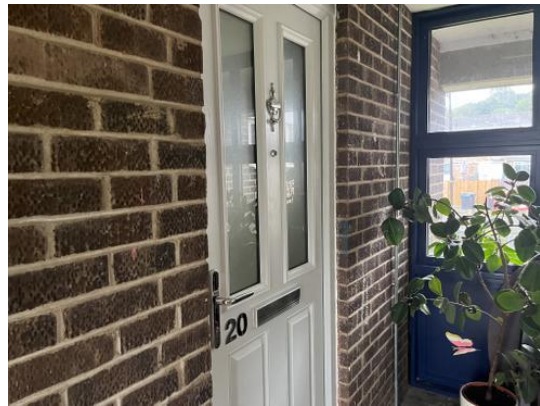
Flat entrance doors appeared to be certified timber fire doors installed to composite frames. (NB. - from limited visual inspection, certification not seen; adequacy of installation not confirmed).

No flats available for sample inspection at the time of the assessment.

As flat entrances have been fitted with composite doorsets/frames, these should have test evidence demonstrating they meet the performance requirement in Building Regulations guidance for fire resistance and smoke control from the flat side only. Management should confirm that suitable fire door test certificates are held and that these relate to the doors fitted. If adequacy cannot be confirmed it may be necessary for doorsets/frames to be replaced under a risk-based programme.

Management should establish an ongoing programme of rolling checks to flat entrance doors to ensure they are installed with combined intumescent strips/cold smoke seals and positive action self-closing devices.

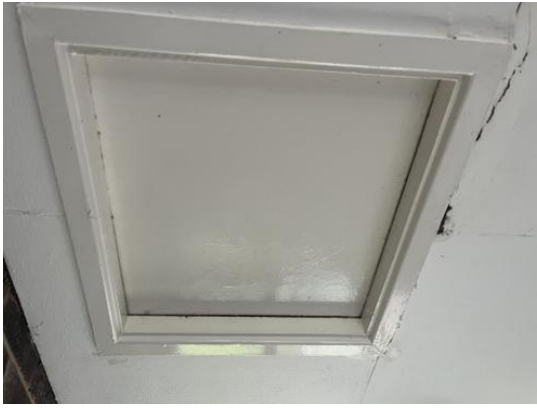
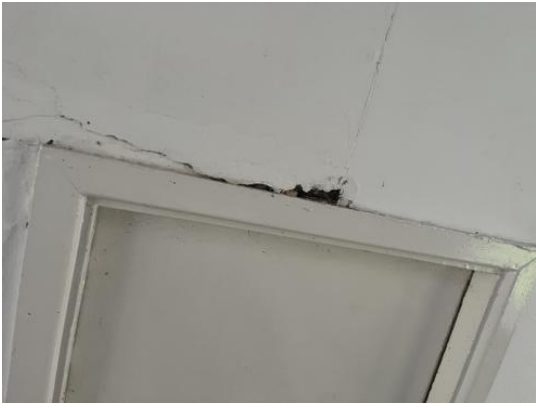
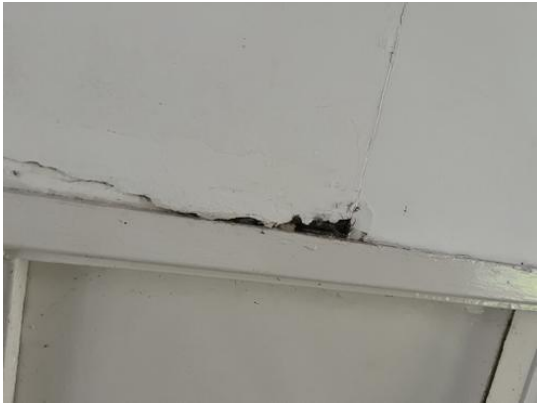
It was noted that the construction around the loft hatch had holes around the frame.

The ceiling around the loft hatch should be repaired to achieve the same level of fire resistance as the rest of the compartment. Remedial works should be completed by a competent contractor.

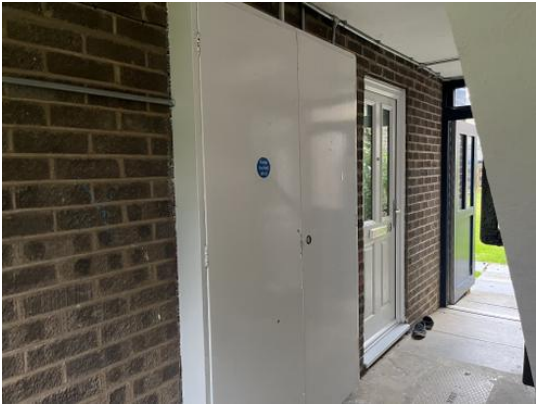
Photo 31

The electrical intake cupboard did not appear to be adequately fire resisting. The cupboard was not available for full inspection at the time of the assessment due to non-standard keys being required.

The doors for the electrical intake from a visual inspection could not be confirmed as adequately fire resisting. The doors also appeared to be damaged and worn around the locking mechanism.

The client should assess the electrical intake cupboard to ensure it is adequately fire resisting. If found not to be fire resisting, the cupboard should be upgraded or replaced to ensure that it offers 30 minutes of fire resistance. This should include the fire stopping of all penetrating services. Remedial works should be completed by a competent contractor.
