Futures Fire Risk Assessment

Futures Homeway, Coleridge Walk: NN11 5AU, - UPRN: 1550000 / 171902 / QA Approved / Andy Cloke

Futures Homeway, Coleridge Walk: NN11 5AU, - UPRN: 1550000, Fire Risk Assessments, Futures Homeway

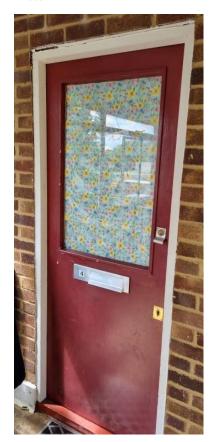
Photo 14

It was not possible to establish fire rating or condition of dwelling doors as no flats were accessible at the time of assessment. The letterbox to dwelling 12 is missing.

Management should inspect all doors to the premises to establish condition and fire rating and repair or replace doors with certificated FD30S self-closing fire door(s) and frame sets where necessary. These should be fitted by an approved, third party certified installation contractor. The

Management should inspect all doors to the premises to establish condition and fire rating and repair or replace doors with certificated FD30S self-closing fire door(s) and frame sets where necessary. These should be fitted by an approved, third party certified installation contractor. The letterbox to dwelling 12 also requires replacing
