Futures Fire Risk Assessment

Futures Homeway, Flats 55-61 Trafalgar
Way: NN11 4LP, - UPRN: 2650003 /
171949 / QA Approved / Rizwan Tanveer

**Futures Homeway, Flats 55-61
Trafalgar Way: NN11 4LP, -
UPRN: 2650003, Fire Risk
Assessments, Futures Homeway**

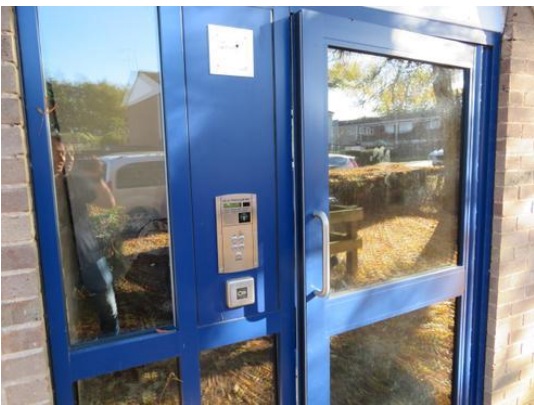
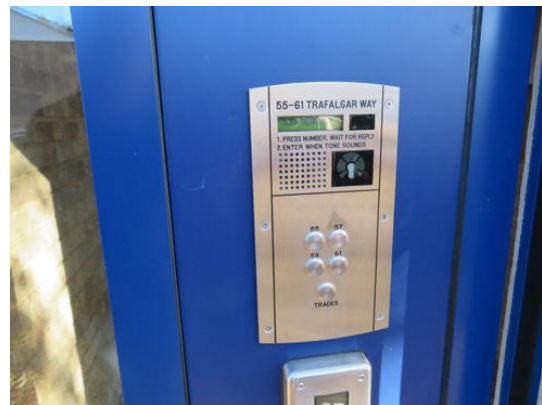
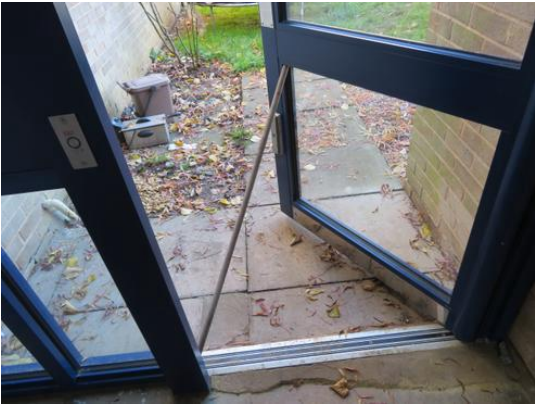
The block is installed with an access control system and self closing entrance doors.

The front entrance door was sticking open on the floor leaving the block unsecured.

The rear entrance door to the block was noted to be wedged open with a steel pole at the time of the assessment leaving the block unsecured.

The front entrance door should be repaired/adjusted to ensure it does not stick open on the ground and closes fully under the power of its self closing device to prevent unauthorised access.

Block entrance doors should remain closed at all times when not in use. Residents should be informed that block entrance doors must remain closed at all times when not in use. Regular checks should be conducted to ensure compliance.

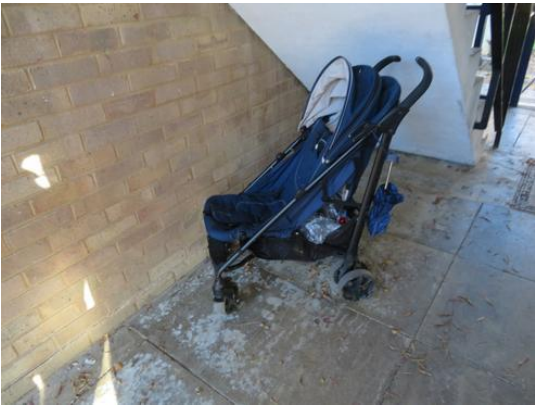
Photo 9

The common escape routes were clear of combustible materials, trip hazards and waste at the time of inspection with the exception of a buggy that was being stored under the stairs on the ground floor.

Items noted should be removed from the communal areas as soon as is reasonably practicable. Residents should be informed that items must not be stored in the communal areas at any time. Regular checks should be conducted to ensure compliance.

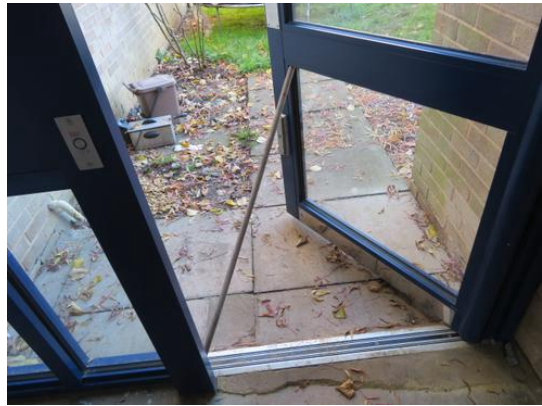
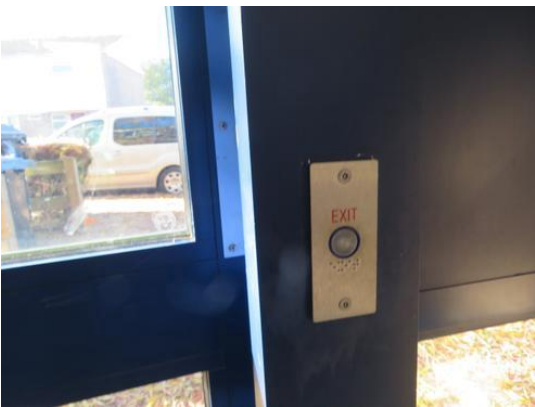
All doors on escape routes are fitted with ironmongery which is easily opened without the use of a key, and there are no sliding or revolving doors.

Push to exit release buttons are installed to the front and rear entrance doors for the block.

The client should confirm that the exit system defaults to an open position in the event of a power failure, or that it is installed with a battery backup power supply. The omission of a manual override in accordance with BS7273-4 is noted and acceptable if the above is confirmed and if malicious activation risk is high. If the risk of malicious activation is deemed to be low, the client should consider the installation of manual override systems to the entrance doors of the block.

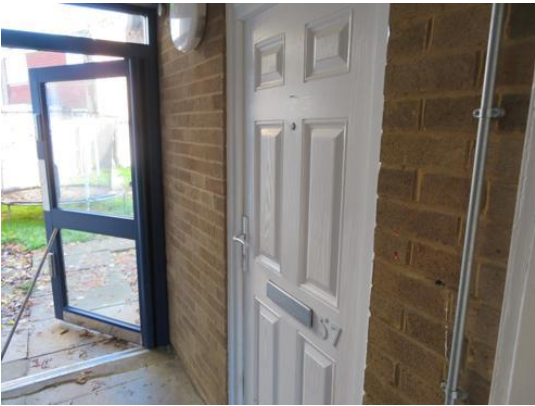
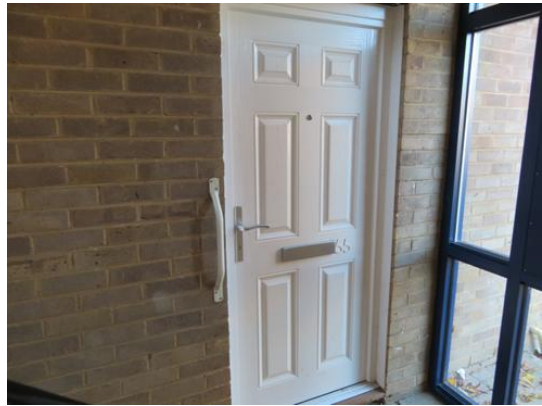
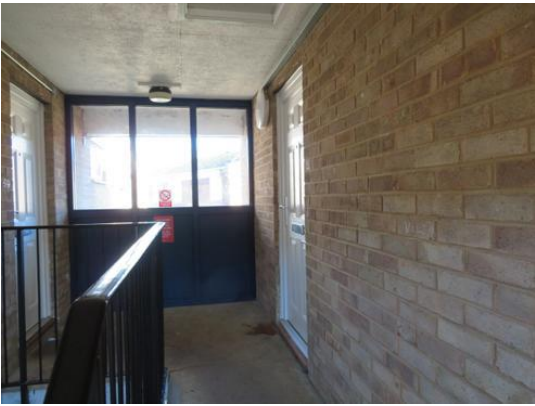
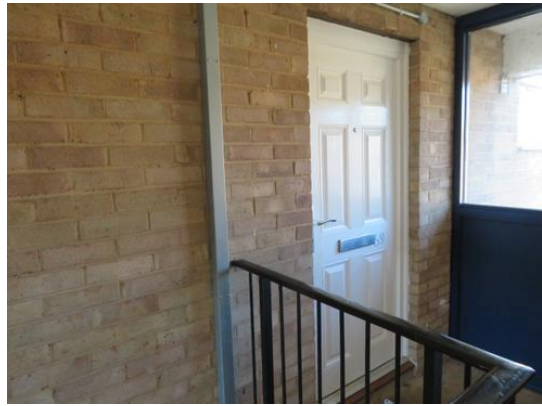
Flat entrance doors appeared to be replacement certified FD30 fire doors. (NB. - from limited visual inspection, certification not seen; adequacy of installation not confirmed).

Management should establish an ongoing programme of rolling checks to flat entrance doors to ensure they are installed with combined intumescent strips/cold smoke seals and positive action self-closing devices.

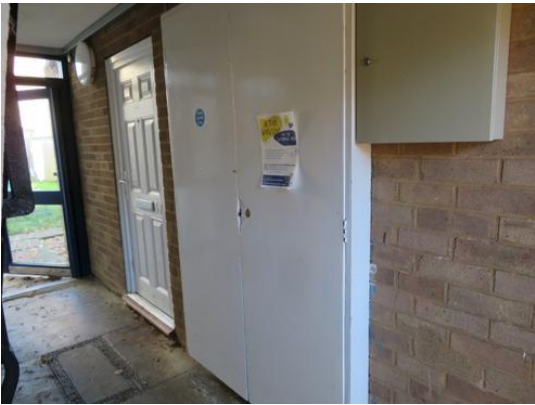
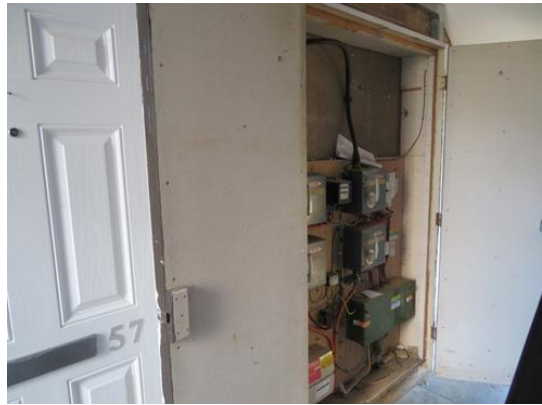
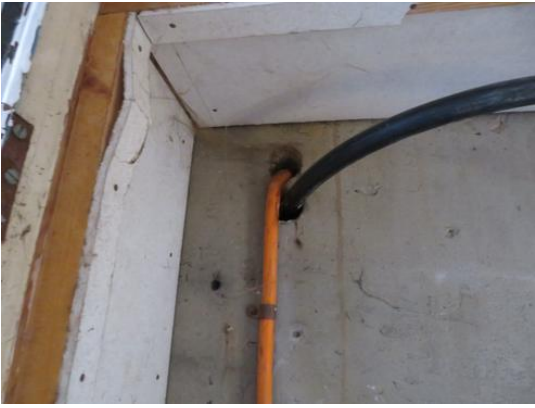
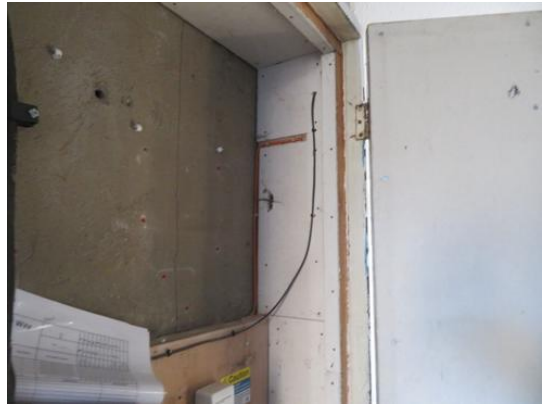
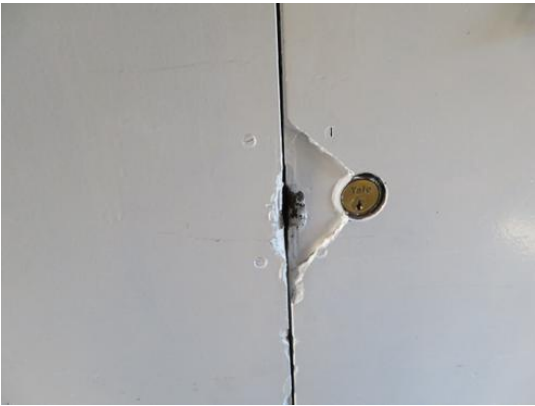
The doors noted to the electrical intake cupboard appeared to be 44mm thick solid core timber doors installed with intumescent strips only. The doors were noted to be in a poor state of repair with damage noted to the door edges and faces, and a damaged locking mechanism preventing the door from being locked shut when not in use.

The doors to the electrical intake cupboard should be repaired or replaced to ensure that they are 30 minute fire resisting including the addition of combined intumescent strips/cold smoke seals. Remedial works should be completed by a competent third party accredited contractor.

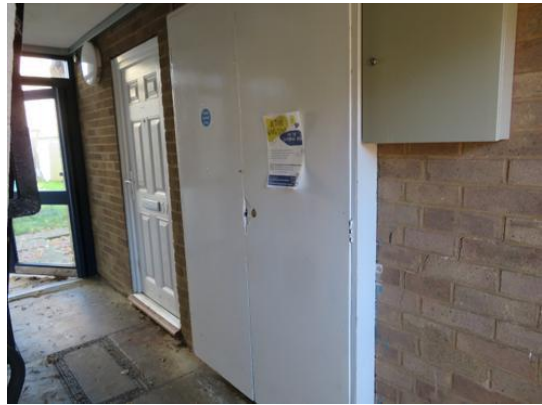
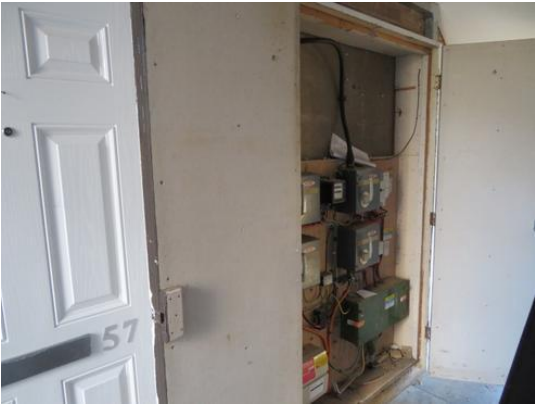
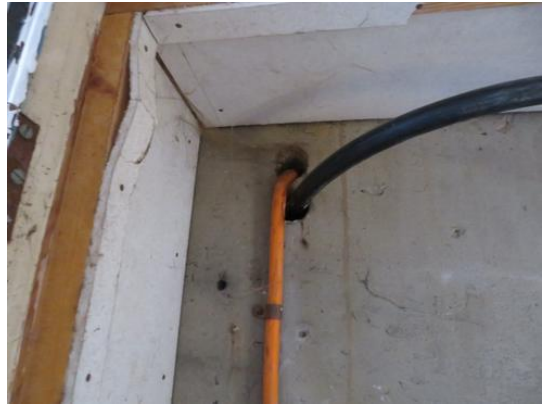
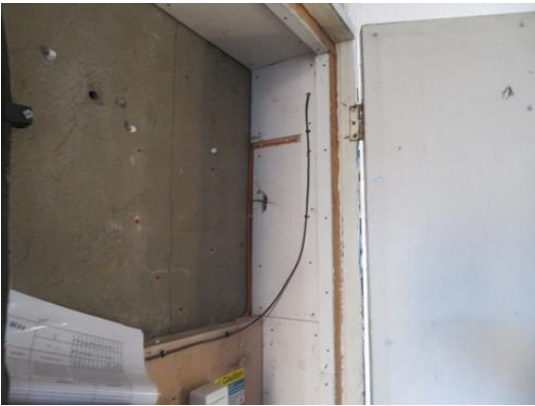
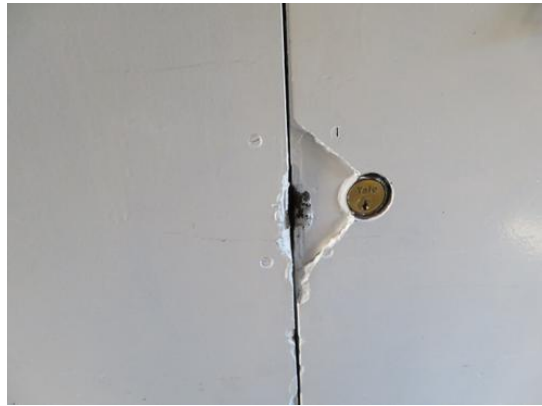
The electrical intake cupboard was not thought to be adequately fire resisting, timbers used in the construction of the cupboard were exposed internally. Penetrating services within the cupboard were also not found to be adequately fire stopped.

It is recommended that the electrical intake cupboard is upgraded to provide a minimum of 30 minutes fire resistance from both sides. This includes the firestopping of all penetrating services from both sides. Remedial works should be completed by a competent third party accredited contractor.
