Futures Fire Risk Assessment

Futures Homeway, RYEHILL CLOSE 18-21:
NN6 7NR, - UPRN: 11469 / 171937 / QA
Approved / Andy Cloke

**Futures Homeway, RYEHILL
CLOSE 18-21: NN6 7NR, - UPRN:
11469, Fire Risk Assessments,
Futures Homeway**

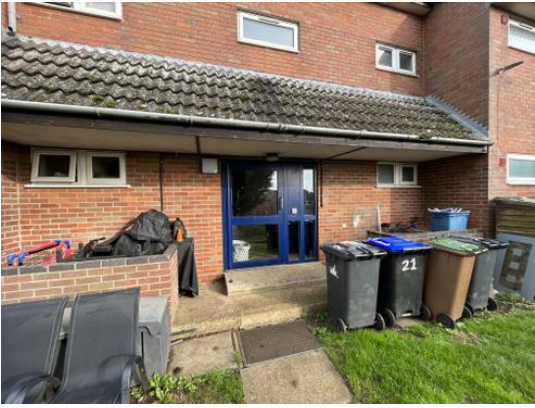
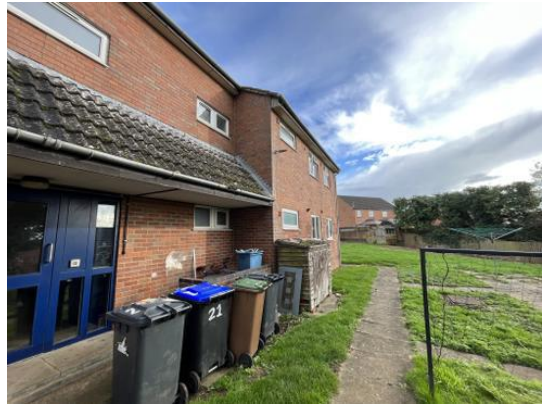
It was noted that domestic wheelie bins and resident personal items were being stored against the rear wall of the building directly outside of the rear entrance/exit door.

Any personal resident items should be removed from the rear of the block as soon as is reasonably practicable. Residents should be reminded that all personal items should be stored within their flats. Regular checks should be conducted to ensure compliance.

The wheelie bins noted should be relocated away from the building a minimum of 2 meters. Ideally bins should be placed in a secure bin store. Regular checks should be conducted by the client to ensure that bins remain away from the building in their designated storage area.

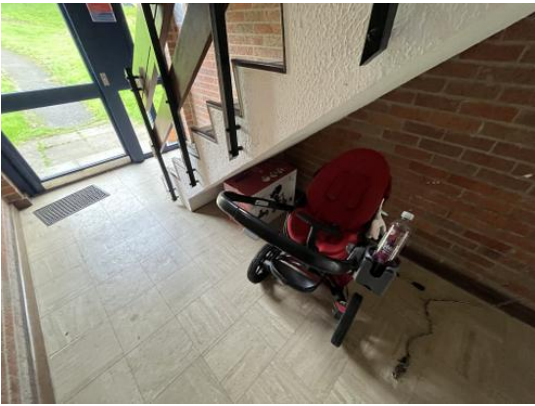
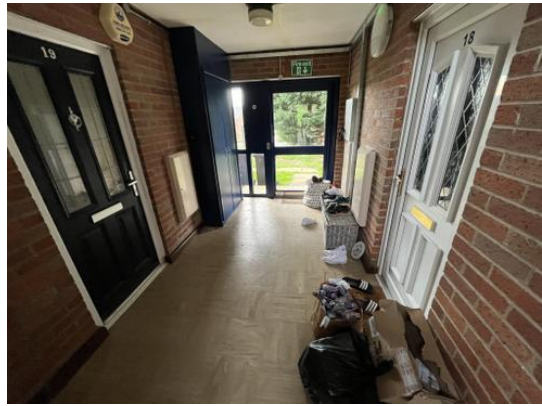
A large amount of personal items were noted outside of flat 18 on the ground floor.

A buggy and box were noted under the stairs on the ground floor.

A cardboard box was noted outside of flat 20 entrance door on the 1st floor.

Items noted should be removed from the communal areas as soon as is reasonably practicable. Residents should be informed that items must not be stored in the communal areas at any time. Regular checks should be conducted to ensure compliance.

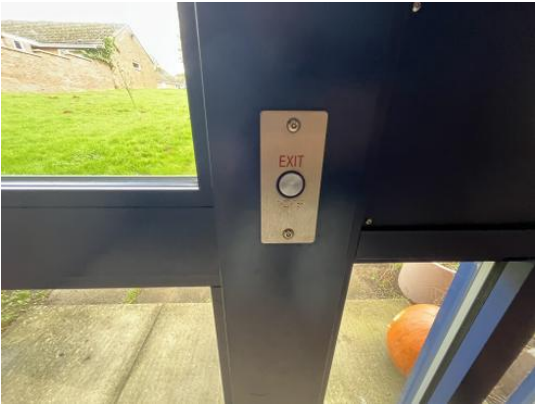
Photo 15

The final exit doors are opened via 'push to exit' buttons. These were not seen to have a manual override call point installed in the event of an emergency, nor could they be confirmed as defaulting to open in the event of a power failure.

The client should confirm that the exit system defaults to an open position in the event of a power failure, or that it is installed with a battery backup power supply. The omission of a manual override in accordance with BS7273-4 is noted and acceptable if the above is confirmed and if malicious activation risk is high. If the risk of malicious activation is deemed to be low, the client should consider the installation of manual override systems to the entrance doors of the block.

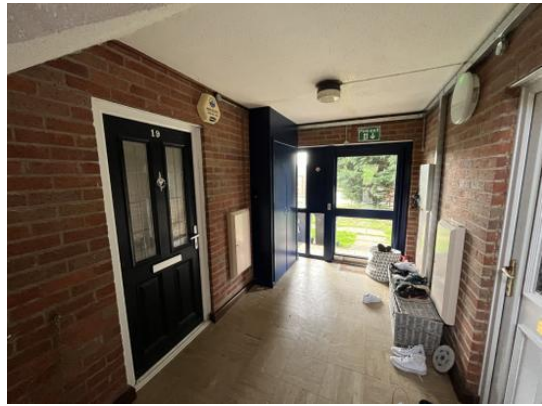
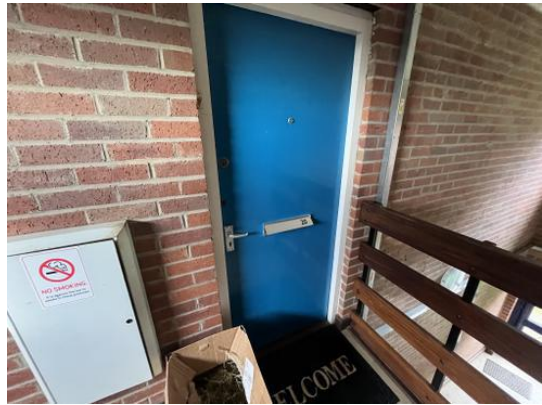
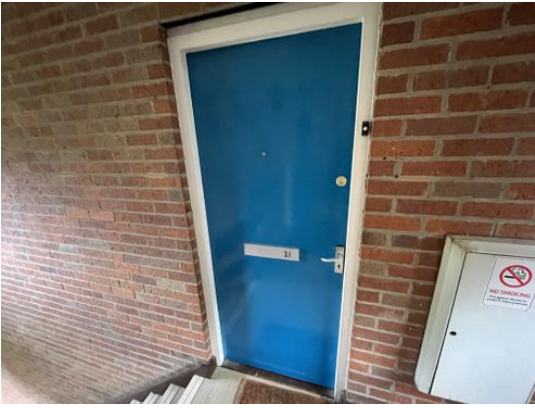
Flat entrance doors appeared to be a combination of notional timber fire doors and replacement composite/uPVC doors. (NB. - from limited visual inspection, certification not seen; adequacy of installation not confirmed).

Flats 18 & 19 on the ground floor appear to be composite or uPVC with no evidence of fire rating.

The letterbox installed to flat 20 appeared to be defective at the time of the assessment.

The letterbox installed to flat 20 entrance door should be repaired or replaced with a self closing fire rated letterbox. This is to prevent the passage of fire and other products of combustion between compartments in the event of a fire situation. Remedial works should be completed by a competent contractor.

As flat entrances have been fitted with composite doorsets, these should have test evidence demonstrating they meet the performance requirement in Building Regulations guidance for fire resistance and smoke control from the flat side only. Management should confirm that suitable fire door test certificates are held and that these relate to the doors fitted. If adequacy cannot be confirmed it may be necessary for doorsets to be replaced under a risk-based programme.
