Futures Fire Risk Assessment

Futures Homeway, Flats 10-15 Hawke Road: NN11 4LA, - UPRN: 1910000 / 171903 / QA Approved / Andy Cloke

Futures Homeway, Flats 10-15
Hawke Road: NN11 4LA, - UPRN:
1910000, Fire Risk Assessments,
Futures Homeway

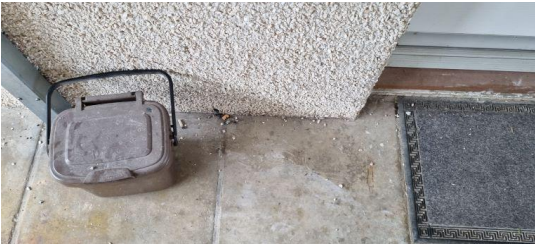
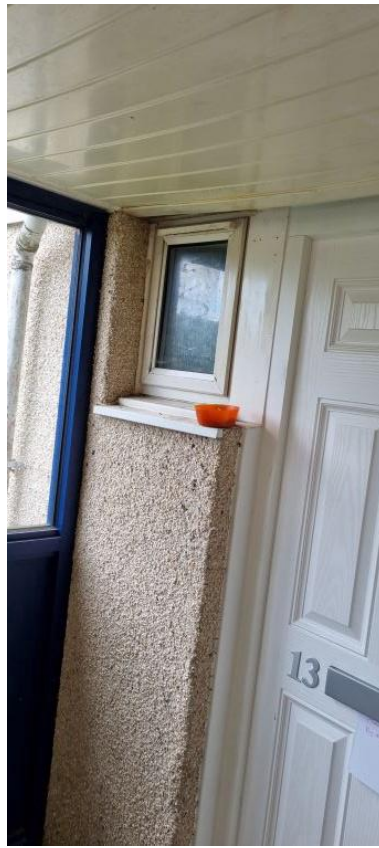
There was evidence of smoking in the ground floor lobby and first floor landing. There is no signage displayed within the common area.

Management should liaise with residents to ensure that the 'no smoking' policy is adhered to. 'No Smoking' signs should be displayed within the ground floor lobby and on the first floor landing. It is also advisable that management carry out spot checks to ensure compliance.

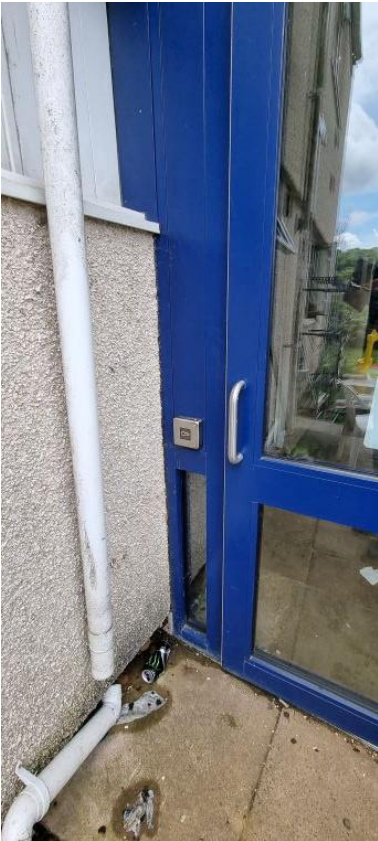
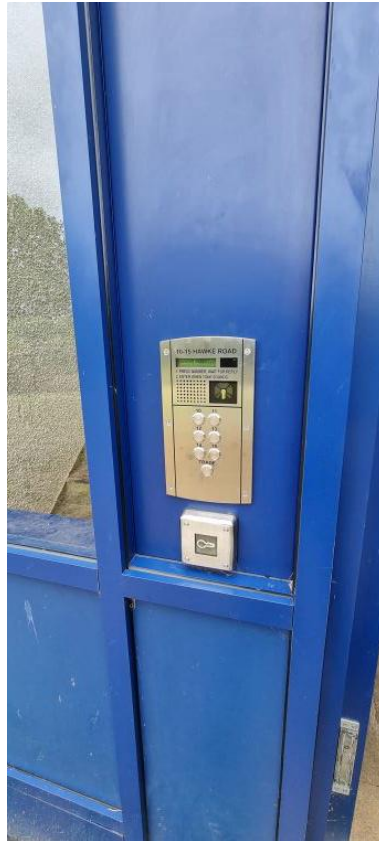
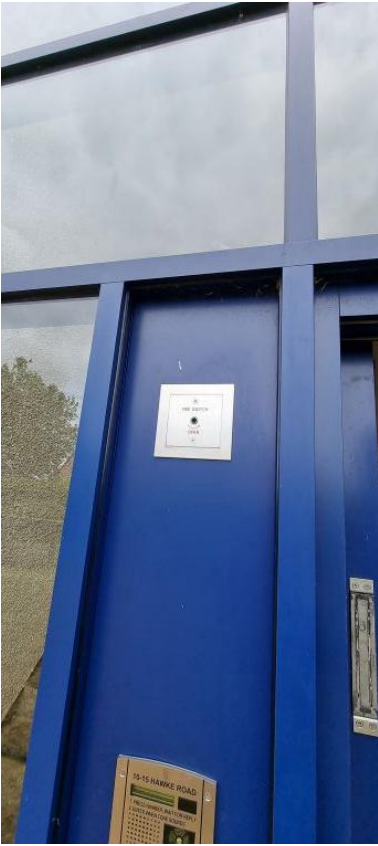
Electronic key fob operated doors are fitted to the front and rear however both doors were wedged open and were accessible at the time of assessment. There is a 'Trades' button and Fireman's drop switch installed.

Management should liaise with residents to ensure that doors are kept shut / locked when not in use in order to maintain adequate measures of security. Signage should be displayed within the entrance lobby advising residents to keep doors locked.

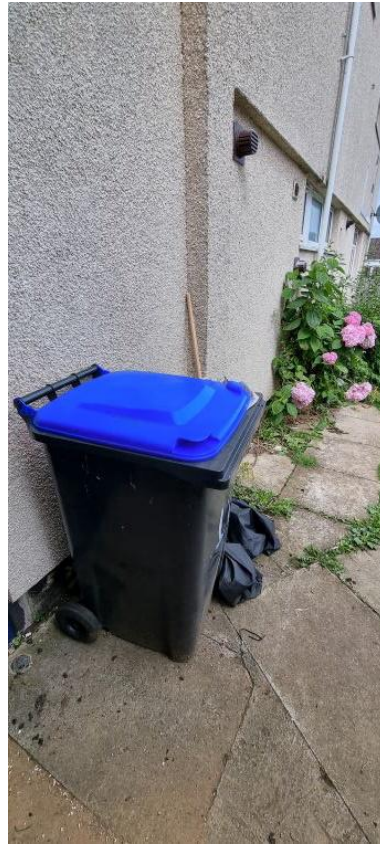
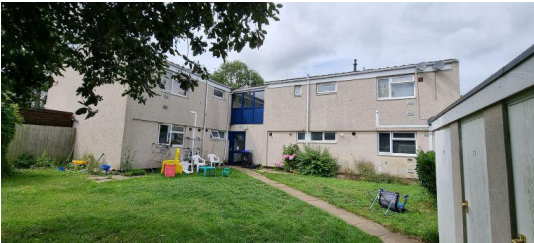
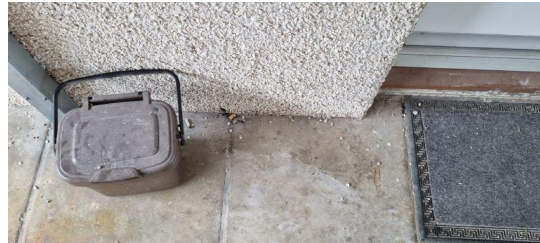
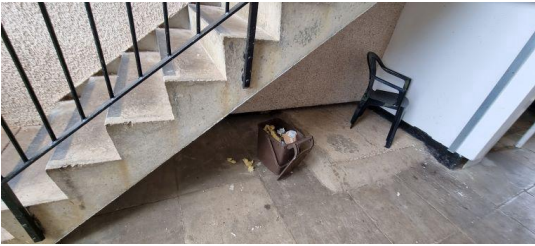
Some wheelie bins were stored against the building wall and close to the exit. In addition, recycling caddies were left in the common area.

Management should ensure that waste bins are stored away from the building and that recycling caddy bins are not stored in common areas.

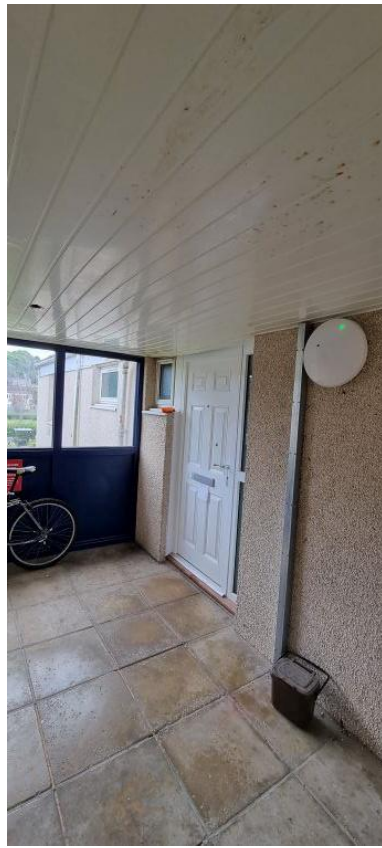
Photo 14

The ceiling to the first floor is UPVC cladded. It was not possible to establish if the cladding is fire rated.

Management should confirm if cladding is fire rated. Where cladding is found not be be fire rated it should be replaced with fire rated materials.

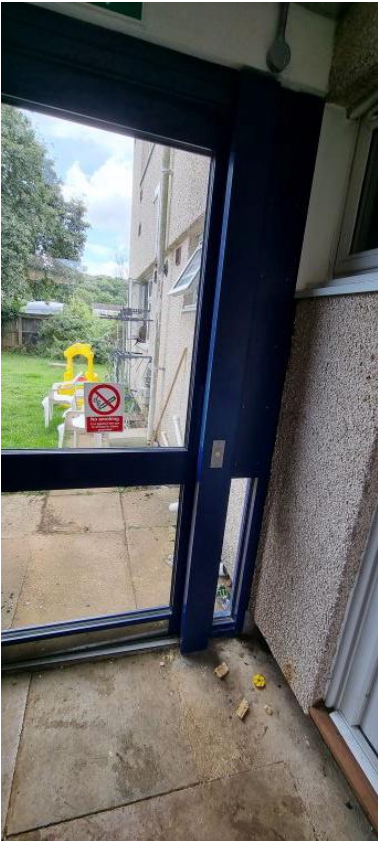
Photo 15

Door release buttons are fitted to the front and rear exit doors. It was not possible to establish if door release buttons fail to safety in the event of mains power failure.

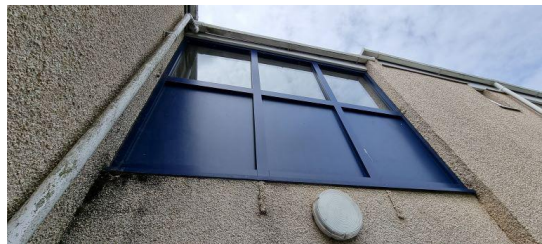
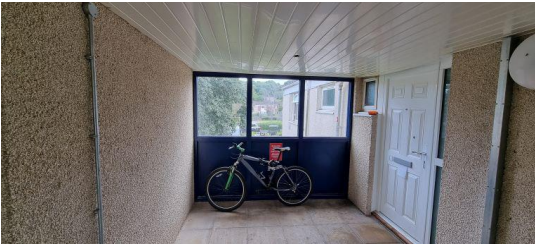
Windows on the first floor landing do not open.

Management should install and openable window to the first floor landing.

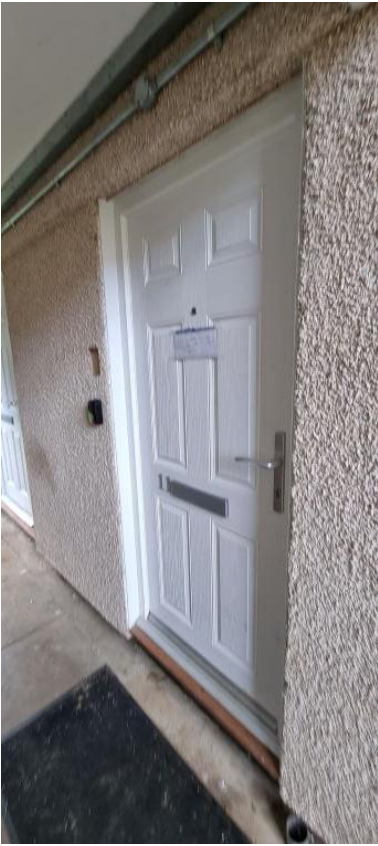
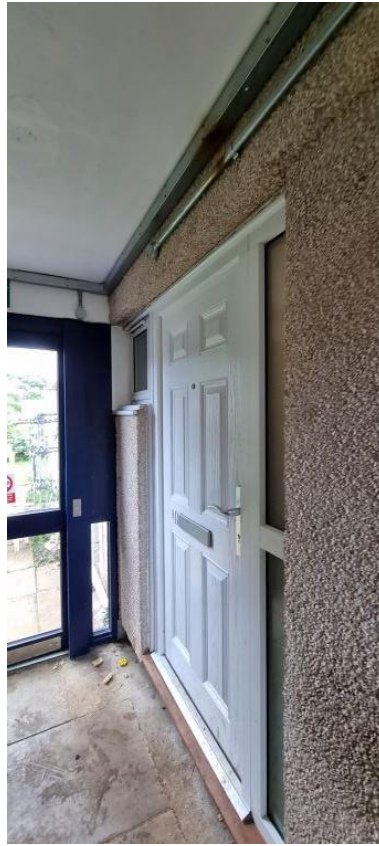
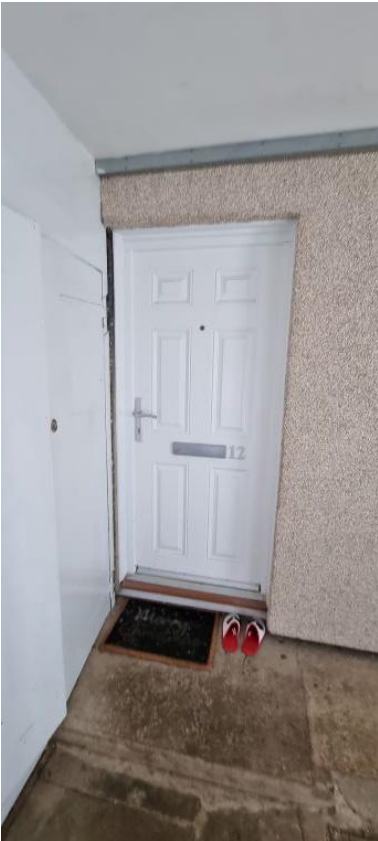
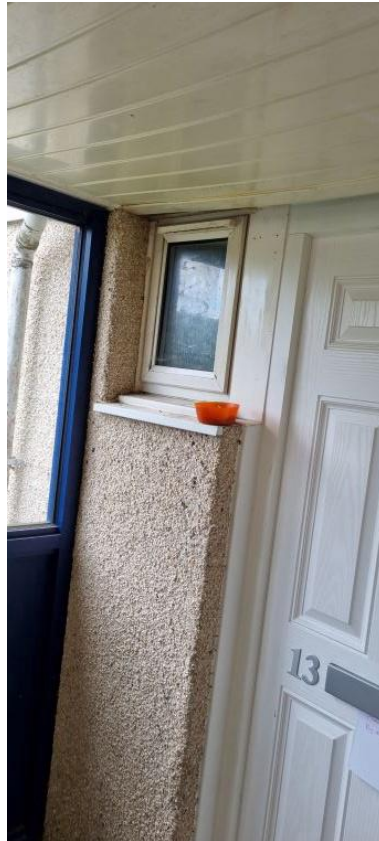
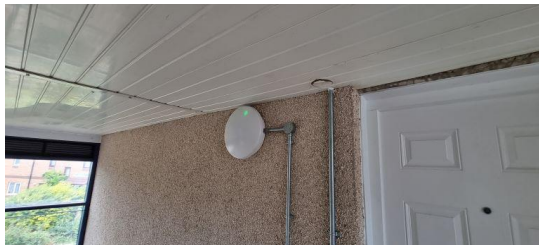
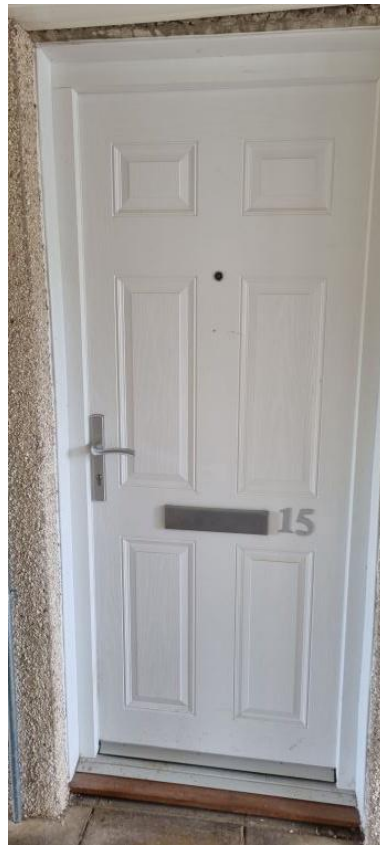
It was not possible to establish fire rating or condition of dwelling doors as no flats were accessed at the time of assessment.

Management should inspect all doors to the premises to establish condition and fire rating and repair or replace doors with certificated FD30S self-closing fire door(s) and frame sets where necessary. These should be fitted by an approved, third party certified installation contractor.

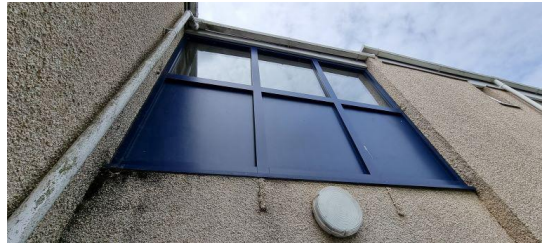
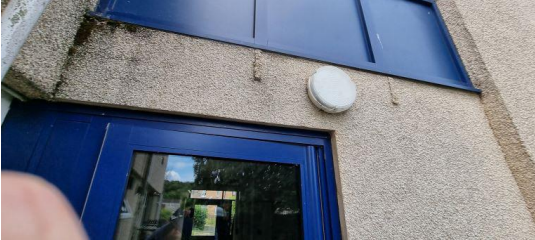
External lighting is installed however no emergency lighting could be detected.

Management should install emergency lighting above exits.

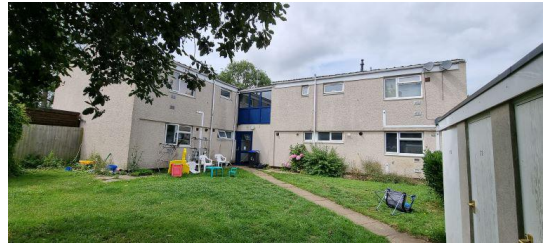
Photo 40

There is no roof space above the common area. It was not possible to establish the level of compartmentation in the roof space above dwellings.

Management should ensure that compartmentation within the roof space above dwellings is sound. Any penetrations should be fire stopped with fire rated building materials.

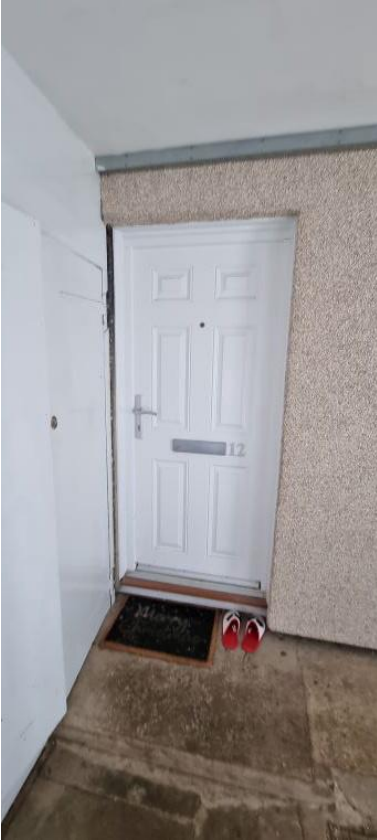
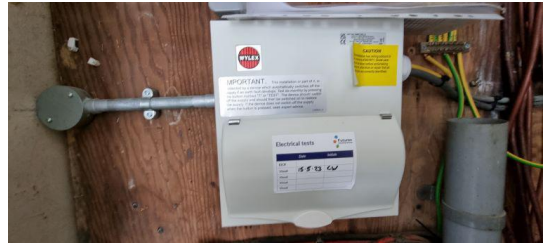
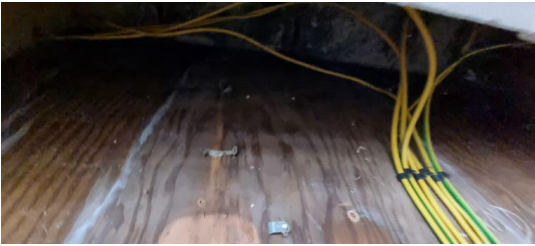
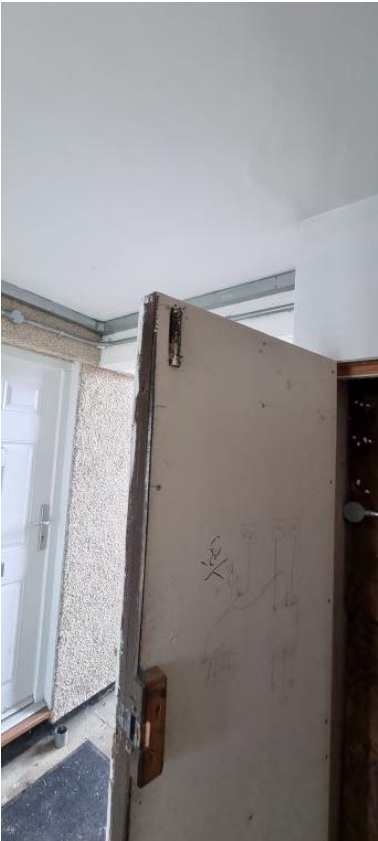
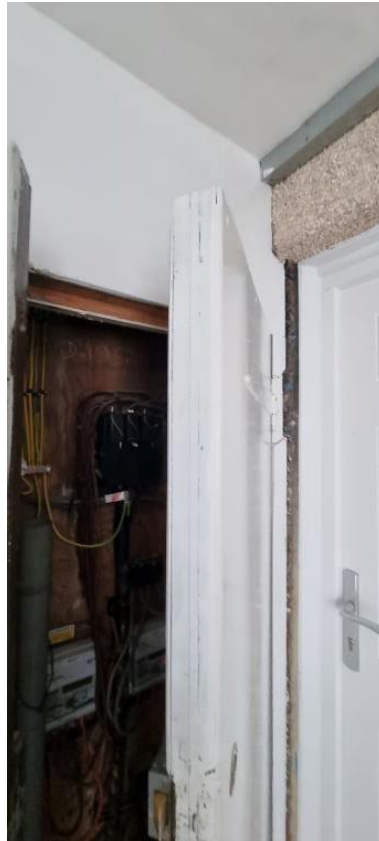
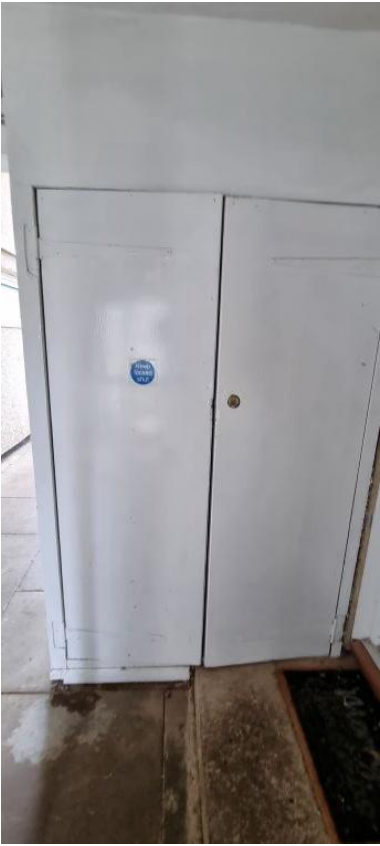
The electrical intake is not contained within a fire rated cupboard and penetrations were identified around wiring.

The electrical intake should be contained within a fire rated enclosure / cupboard. Penetrations around wiring required fire stopping with fire rated building materials. Any work required should only be completed by a certified third-party contractor.
