## Futures Fire Risk Assessment

Futures Homeway, Flats 7-12 Kennedy Close:  
NN11 4JX, - UPRN: 2150000 / 171919 / QA  
Approved / Jack McLinden

Futures Homeway, Flats 7-12  
Kennedy Close: NN11 4JX, -  
UPRN: 2150000, Fire Risk  
Assessments, Futures  
Homeway

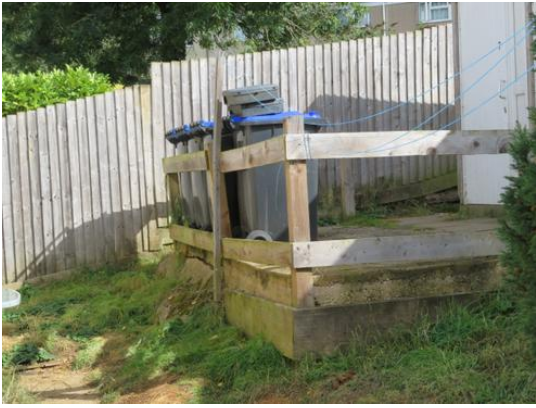
The majority of wheelie bins were noted to be stored away from the building within an enclosed rear garden area. It was however noted that 2 wheelie bins were being stored within the internal common area of the block on the ground floor outside of flats 7 & 9.

The wheelie bins noted as being stored internally should be relocated outside as soon as is reasonably practicable. Residents should be informed that bins are not to be stored internally or on any escape routes externally. Regular checks should be conducted to ensure compliance.

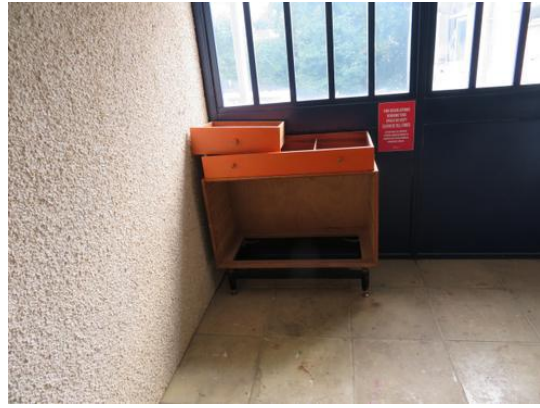
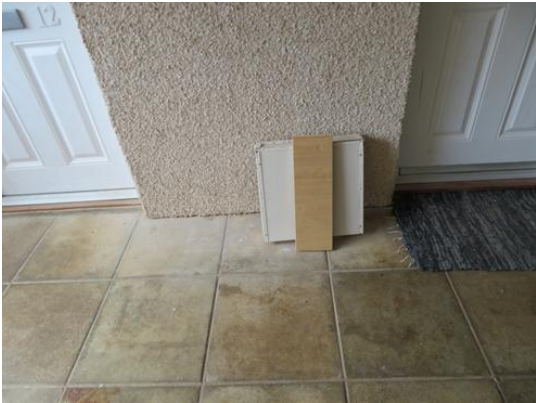
The common escape routes were clear of combustible materials, trip hazards and waste at the time of inspection with the exception of bins noted in section C2 and some discarded furniture items on the first floor landing.

The furniture items noted on the first floor landing should be removed as soon as is reasonably practicable. Residents should be informed that communal areas are not to be used for storage of any items. Regular checks should be conducted to ensure compliance.

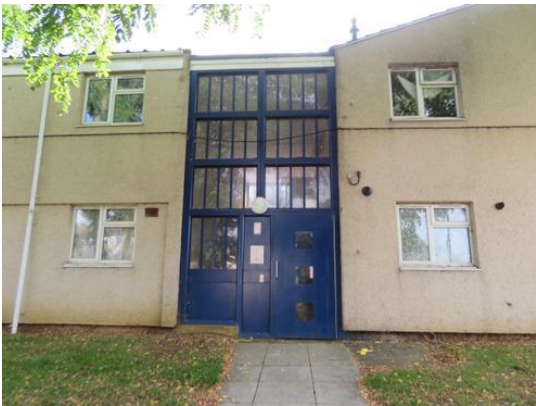
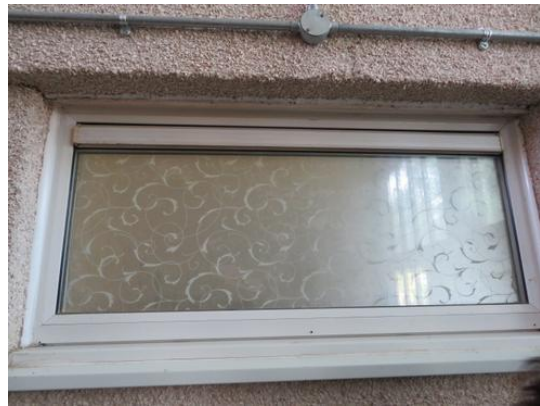
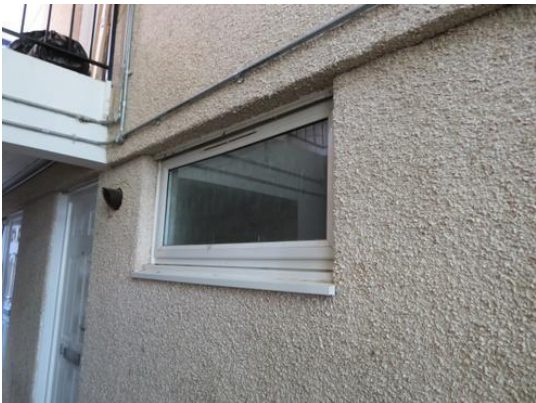
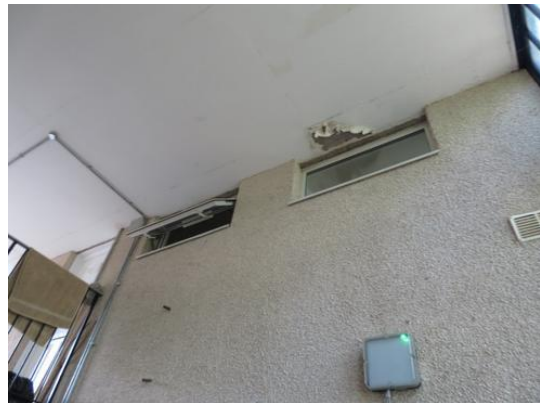
The communal areas are currently ventilated via the front and rear entrance doors.

It is thought that the block was originally designed as an open access balcony style approach block and has since been enclosed to the front and rear with glazed walls and doors to provide security. This has effectively enclosed the communal area with no form of ventilating the upper level. There are no manually or automatic opening windows.

The original design would likely have accepted the openable windows between flats and communal areas as well as venting of boilers into common areas. It cannot be confirmed if the current design allows for this.

The client should refer to the original fire strategy for the building to ascertain the ventilation requirements detailed and approved by the planning authority. If the current arrangement does not meet the requirements laid out in the fire strategy, a fire engineer should be consulted to advise on the suitability of the arrangement, and any remedial works that may be required which should include allowing for manually opening windows into the common area and boiler ventilation from flats.

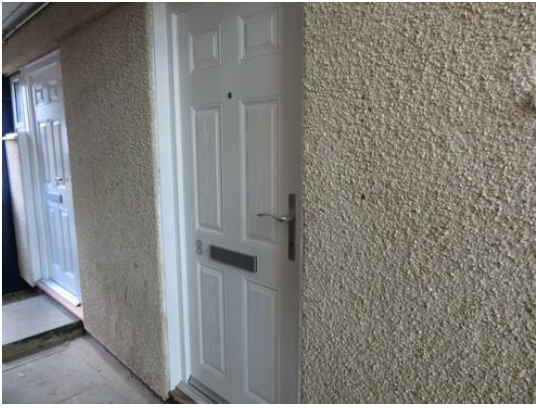
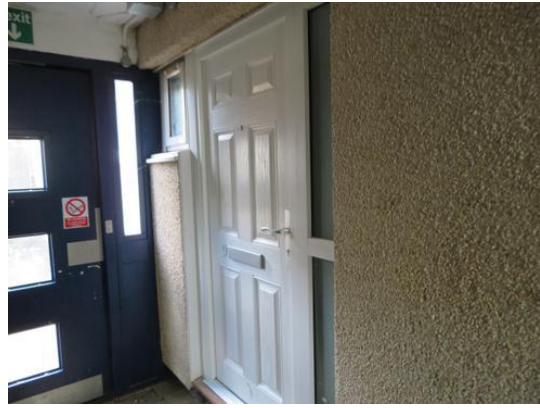
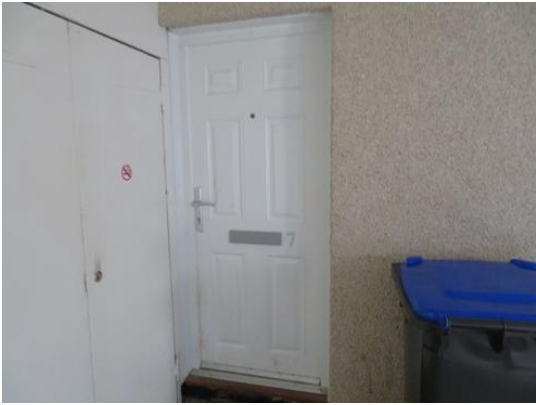
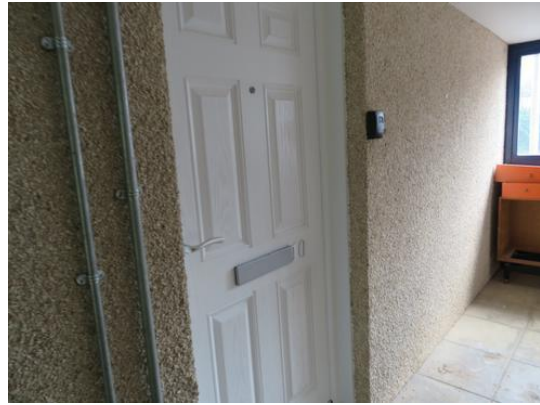
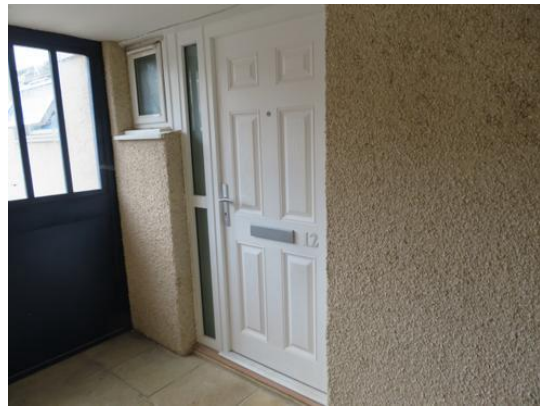
Flat entrance doors were seen to be FD30 fire rated doors. (NB. - from limited visual inspection, certification not seen; adequacy of installation not confirmed).

No flats sample inspected at the time of the assessment.

Management should establish an ongoing programme of rolling checks to flat entrance doors to ensure they are installed with combined intumescent strips/cold smoke seals and positive action self closing devices.

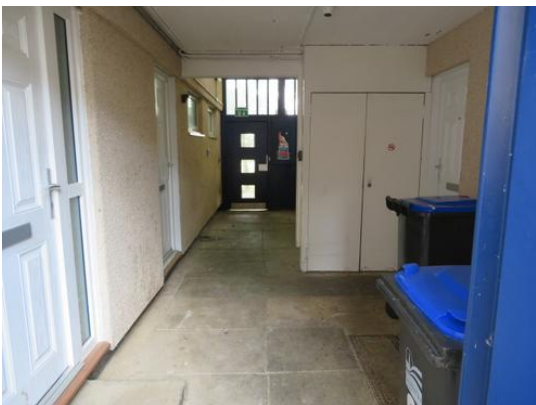
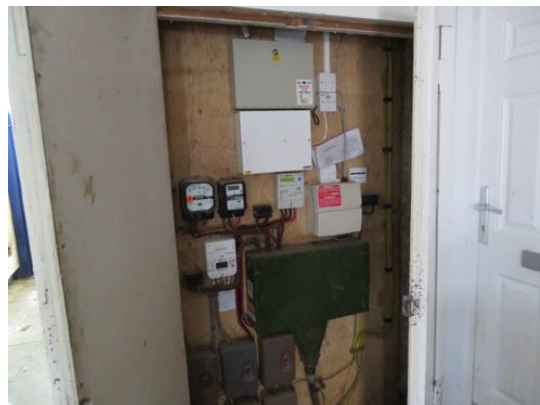
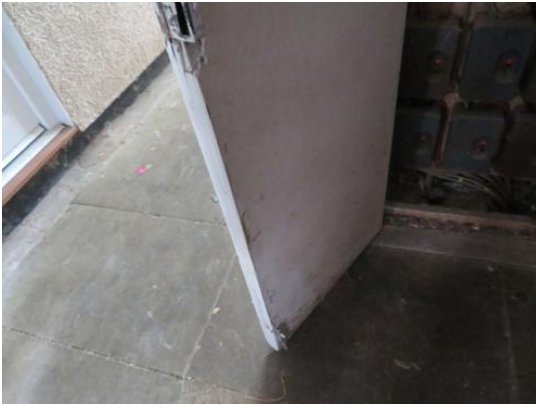
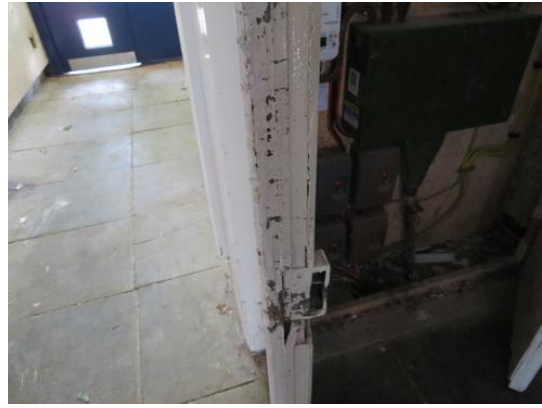
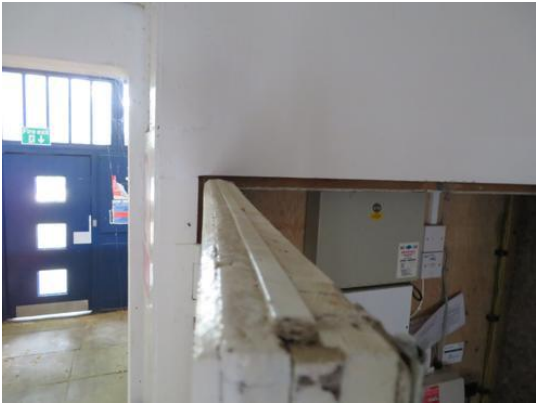
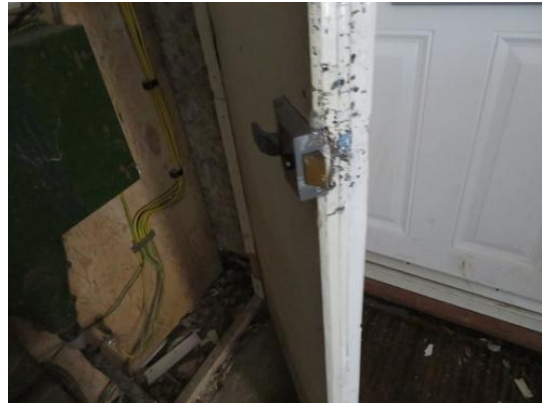
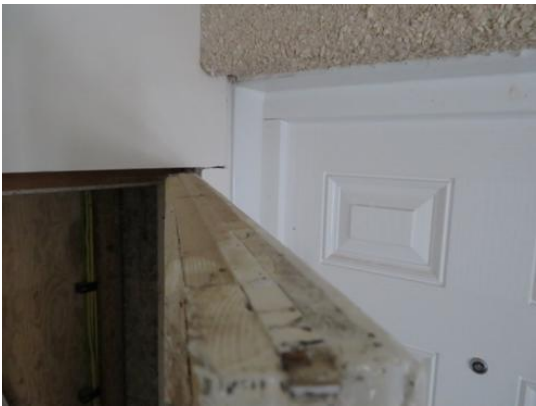
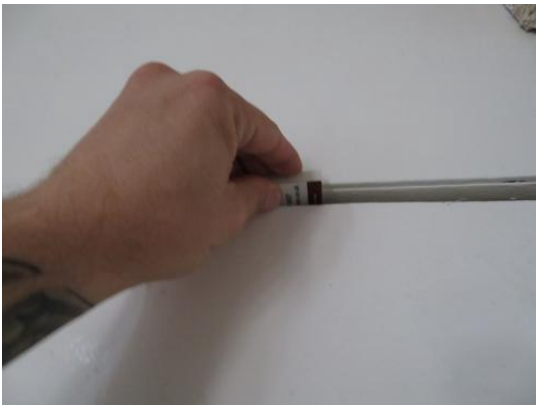
The electrical intake cupboard doors were seen to be 44mm thick solid core timber fire doors installed with intumescent strips only. The following defects were noted:

- Minor repairs are required to the door edge and face
- Gaps noted in intumescent strips on door edges
- Excessive perimeter and meeting gaps noted.

The defects noted to the electrical intake cupboard doors should be repaired or the doors replaced. Remedial works should be completed by a competent third party accredited contractor.

It is recommended that the intumescent seals for the door are replaced with combined intumescent strips/cold smoke seals. This is to prevent the passage of cold smoke between the cupboard and the common area in the event of a fire situation.

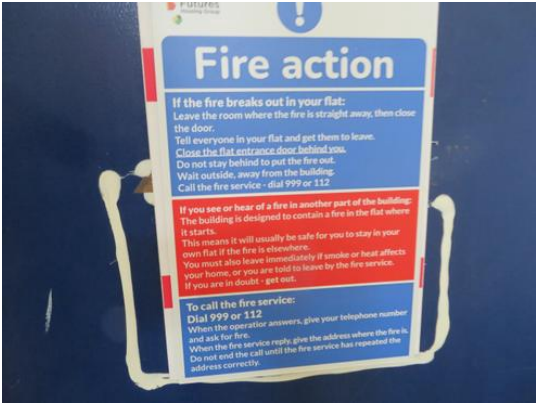
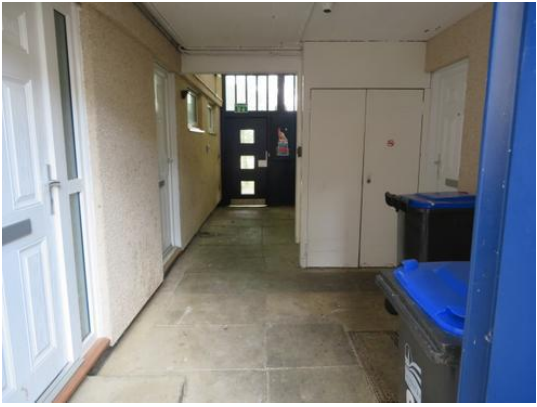
Fire door signage was not installed to the electrical intake cupboard doors.

The 'Push to exit' wording for the final exit doors was worn.

The wording to the push button mechanism should be repaired or new signage installed.

'Fire Door - Keep Locked Shut' signage should be installed to the electrical intake cupboard doors.

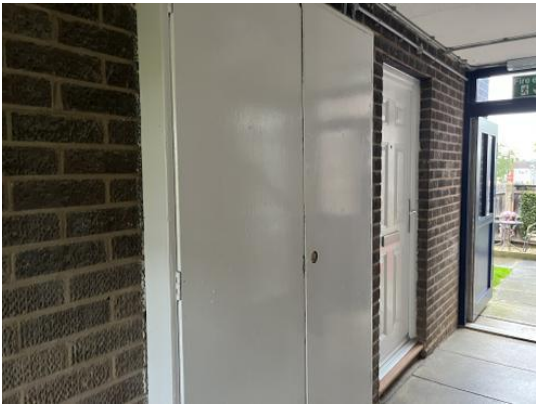
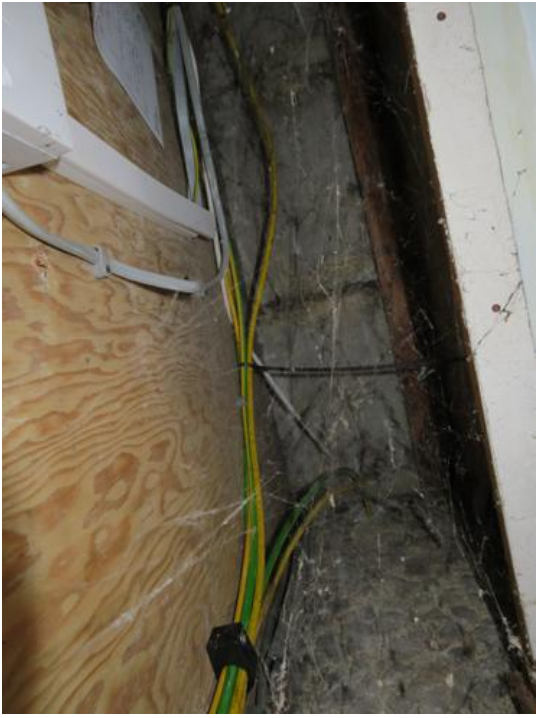
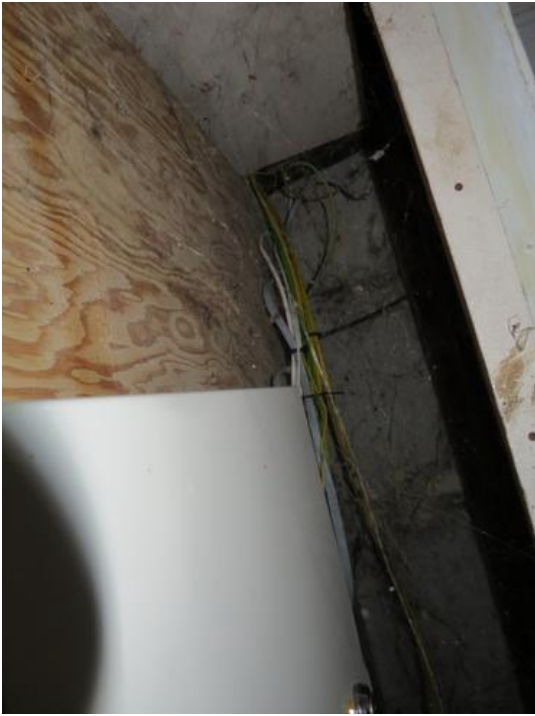
Internal compartment walls of the electrical intake cupboard did not appear to be fire resisting.

The electrical intake cupboard should be upgraded to provide 30 minutes fire resistance. This should include adequate fire stopping of all penetrating services. Remedial works should be completed by a competent third party accredited contractor.

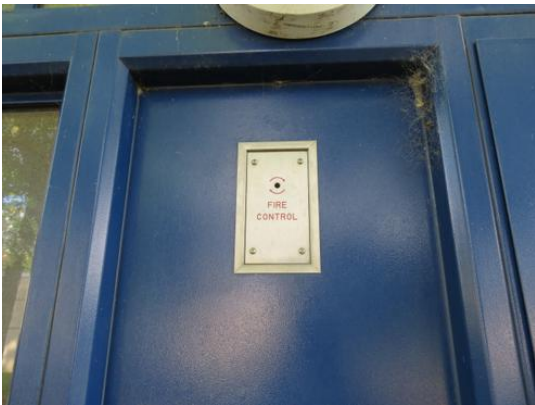
Photo 39

A fire bridge override drop key facility was seen to be installed to the block entrance door. This was not working at the time of the assessment.

The fire brigade override facility should be repaired or replaced.
