Futures Fire Risk Assessment

Futures Homeway, Flats 5A-D Clipston Lane:
LE168LY, - UPRN: 3650000 / 171921 / QA
Approved / Jack McLinden

Futures Homeway, Flats 5A-D
Clipston Lane: LE168LY, - UPRN:
3650000, Fire Risk
Assessments, Futures
Homeway

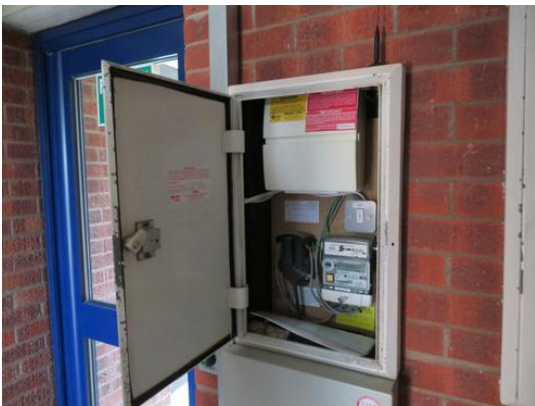
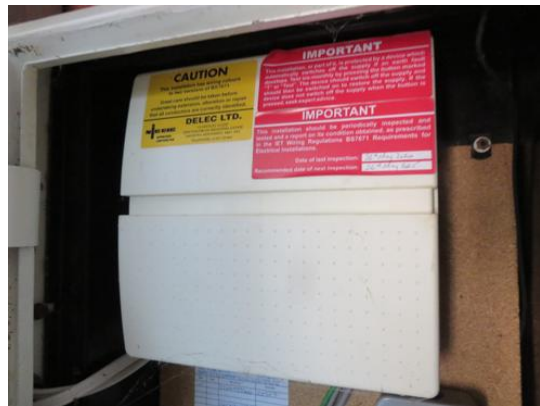
The communal electrical distribution board had a sticker attached indicating the last fixed wiring test took place on 26/05/2020 which is within the last 5 years.

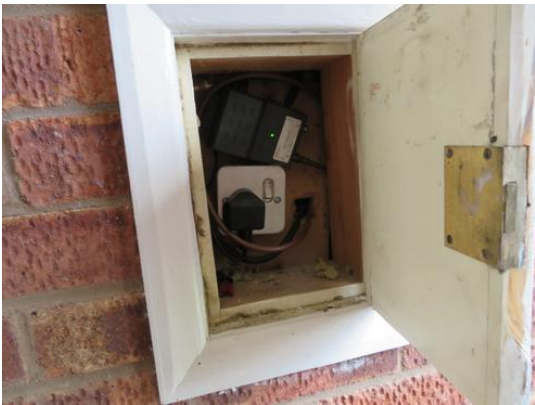
Photo 5

An AV portable appliance was noted within a small void on the first floor landing. There was no evidence to suggest that this has been adequately tested.

The client should confirm that the item noted has been adequately tested as part of the PAT testing schedule mentioned within the Policy Principle.

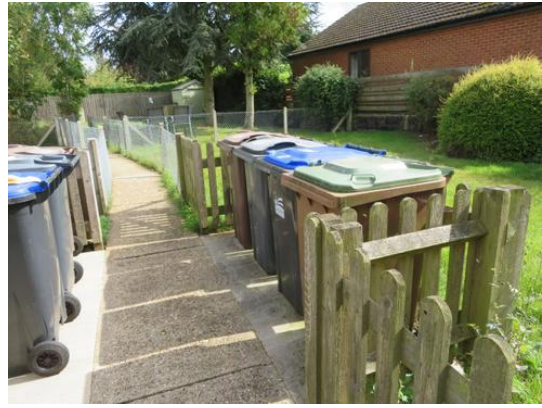
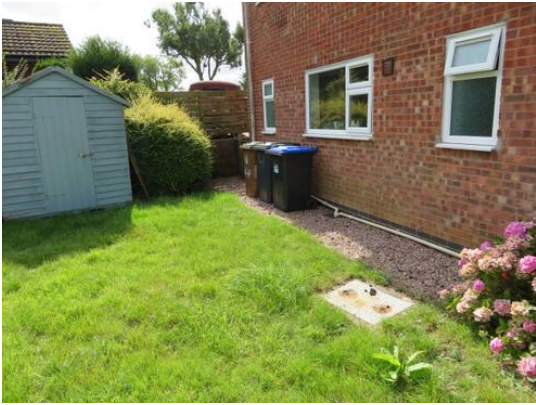
Wheelie bins were noted to be stored away from the building within an enclosed rear garden area. It was however noted that a small amount of bins were being stored against the rear wall of the block, directly beneath windows.

The bins noted as stored against the rear wall of the block should be relocated to the designated storage area away from the building. Residents should be informed that bins must remain in this location. Regular checks should be conducted to ensure compliance.

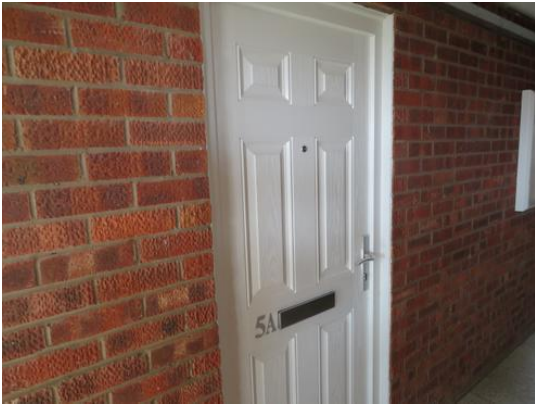
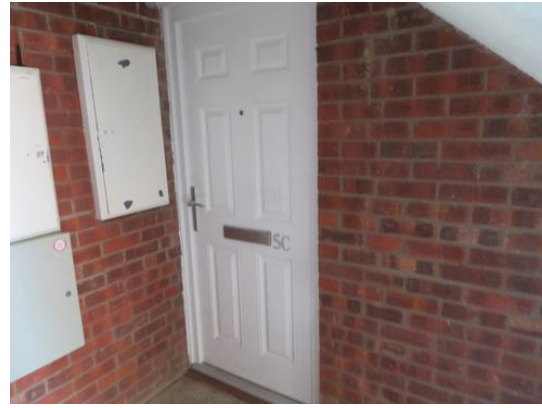
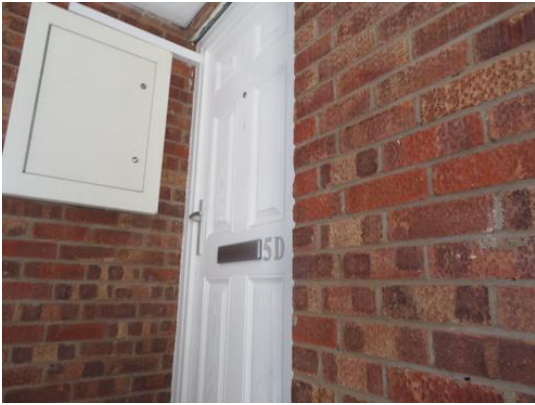
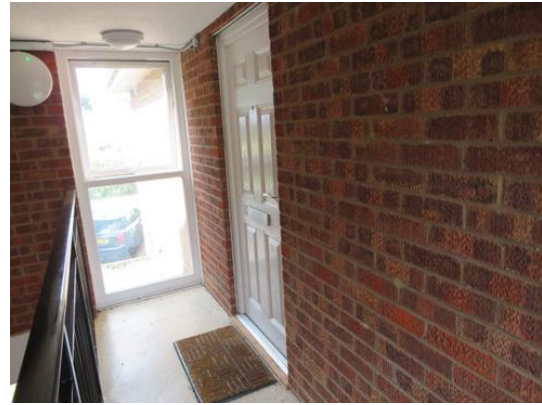
Flat entrance doors were seen to be FD30 fire rated doors. (NB. - from limited visual inspection, certification not seen; adequacy of installation not confirmed).

No flats were available for sample inspection at the time of the assessment.

Management should establish an ongoing programme of rolling checks to flat entrance doors to ensure they are installed with combined intumescent strips/cold smoke seals and positive action self closing devices.

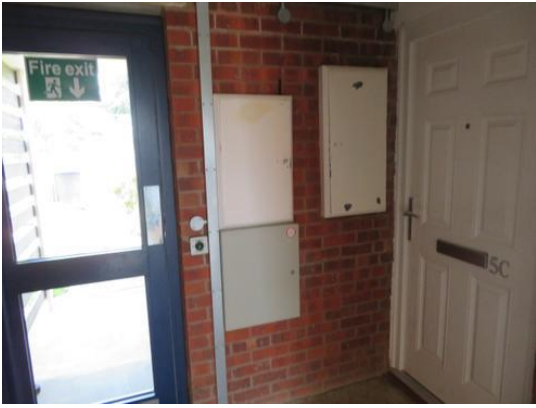
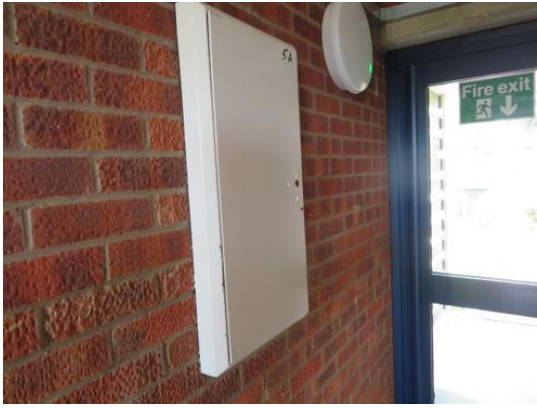
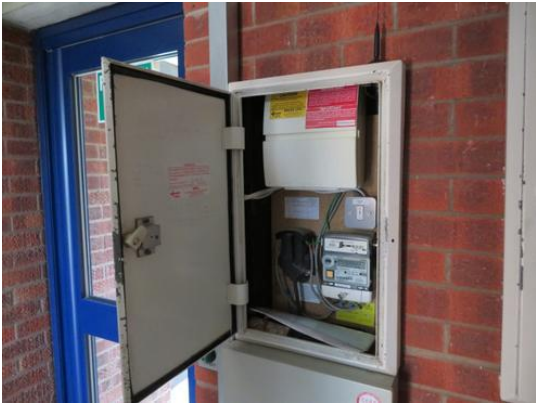
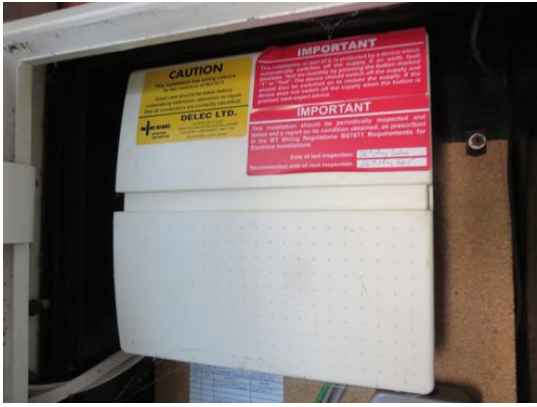
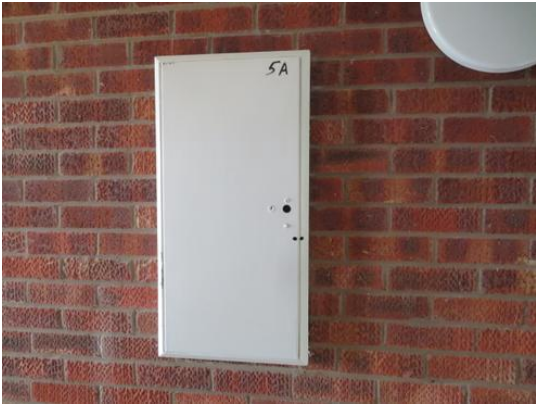
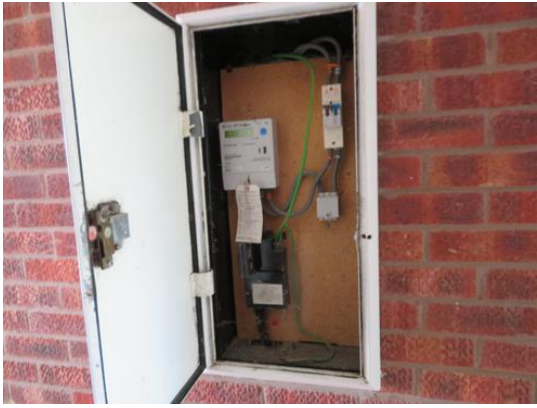
Multiple recessed enclosures were located within the communal areas. This included recessed electricity meter enclosures, a recessed communal electricity supply and meter and a recessed enclosure for AV equipment. The enclosures were not found to be adequately fire resisting or fire stopped.

The recessed enclosures noted should be upgraded to provide 30 minutes of fire resistance, this should also include fire stopping of penetrating services between compartments. It would also be acceptable to install 30 minute fire rated over boxes in addition to fire stopping in lieu of upgrading the enclosures.
